Date:	**June 23, 2010**	**HP District:**	
File #:	**10 - 511807**	**Property Name:**	
Folder Name:	**755 ANDREW ST**	**Survey Info:**	
PIN:	**082822410090**

Date:	**May 10, 2011**	**HP District:**	
File #:	**10 - 511807**	**Property Name:**	
Folder Name:	**755 ANDREW ST**	**Survey Info:**	
PIN:	**082822410090**

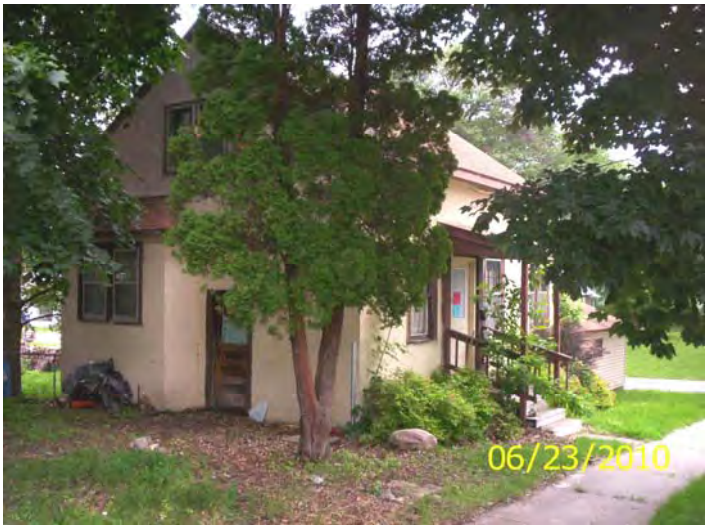
South and east sides, posting
