September 13, 2021

RE: Request for Appeal: Fire Inspection Correction Notice 35410
Versacold USA LLC /Americold
240 Chester Street
Saint Paul, MN

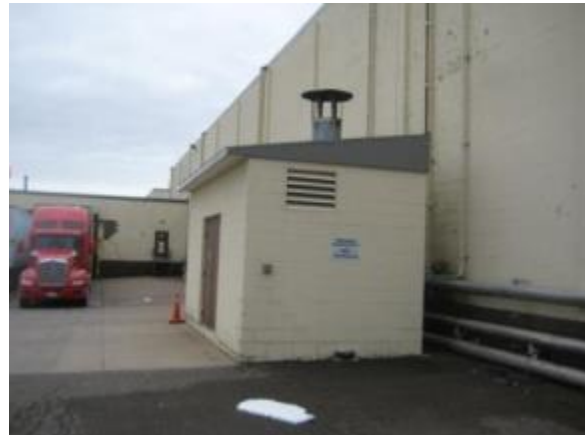
Boiler Building

The boiler is a Bryan water tube hot water unit, M# CL-270W-CI, rated at 2,700,000 Btu/hr. and 30 psi built in 1989. Gas train controls include: Low and high gas pressure switches, two safety shut off valves with no bleed line in between and flame supervision. There is a separate pilot line with a single solenoid valve for a safety shut off valve. Since the boiler has not been used, the gas train safeties have not been tested. This will be done before firing the boiler again.

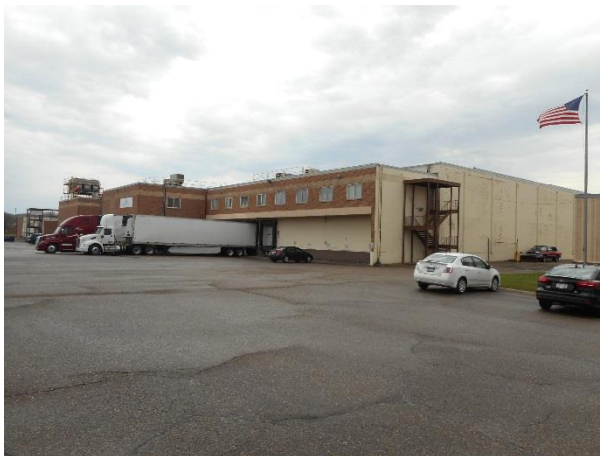
240 Building

Internal partitions include a variety of construction styles such as metal panel sandwich walls, concrete block, combustible "composite" walls (plaster lathe finish over expanded polystyrene or other foam insulation), exposed foam insulation, and drywall. Condition varies from good to poor with certain areas exhibiting exposed foam plastic insulation.

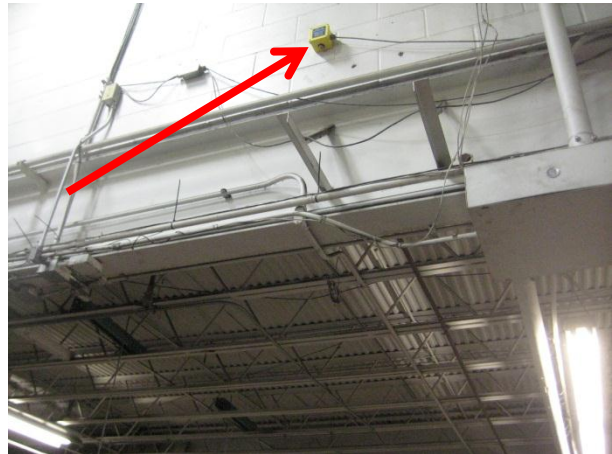
- Raising the existing ammonia detection to the ceiling level versus the current 5 to 12 ft. above the floor in most areas as ammonia is lighter than air.

- Add additional detectors in both engine rooms as both currently only have the one detector.

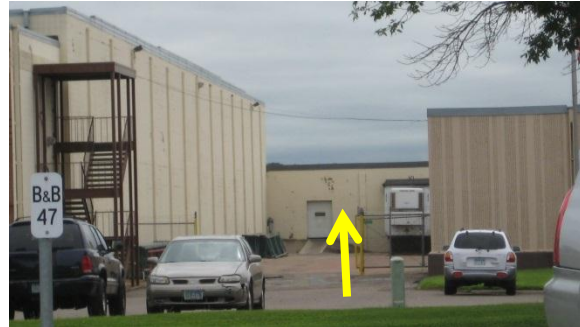
Connecting Dock

The St. Paul site consists of 2 contiguous buildings, the 240 Building and the 260 Building. The two buildings are 70 ft. apart except that they are connected by a dock on the east side of the buildings. Both buildings are subdivided into various freezers and coolers.

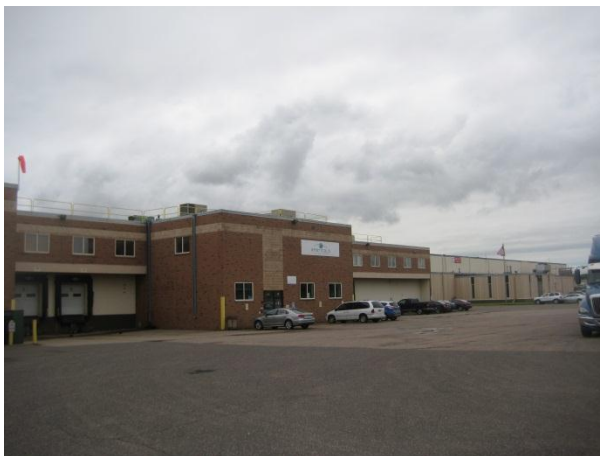
The 240 Building is 1=2 and 2 story office built in 1970. Wall construction is brick veneer on concrete block for the nonfreezer portions and insulated panels for the freezer portions. The roof is a metal deck on steel bar joists supported by unprotected steel columns and is about 25 ft. high. The roof cover is a fully adhered single ply rubber membrane over the nonfreezer portions and a ballasted single ply membrane over the freezer portions. The fire rating of the roof cover is unknown.

Internal partitions include a variety of construction styles such as metal panel sandwich walls, concrete block, combustible "composite" walls (plaster lathe finish over expanded polystyrene or other foam insulation), and drywall. Condition varies from good to poor with certain areas exhibiting exposed foam plastic insulation.

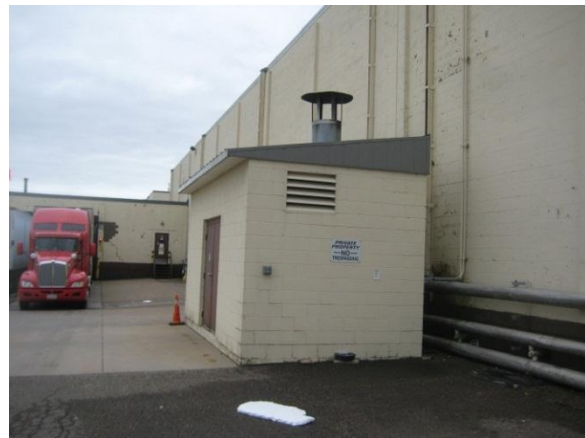
Boilers: There is a small natural gas fired hot water heating boiler located in a detached Boiler Building along the east wall of the 240 Building. This boiler used to be used to heat glycol that was circulated in a heating loop contained in the floors of the 240 Building freezers. However, this boiler is no longer used as it was found that the floors could be heated adequately by just circulating the glycol through the loop using one of two glycol pumps. But, the boiler is still fully connected and could be used.

The boiler is Bryan water tube hot water unit, M# CL-270W-CI, rated at 2,700,000 Btu/hr and 30 psi built in 1989. Gas train controls include: low and high gas pressure switches, two safety shut off valves with no bleed line in between and flame supervision. There is a separate pilot line with a single solenoid valve for a safety shut off valve. Since the boiler has not been used, the gas train safeties have not been tested. This needs to be done before firing the boiler again.

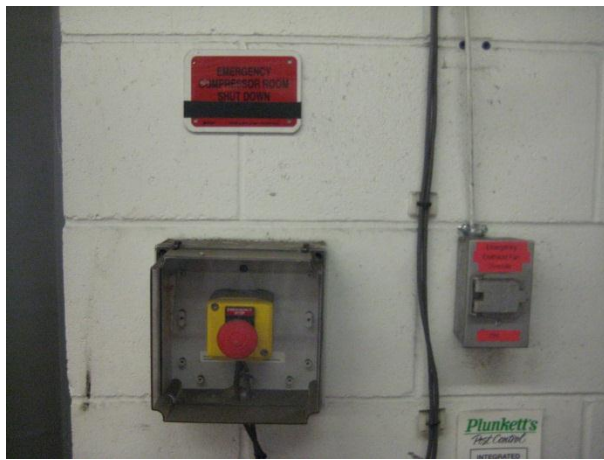
Engine Room 1 E-Stop and Manual Exhaust Control

There are ammonia detectors in each engine room, each warehouse area and the docks. All ammonia detectors are tested monthly per the manufacturer's instructions and the emergency exhaust fan interlock is tested at the same time. The ammonia detectors are calibrated annually per the manufacturer's instructions. The site has three hand held ammonia detectors that there is a regular PM set up on each one for calibrations. Both engine rooms have manual emergency exhaust activation controls and E-Stops located outside the room.

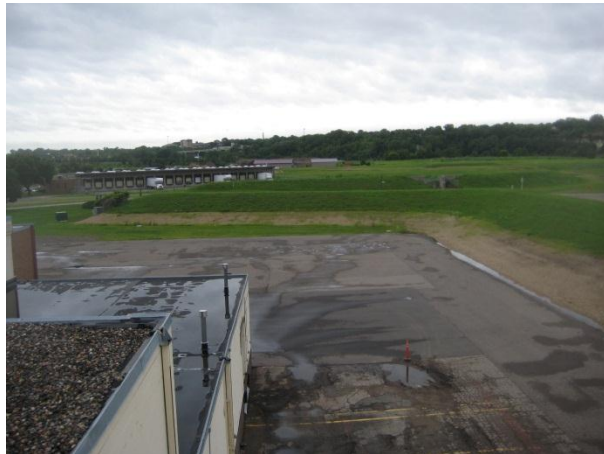
Levee Looking North from 240 Building

The levee was built by the US Army Corps of Engineers and is maintained by the City of St. Paul. The levee appeared in excellent condition during this visit.
