# **Comprehensive Inspections**

# **SUMMARY REPORT**

**Inspection Address:** 132 Western Ave S, St Paul, MN 55102

**Inspection Date:** 10/23/2018 Start: 2:00 pm

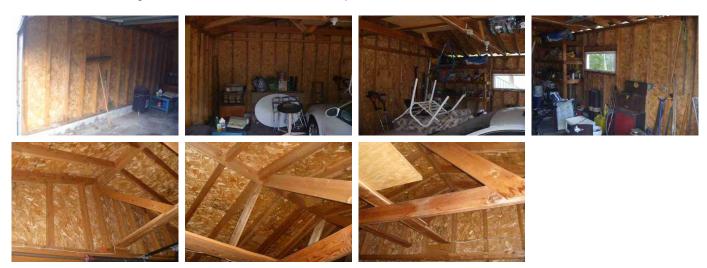
The walls and ceiling are not sheathed and are in acceptable condition.

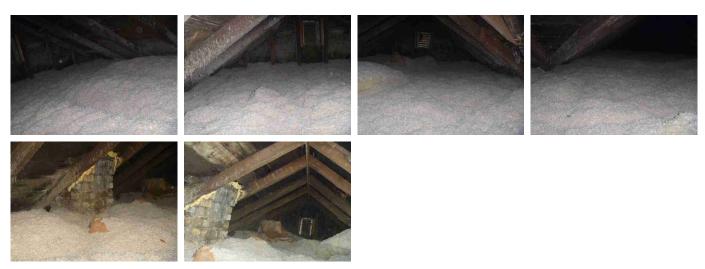
1979, consist of shredded paper and are flammable. However, we do not categorically recommend removing and replacing the insulation, because this is a personal decision that is best made by the owners or the occupants.
