July 23, 2023

I am writing to respectfully request that the Department of Safety and Inspections (DSI) grant me the certificate of occupancy to my 733 Fairview Ave. N., Saint Paul Home for the reasons I will illustrate.

Re: 733 Fairview Ave N  
File#: 14 325587 VB2

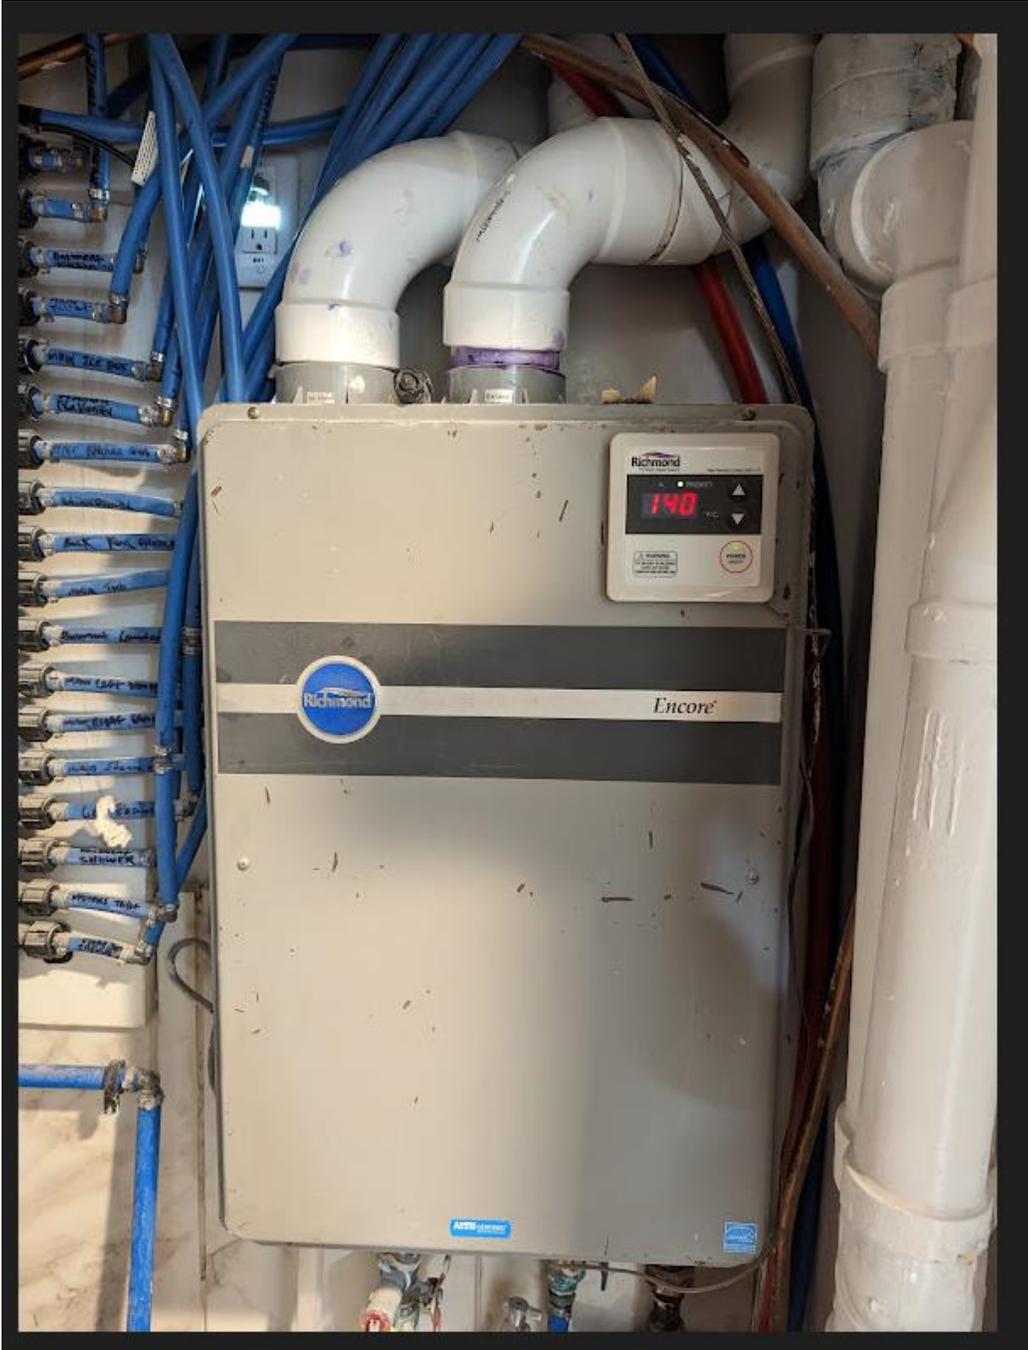
The aforementioned was corrected and the elbows were secured, but that does not warrant a new directive in 2023 for the Plumbing Inspector, Jim Kaufer, who has already seen and inspected the PVC gas venting pipes in 2015 – to require the homeowner to open up the sheetrock of an already finished basement for the inspector to re-inspect what he already himself inspected and passed in 2015-2016. It should be noted, still, into the first half of 2021, the basement ceilings remained open (not sheetrocked) and the gas venting was still exposed and visible. Thus, for the homeowner to now be required as of June 2023 for **“The walls/ceiling will need to be opened**

**up to inspect the water heater venting”** is unreasonable, counterproductive, onerous, but also arbitrary and capricious.

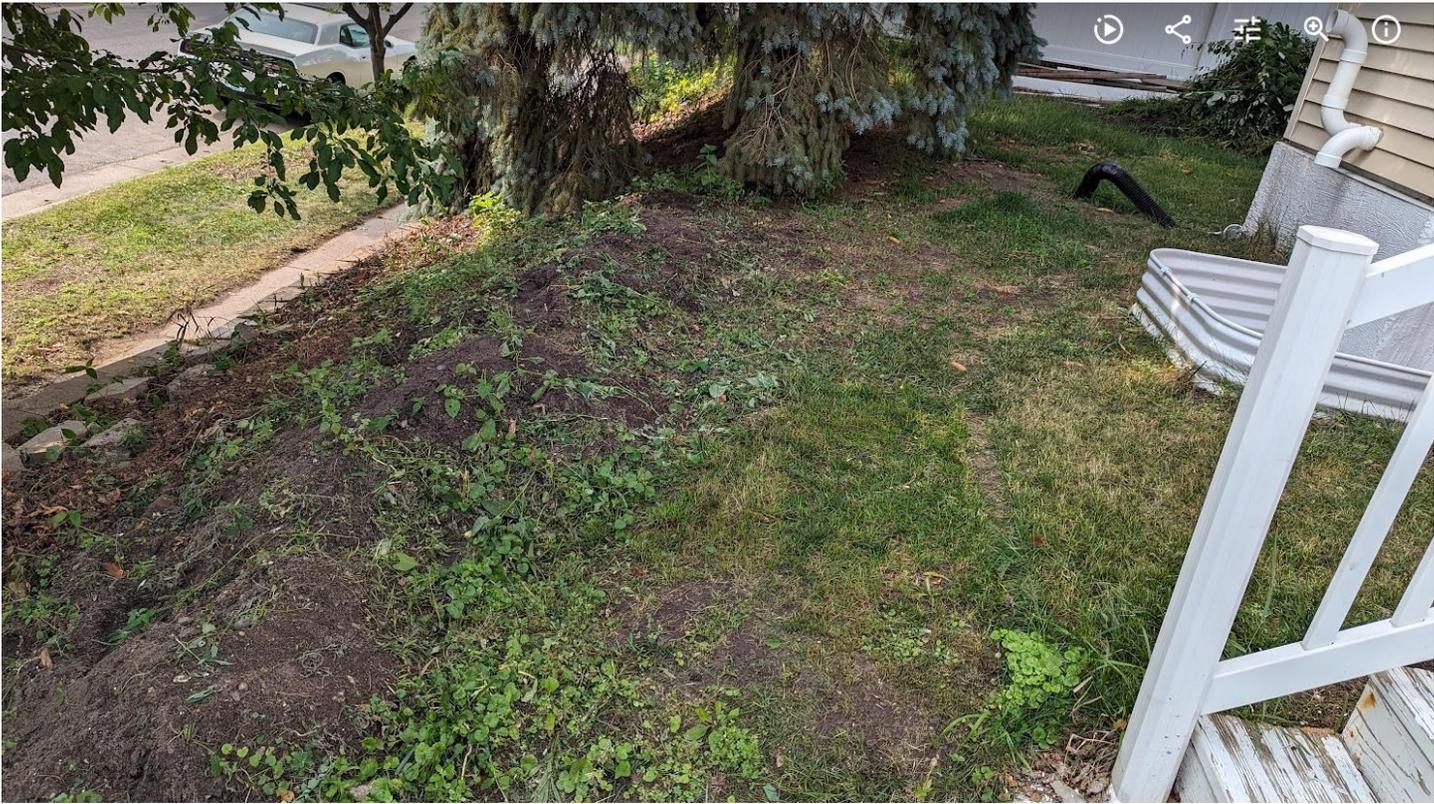
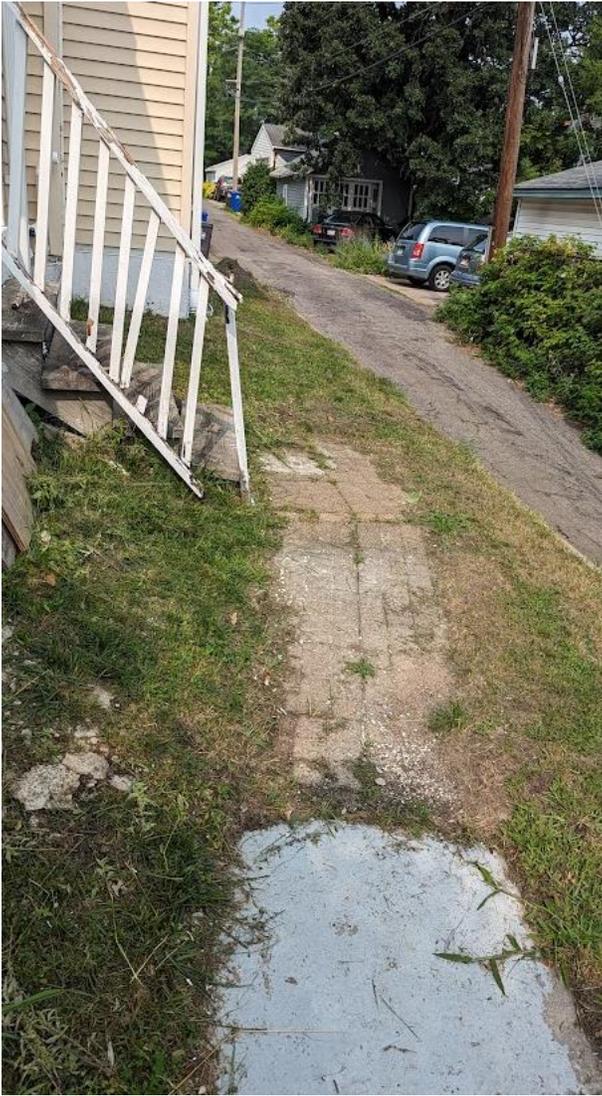
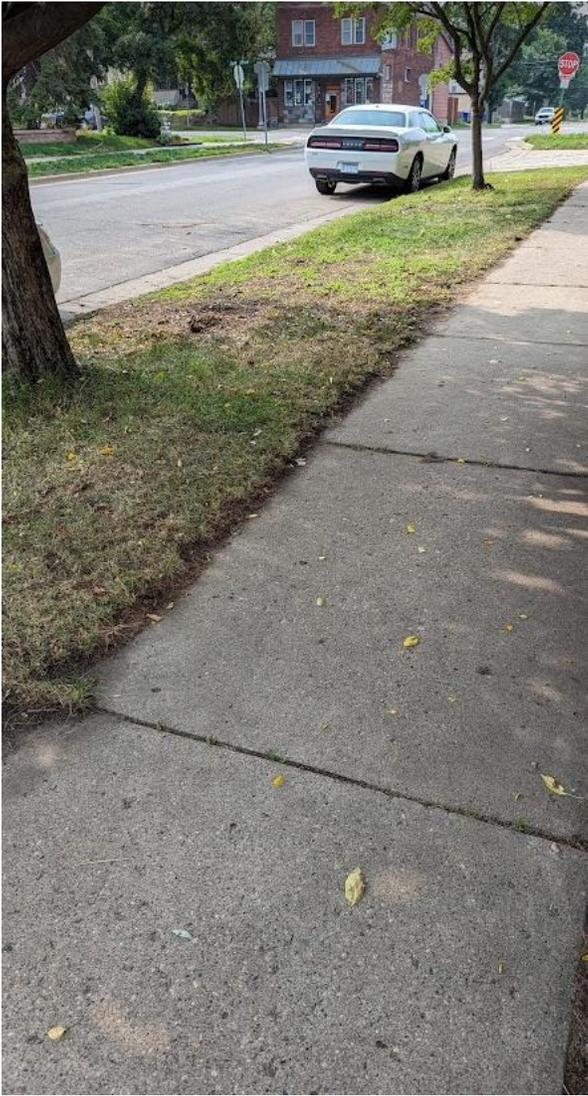
P.S. #2 The grounds (lawn and home)

As of this writing, July 23, 2023, all tall grass, weeds and rank plant growth from the yard, boulevard and even my neighbors' boulevard and alley areas have been cut.
