September 13, 2021

RE: Request for Appeal: Fire Inspection Correction Notice 35410  
Versacold USA LLC /Americold  
240 Chester Street  
Saint Paul, MN

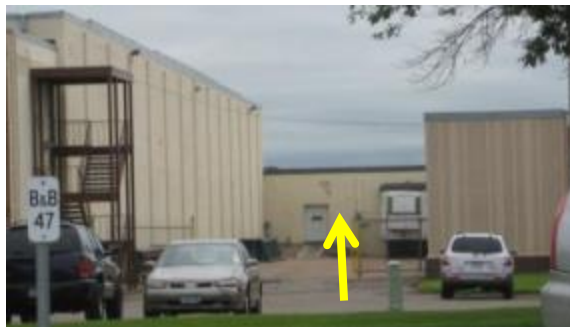
**Connecting Dock**

The St. Paul site consists of two contiguous buildings, the 240 Building and the 260 Building. The two buildings are 70 ft. apart except that they are connected by a dock on the east side of the buildings. Both buildings are subdivided into various freezers and coolers.

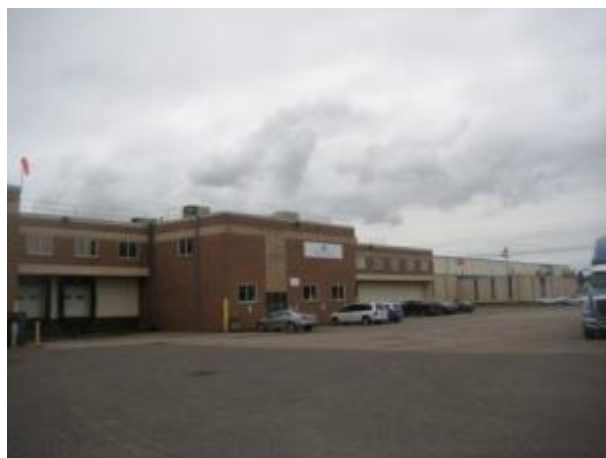
**240 Building**

The 240 Building is 1=2 and 2-story office and was built in 1970. Wall construction is brick veneer on concrete block for the non-freezer portions and insulated panels for the freezer portions. The roof is a metal deck on steel bar joists supported by unprotected steel columns and is about 25 ft. high. The roof cover is a fully adhered single ply rubber membrane over the non-freezer portions and a ballasted single ply membrane over the freezer portions. The fire rating of the roof cover is unknown.

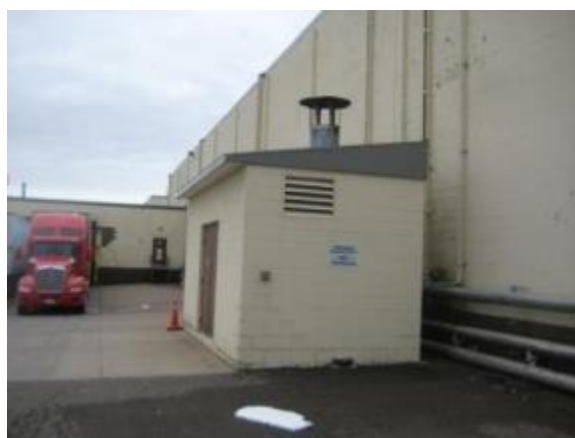
**Boiler Building**

**Boilers:** There is a small natural gas fired hot water heating boiler located in a detached Boiler Building along the east wall of the 240 Building. This boiler used to be used to heat glycol that was circulated in a heating loop contained in the floors of the 240 Building freezers. However, this boiler is no longer used as it was found that the floors could be heated adequately by just circulating the glycol through the loop using one of two glycol pumps. But, the boiler is still fully connected and could be used.

The boiler is a Bryan water tube hot water unit, M# CL-270W-CI, rated at 2,700,000 Btu/hr. and 30 psi built in 1989. Gas train controls include: Low and high gas pressure switches, two safety shut off valves with no bleed line in between and flame supervision. There is a separate pilot line with a single solenoid valve for a safety shut off valve. Since the boiler has not been used, the gas train safeties have not been tested. This will be done before firing the boiler again.

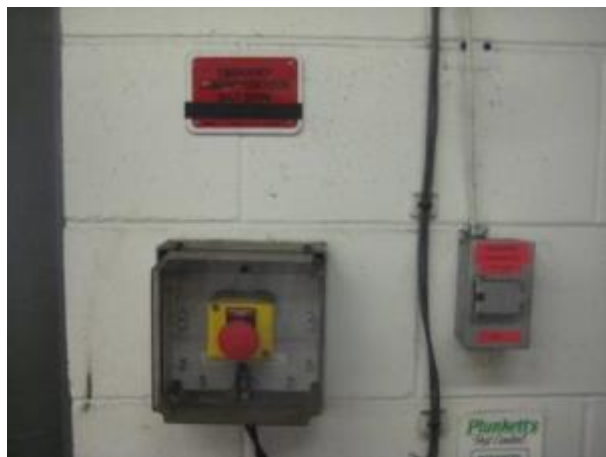
**Engine Room 1 E-Stop and Manual Exhaust Control**

There are ammonia detectors in each engine room, each warehouse area and the docks. All ammonia detectors are bump tested quarterly and the emergency exhaust fan interlock is tested at the same time. The ammonia detectors are calibrated semi-annually. The site has three hand held ammonia detectors that there is a regular PM set up on each one for calibrations (semi-annually). Both engine rooms have manual emergency exhaust activation controls and E-Stops located outside the room.

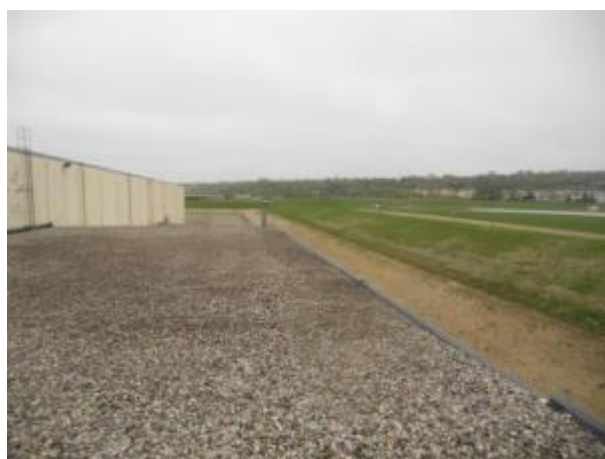
Levee East of 240 Building

The levee was built by the US Army Corps of Engineers and is maintained by the City of St. Paul. The levee appeared in excellent condition during this visit.

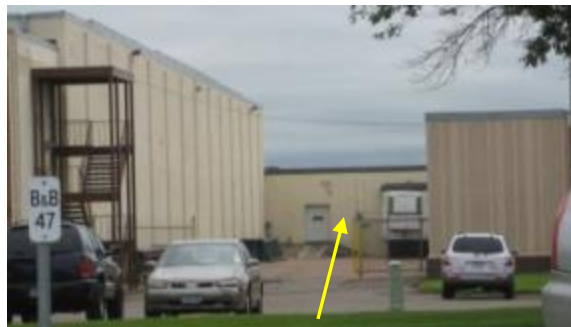
**Connecting Dock**

The St. Paul site consists of two contiguous buildings, the 240 Building and the 260 Building. The two buildings are 70 ft. apart except that they are connected by a dock on the east side of the buildings. Both buildings are subdivided into various freezers and coolers.

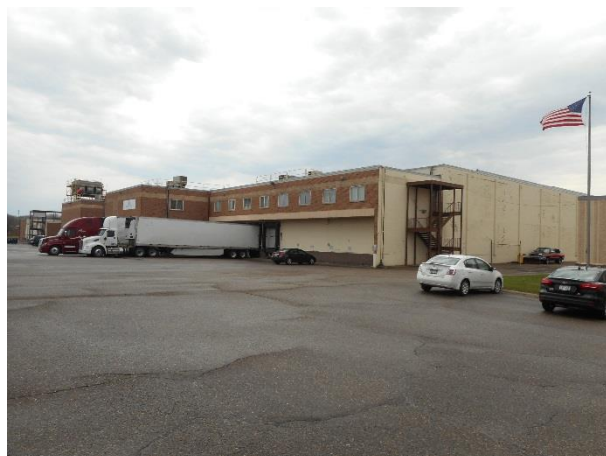
**240 Building**

The 240 Building (north) is 1=2 and 2-story office and was built in 1970. Wall construction is brick veneer on concrete block for the non-freezer portions and insulated panels for the freezer portions. The roof is a metal deck on steel bar joists supported by unprotected steel columns and is about 25 ft. high. The roof cover is a fully adhered single ply rubber membrane over the non-freezer portions and a ballasted single ply membrane over the freezer portions. The fire rating of the roof cover is unknown.

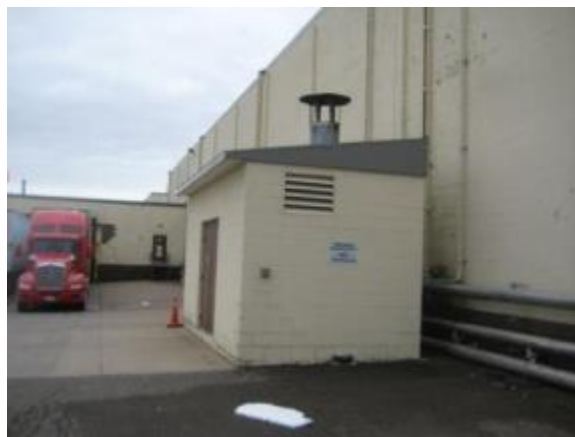
**Boiler Building**

**Boilers:** There is a small natural gas fired hot water heating boiler located in a detached Boiler Building along the east wall of the 240 Building. This boiler used to be used to heat glycol that was circulated in a heating loop contained in the floors of the 240 Building freezers. However, this boiler is no longer used as it was found that the floors could be heated adequately by just circulating the glycol through the loop using one of two glycol pumps. But, the boiler is still fully connected and could be used.

The boiler is a Bryan water tube hot water unit, M# CL-270W-CI, rated at 2,700,000 Btu/hr. and 30 psi built in 1989. Gas train controls include: Low and high gas pressure switches, two safety shut off valves with no bleed line in between and flame supervision. There is a separate pilot line with a single solenoid valve for a safety shut off valve. Safety controls are still tested. (Last done February 2018.)

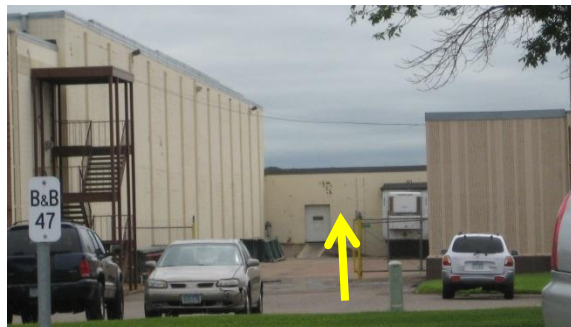
**Connecting Dock**

The St. Paul site consists of 2 contiguous buildings, the 240 Building and the 260 Building. The two buildings are 70 ft. apart except that they are connected by a dock on the east side of the buildings. Both buildings are subdivided into various freezers and coolers.

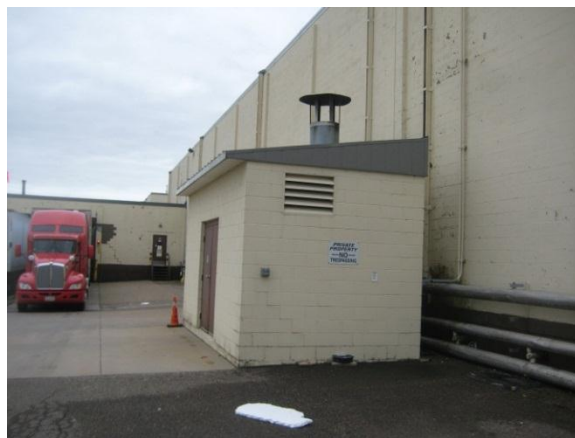
**Boiler Building**

**Boilers:** There is a small natural gas fired hot water heating boiler located in a detached Boiler Building along the east wall of the 240 Building. This boiler used to be used to heat glycol that was circulated in a heating loop contained in the floors of the 240 Building freezers. However, this boiler is no longer used as it was found that the floors could be heated adequately by just circulating the glycol through the loop using one of two glycol pumps. But, the boiler is still fully connected and could be used.

The boiler is Bryan water tube hot water unit, M# CL-270W-CI, rated at 2,700,000 Btu/hr and 30 psi built in 1989. Gas train controls include: low and high gas pressure switches, two safety shut off valves with no bleed line in between and flame supervision. There is a separate pilot line with a single solenoid valve for a safety shut off valve. Since the boiler has not been used, the gas train safeties have not been tested. This needs to be done before firing the boiler again.

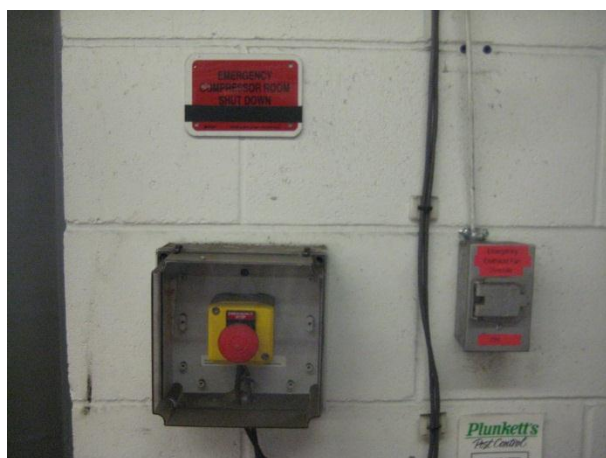
**Engine Room 1 E-Stop and Manual Exhaust Control**

There are ammonia detectors in each engine room, each warehouse area and the docks. All ammonia detectors are tested monthly per the manufacturer's instructions and the emergency exhaust fan interlock is tested at the same time. The ammonia detectors are calibrated annually per the manufacturer's instructions. The site has three hand held ammonia detectors that there is a regular PM set up on each one for calibrations. Both engine rooms have manual emergency exhaust activation controls and E-Stops located outside the room.

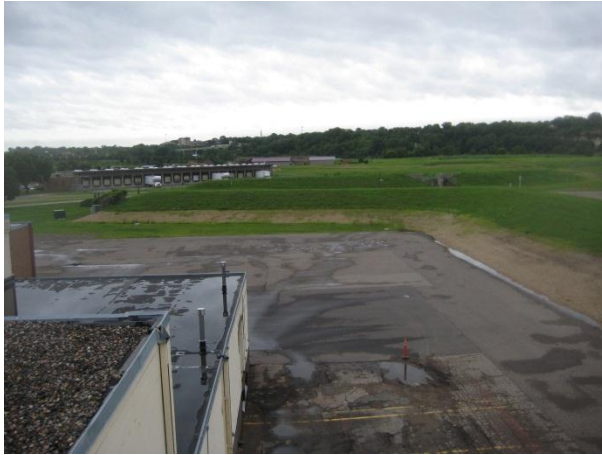
**Levee Looking North from 240 Building**

The levee was built by the US Army Corps of Engineers and is maintained by the City of St. Paul. The levee appeared in excellent condition during this visit.
