PARKING RAMP EVALUATION REPORT

Best Western Plus Como Park Hotel Parking Ramp
1015 Bandana Boulevard East
Saint Paul, Minnesota 55105

Encompass Project #: 22-8144-000

January 3, 2023

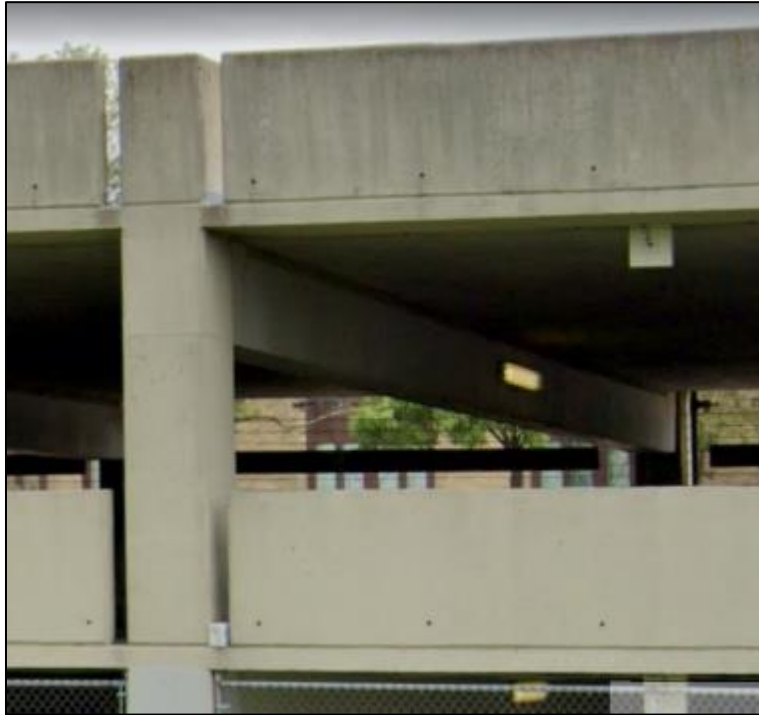
SK-2: Google Image of Level 3 ½ PT Beam

2.3.4.1 The visible traffic coating on Level 2 was in poor condition and the Google aerial image of Level 3.5 shows a severely deteriorated traffic coating present.

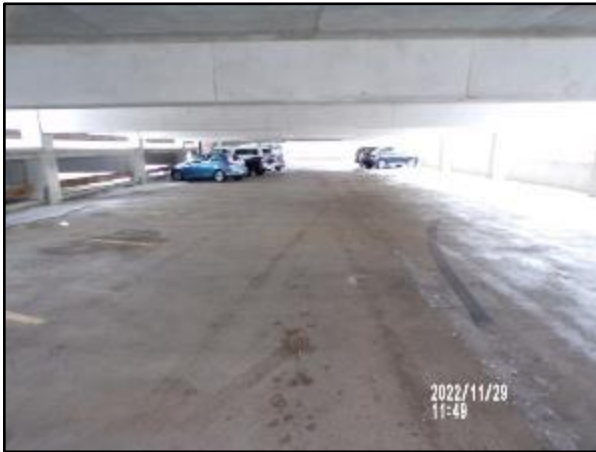
Level 2 looking south

2.3.2.1 Deteriorated traffic coating was observed on level 2 with large tears and missing sections found. The detailing near expansion joints was found to be in the worst condition.

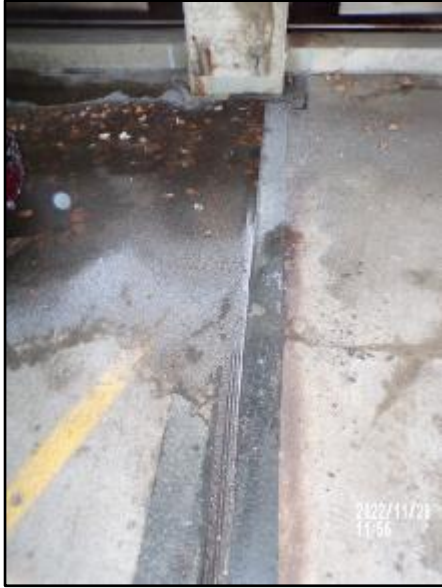
Level 2.5

2.4.1.2 The expansion joints in poor condition had visible tears and debonding of the top horizontal wings (legs) at various points along the joint.

Expansion Joint Top

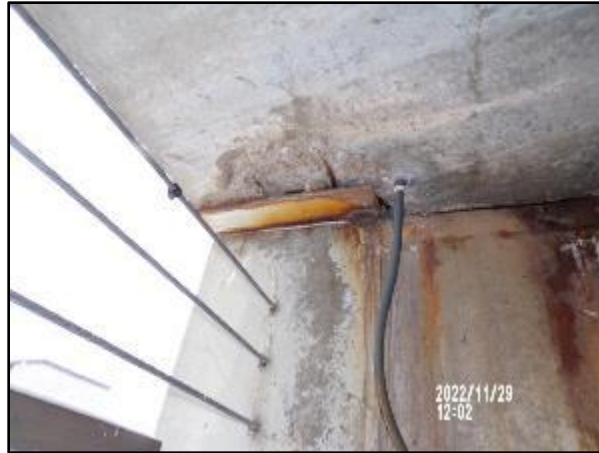
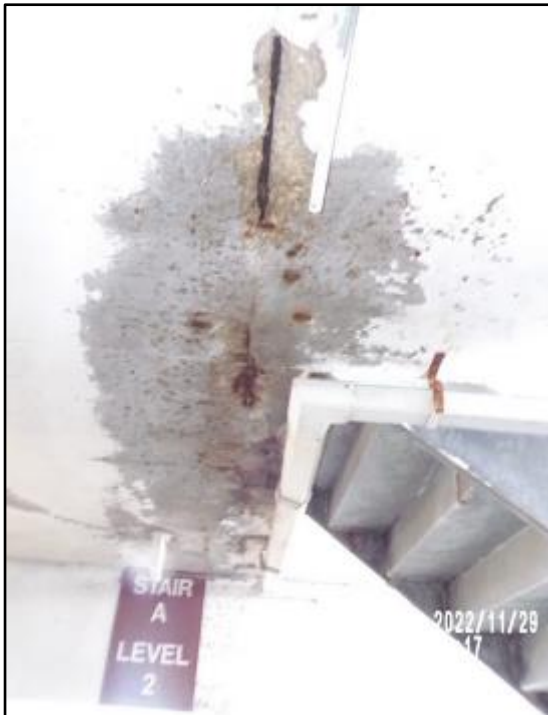
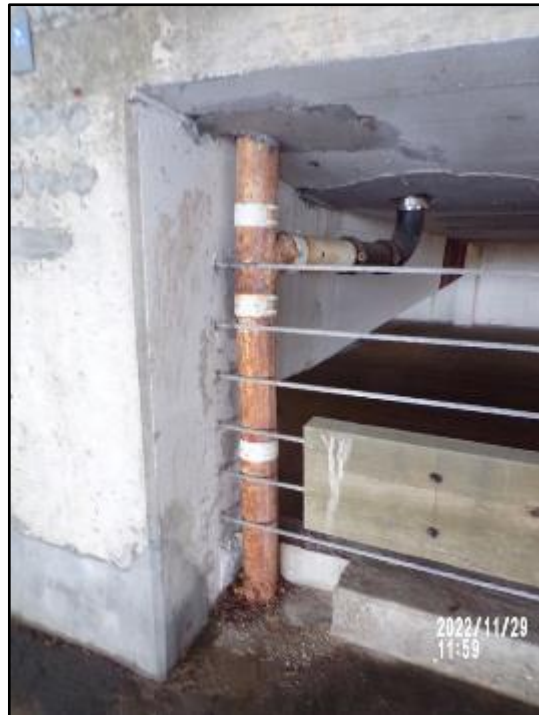
2.5.1 Bottom cracking is present on the underside of all PT slabs with varied levels of cracking.

2.5.1.2 Cracks in the underside of the slabs showed varied degrees of efflorescence present.

Bottom Surfaces of PT Slabs and Beams

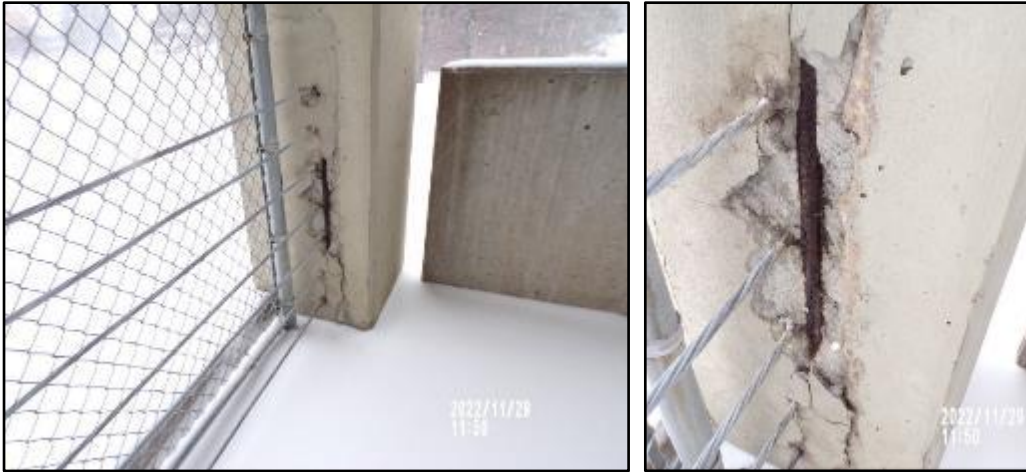
Level 2.5 southwest corner

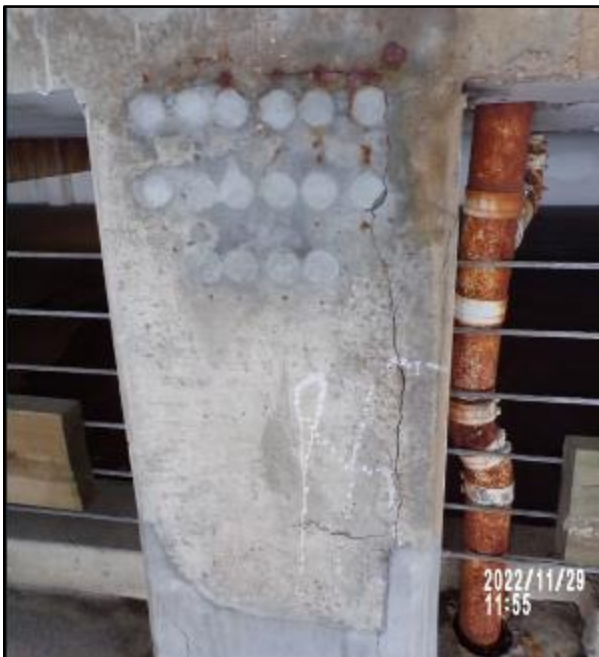
Level 2.5 previous column base patching starting to re crack

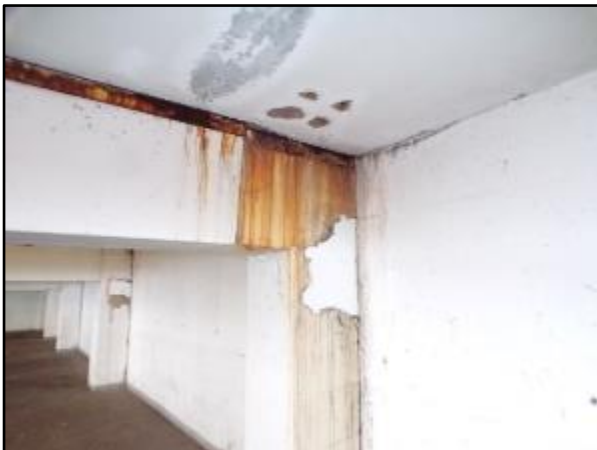
Column spall below beam at east foundation wall
