September 13, 2021

RE: Request for Appeal: Fire Inspection Correction Notice 35410
Versacold USA LLC /Americold
240 Chester Street
Saint Paul, MN

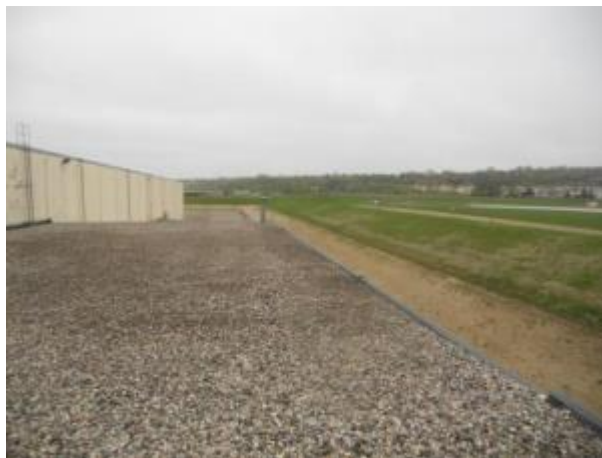
Levee East of 240 Building

The levee was built by the US Army Corps of Engineers and is maintained by the City of St. Paul. The levee appeared in excellent condition during this visit.

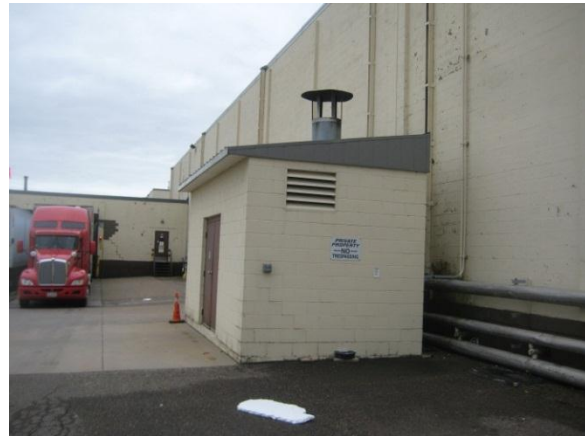
Boiler Building

The boiler is Bryan water tube hot water unit, M# CL-270W-CI, rated at 2,700,000 Btu/hr and 30 psi built in 1989. Gas train controls include: low and high gas pressure switches, two safety shut off valves with no bleed line in between and flame supervision. There is a separate pilot line with a single solenoid valve for a safety shut off valve. Since the boiler has not been used, the gas train safeties have not been tested. This needs to be done before firing the boiler again.
