February 10, 2016

RE: Foundation Assessment
956 Geranium Ave E
St. Paul, Minnesota

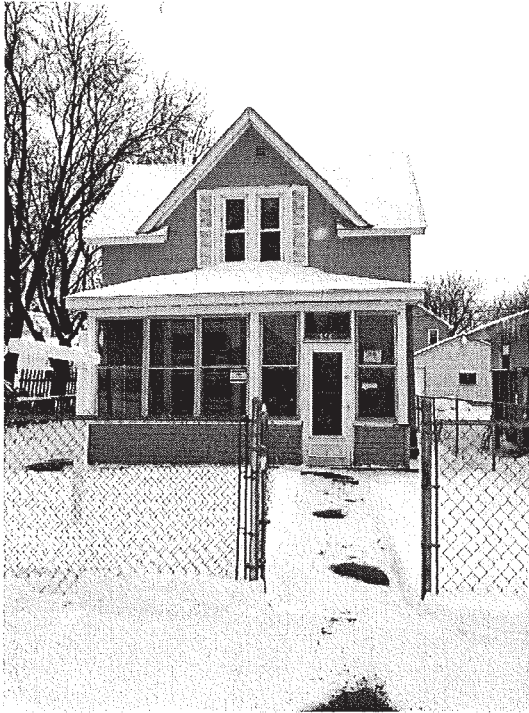
Photo 1 – North Elevation of 956 Geranium Ave

As requested, I visited the above referenced site to assess the condition of the residential foundation. The home is currently vacant and on the market for sale. The 1 1/2 story, single family residence (see Photo 1) sits atop a foundation system of exterior stone walls and interior heavy timber support beams. My review was limited to the main level structure and the foundation area below. No lighting was available in the lower level, so my review was limited to those areas I could illuminate with a flash light.
