**Limited Structural Engineering Services Report
511 Minnehaha Avenue East, St. Paul, Minnesota 55130
SRC Project No. SRC24-302
January 2, 2025
for
Jerry Brashier**

RE: Limited Structural Engineering Services Report
Building location: 511 Minnehaha Avenue East, St. Paul, Minnesota 55130
Via: Emailed this date.

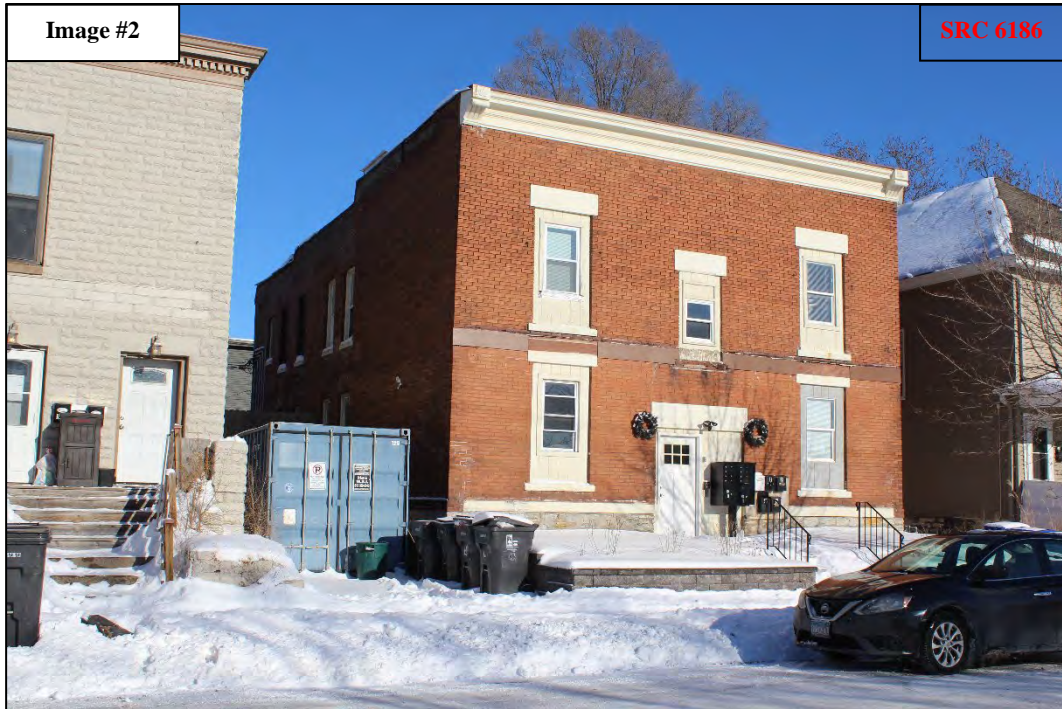
Image #2

21. See **Image #2** for a view of the exterior of the front left corner of the structure taken from the front looking towards the front left corner of the structure.

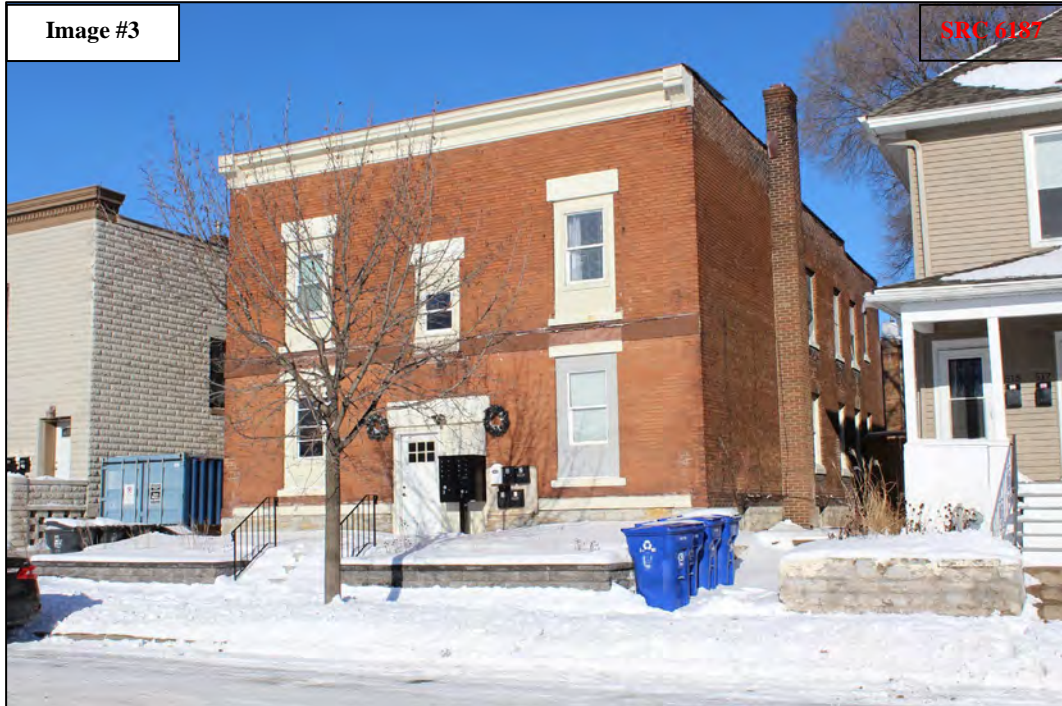
Image #3

22. See **Image #3** for a view of the exterior of the front right corner of the structure taken from the front looking towards the front right corner of the structure.

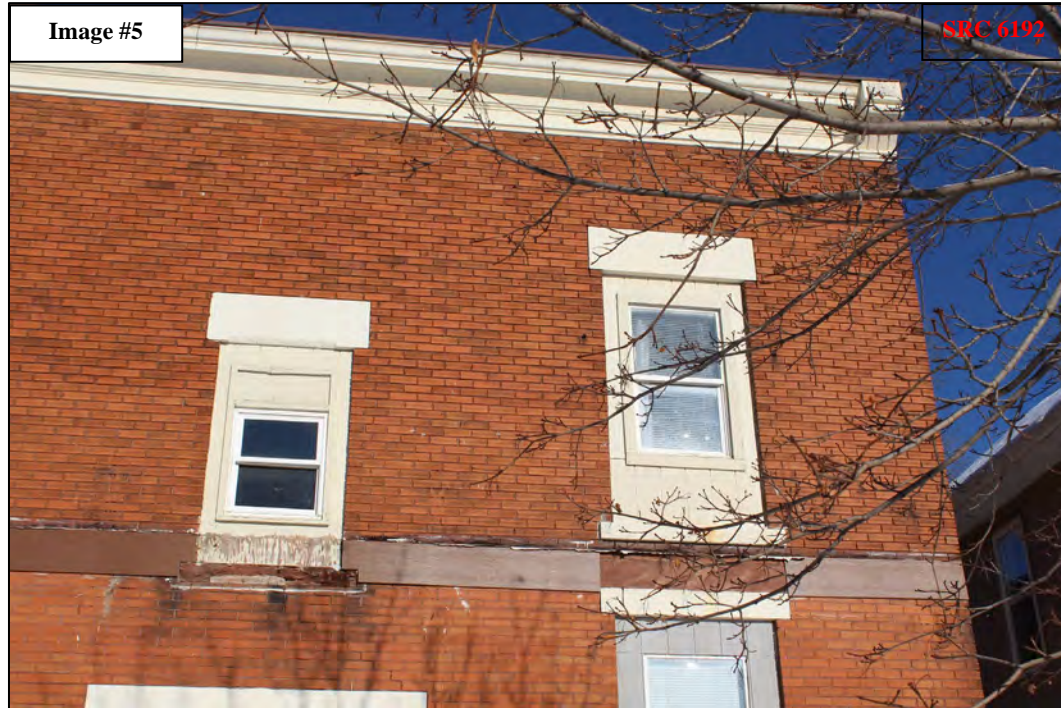
Image #5

24. See **Image #5** for a view of the top of the front right corner of the structure. See the previous image for comments that may apply to this image.

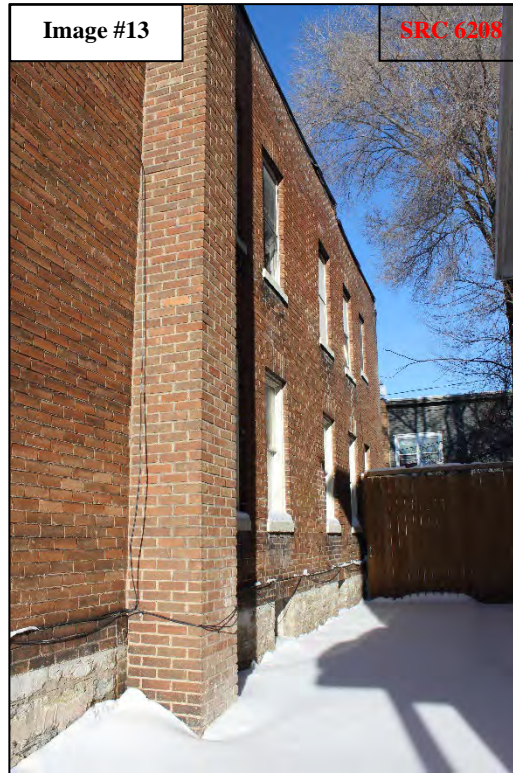
Image #13

32. See **Image #13** for a view of the back end of the right side wall of the structure.
33. See **Image #14** for a closer view of the top of the right side wall. This image shows the cap flashing of the wall is not secured to the top of the wall. The membrane under the cap flashing appears to be loose. The cap flashing should be repaired as soon as possible to reduce the potential of moisture intrusion into and around the wall area and to reduce the potential of roofing damage due to moisture intrusion and wind.

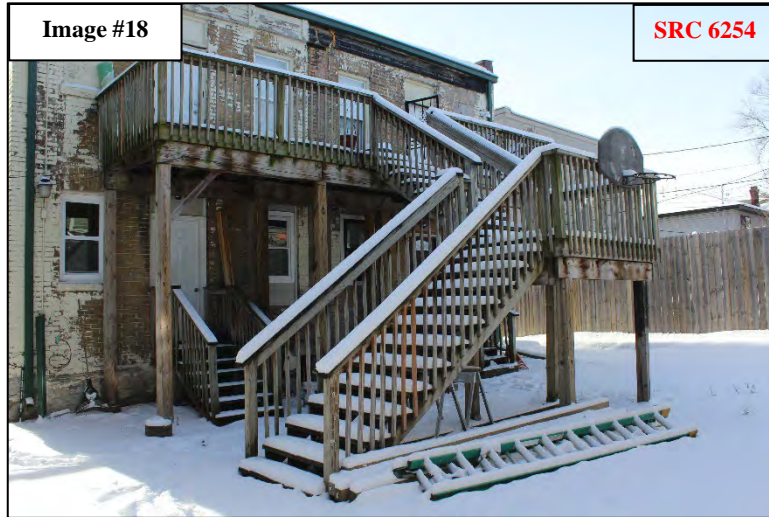
Image #18

37. See **Image #18** for an overall view of the right end of the back deck and stairway. This image is taken from the back right corner of the property looking towards the back left corner of the structure.

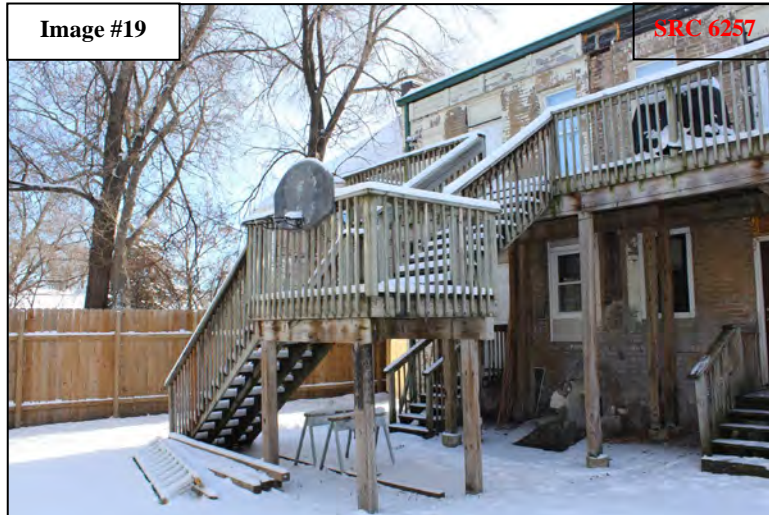
Image #19

38. See **Image #19** for an overall view of the right end of the back deck and stairway. This image is taken from the back left corner of the property looking towards the back right corner of the structure.

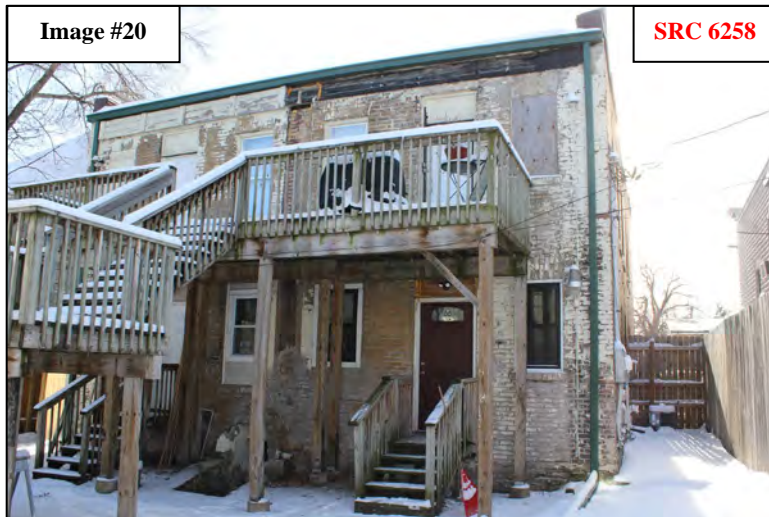
Image #20

39. See **Image #20** for an overall view of the left end of the back deck and stairway. This image is taken from the back left corner of the property looking towards the back left corner of the structure.

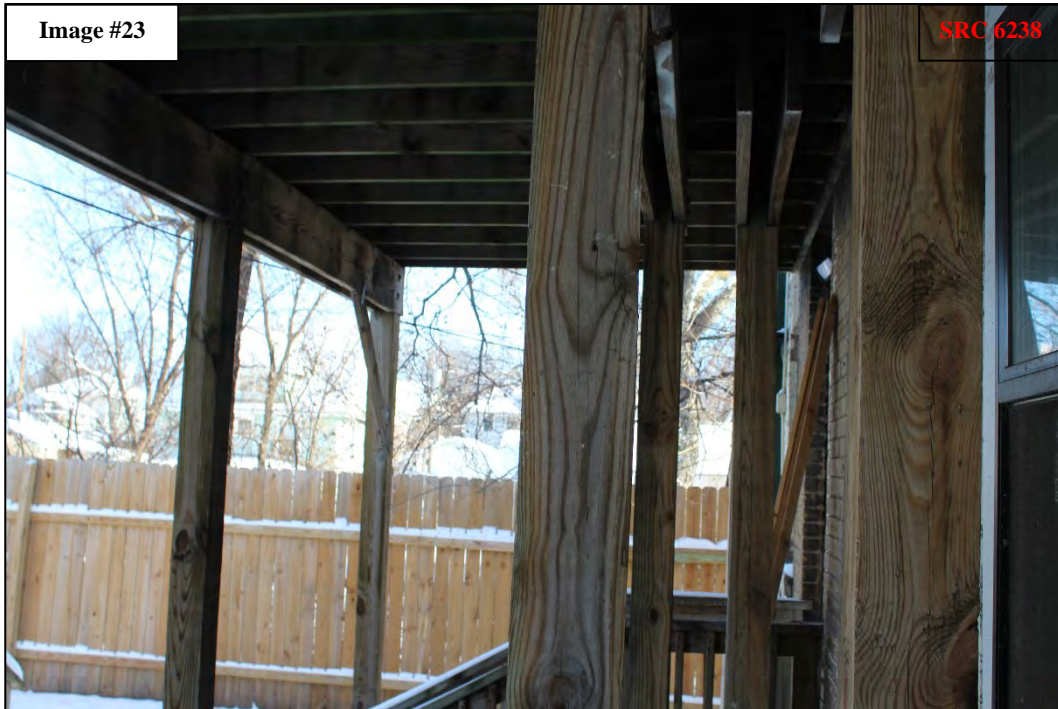
Image #23

42. See **Image #23** for a view of the deck floor framing including the drop beams and the floor joists. This view is taken from the back left side of the structure looking towards the right side of the structure.

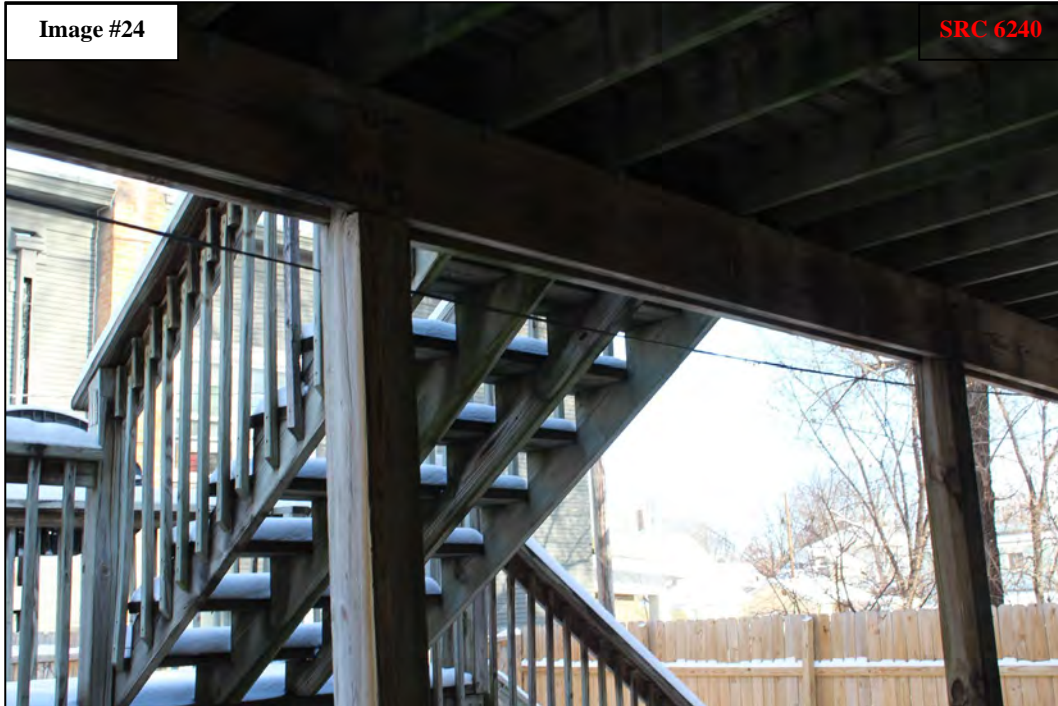
Image #24

43. See **Image #24** for a view of the back edge beam of the deck floor framing showing the drop beam and the joists bearing over the top of the beam and the stair framing into the deck.

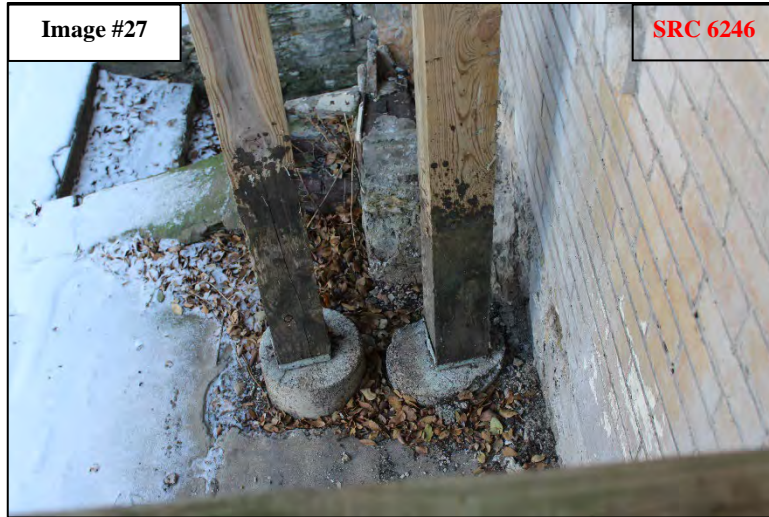
Image #27

46. See **Image #27** for a view of the second interior posts from the right side next to the building structure. A closer view of these post bases is shown in the next image.

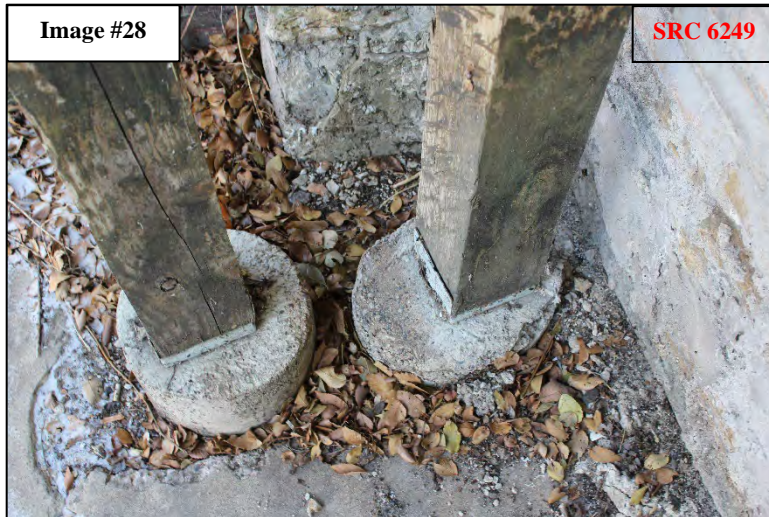
Image #28

47. See **Image #28** for a closer view of the second interior posts from the right side next to the building structure.
48. See **Image #29** for a view of the deck back right corner post on the concrete pier.
