Jack Pixley Sweeps

Customer: Vander, Nick - 04/23/2013 Job

Service Address: 2228 Bush Ave E

Internal Inspection

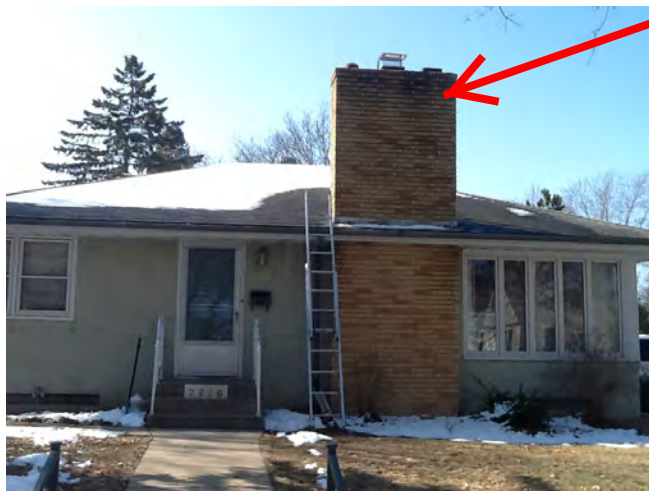
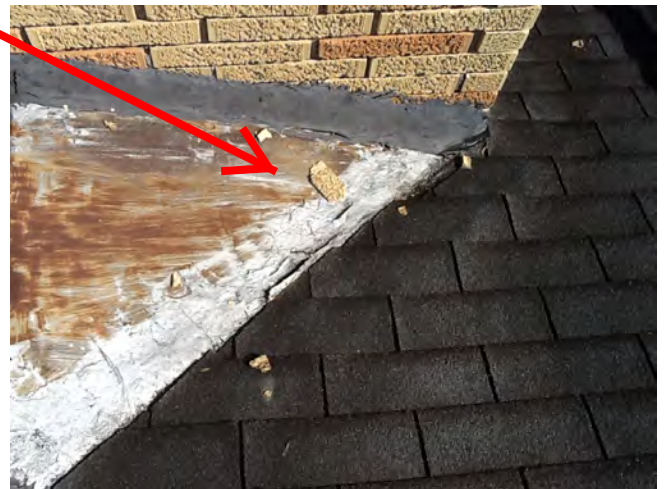
Spalling brick and deteriorating mortar joints

Our recommendation for this is to remove the wash and 6 courses of brick and rebuild these areas.

Cost to repair all the areas needed will be \$5490.00.
