Jack Pixley Sweeps

Customer: Vander, Nick - 04/23/2013 Job

Service Address: 2228 Bush Ave E

Internal Inspection

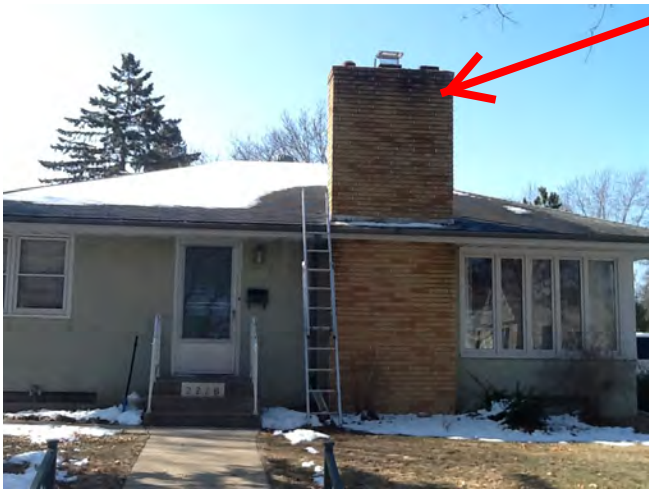
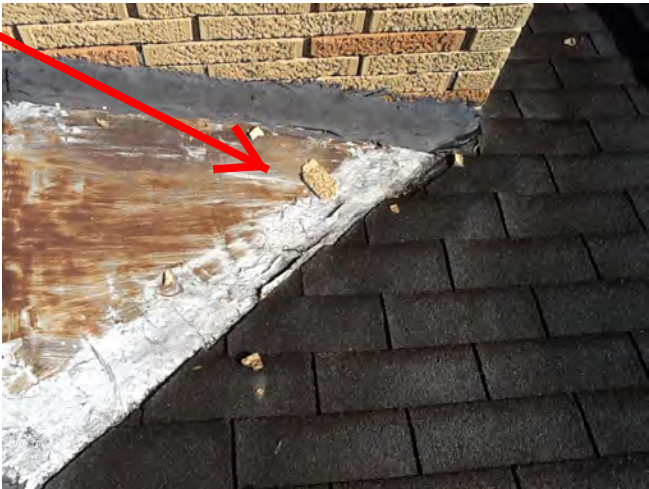
- ☒ The wash at the top of the chimney is cracked and should be repaired as soon as possible.
- ☒ The chimney above the roofline has spalling bricks.
- ☐ The chimney above the roofline has loose and deteriorated bricks and should be repaired or rebuilt as soon as possible.
- ☒ There are not screens or rain covers present. We recommend screen and rain cover(s). Lower level
- ☐ The chimney height does not meet current code requirements. The code requires every chimney to extend beyond roof level at least 3 feet and be 2 feet taller than anything within 10 feet.

Spalling brick and deteriorating mortar joints

Cost to repair all the areas needed will be \$5490.00.
