Inspection Report

Date:	05/11/2018
Inspector:	David Eide
License Address:	1202 Dale St N
Licensee/ Violator:	Bee Lee & Tou Yang, d/b/a MC Auto Repair & Tire Services
License Number:	20160000541
Violation:	License Conditions 1, 2, 3, 4, 5, 6, 11, and 17

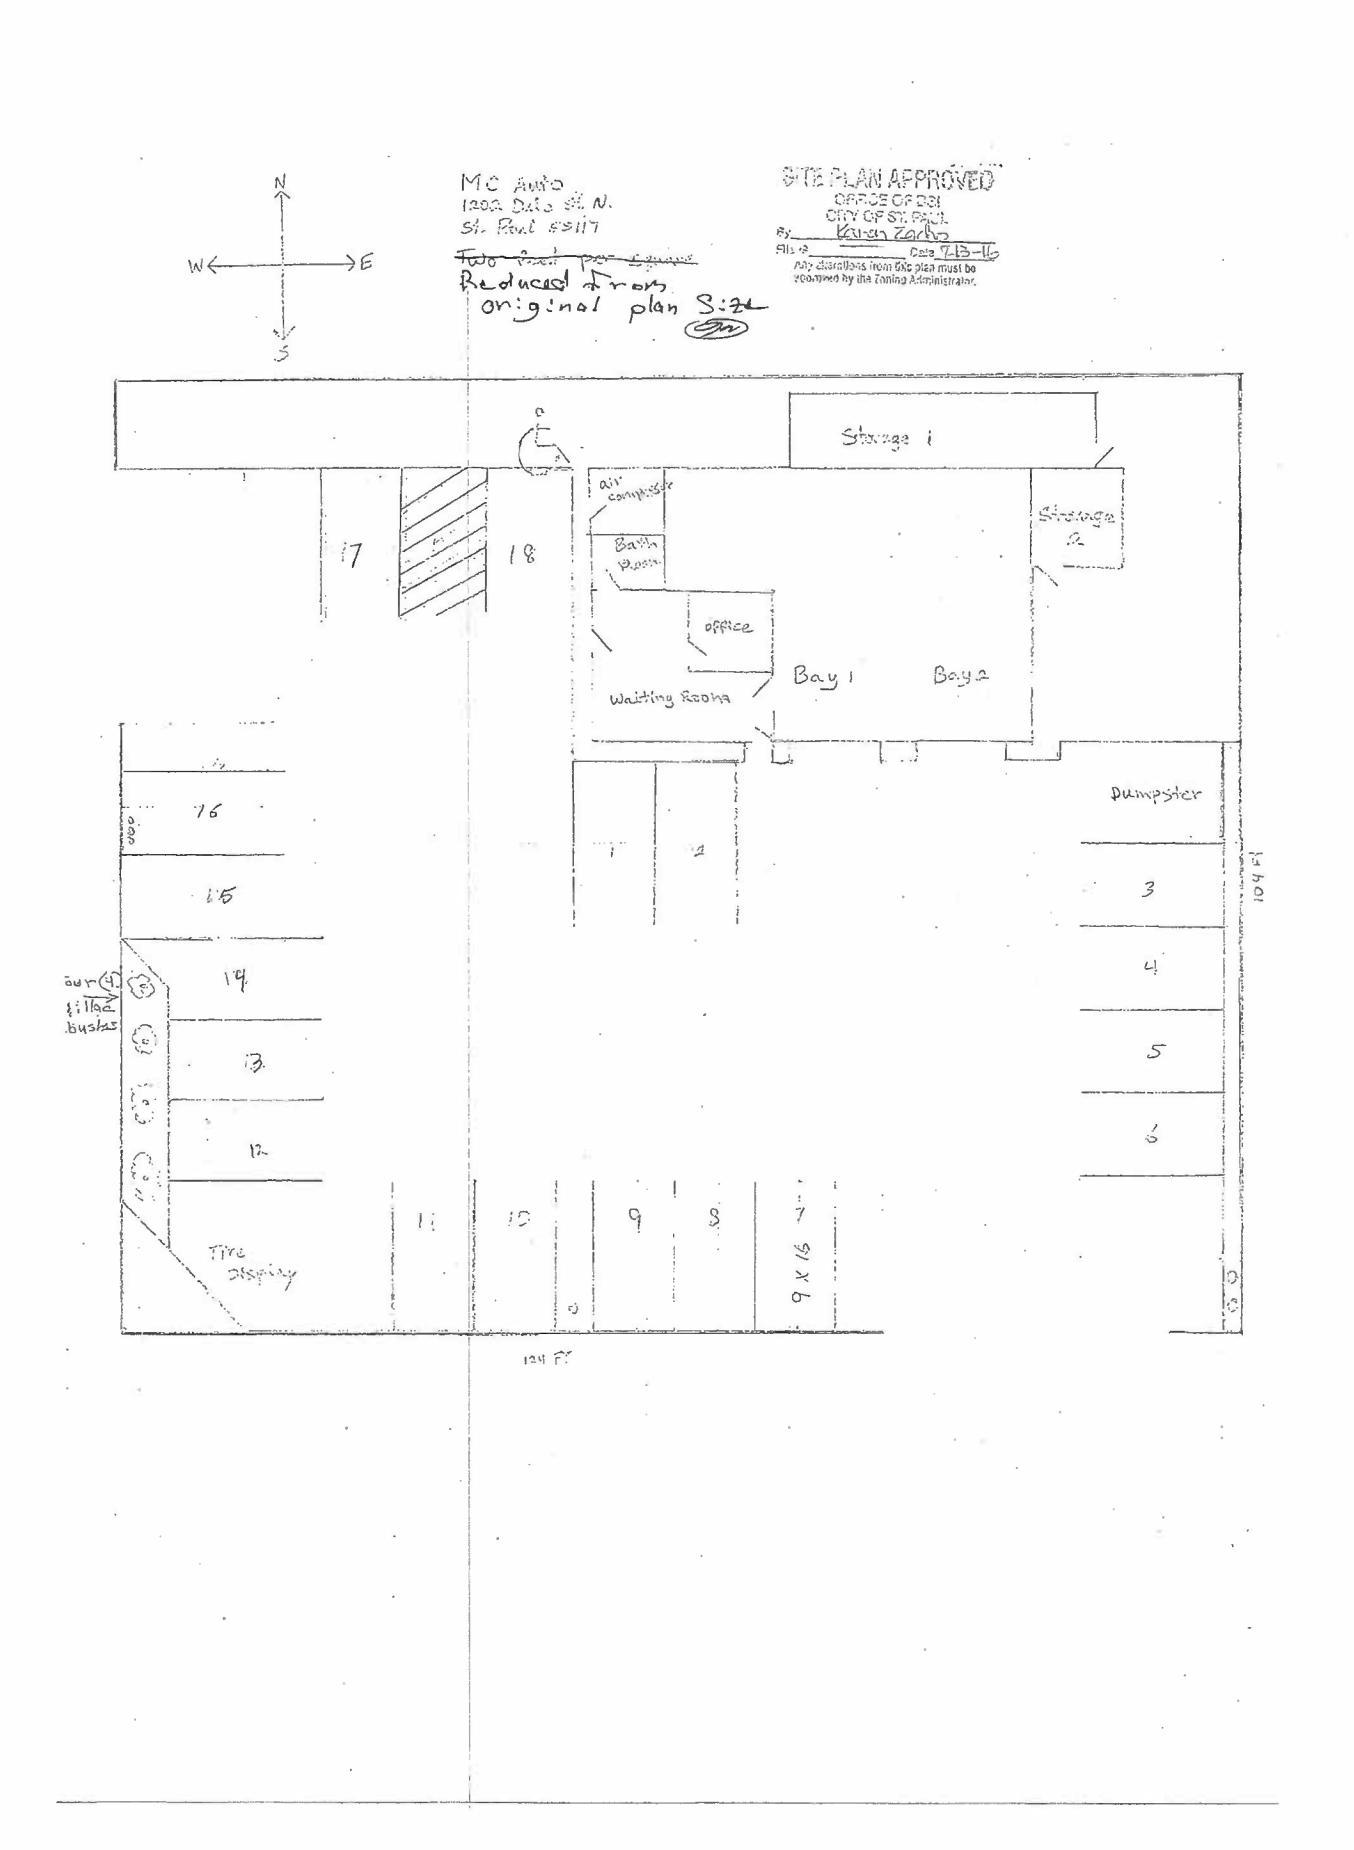
Condition #3: Lot must be striped and landscaped in accordance with 7/13/16 site plan. Four medium sized trees must be installed along Dale and are missing.

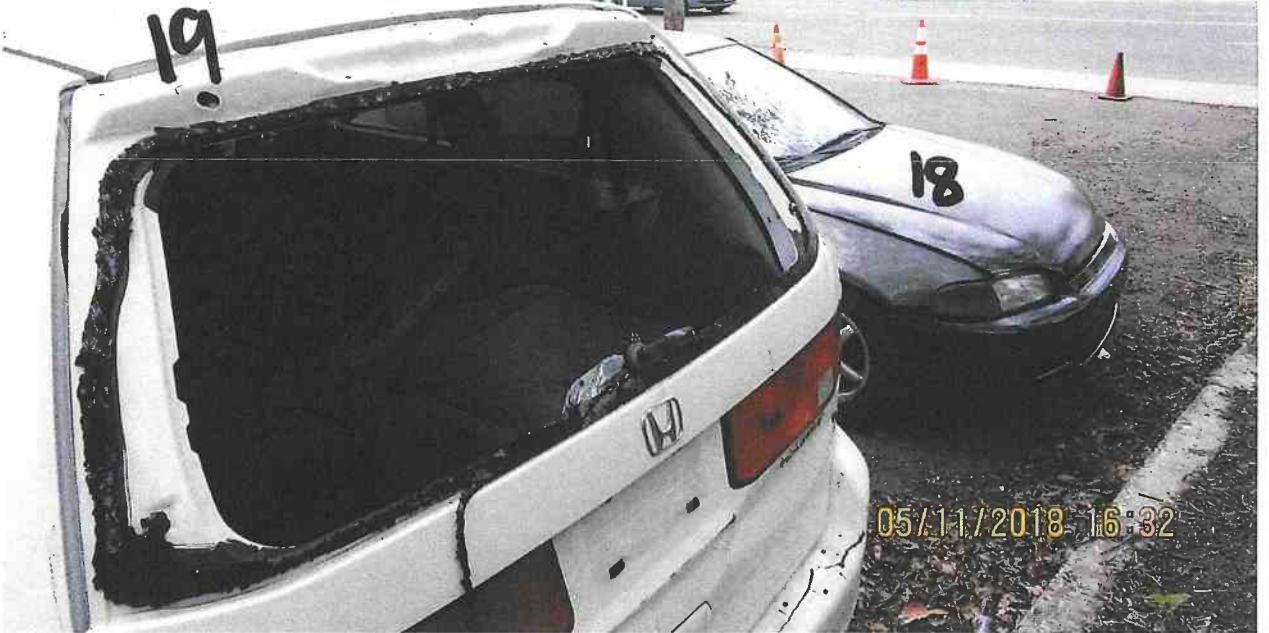
Condition #2: Maneuvering space must be provided. (Driveway blocked with cones and vehicle.)

Condition #3: Lot not striped as indicated in 7/13/16 site plan.

Condition #4: No exterior storage on inoperable vehicles.

Condition #6: All vehicles parked outdoors on the lot must appear to be completely assembled with no major body parts missing.

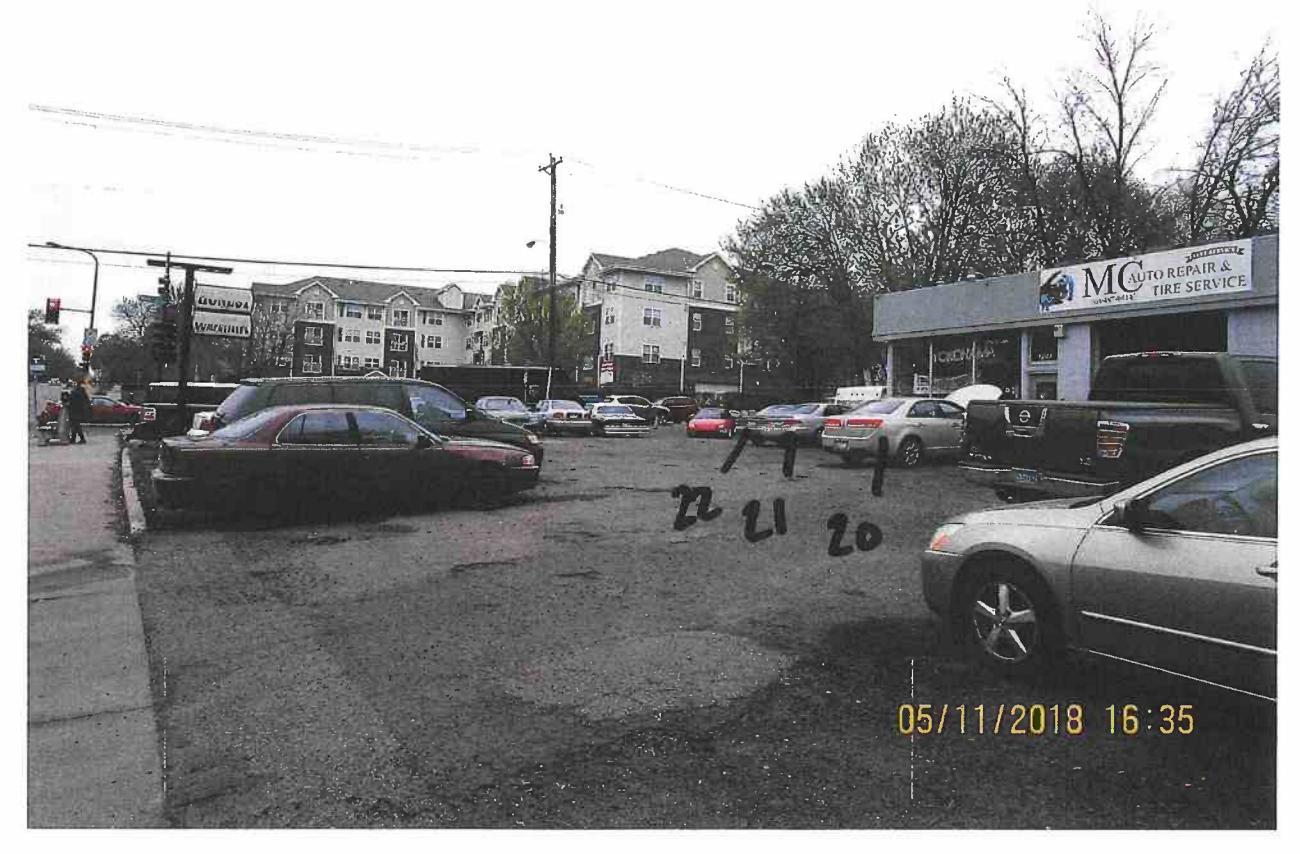
Condition #1: License holder is limited to 18 vehicles parked on exterior. 24 vehicles were on premesis at time of Inspection. Vehicles not parked according to site plan.
