**Becklin & Whitney**  
*Consulting Engineers, Inc.*  
**139 1<sup>ST</sup> AVE. E, SUITE 100**  
**P. O. BOX 471**  
**CAMBRIDGE, MN 55008**  
**PHONE (763) 689-5631 FAX (763) 552-5631**

April 17, 2019

RE: Vehicle Impact  
377 Maryland Ave. W  
St Paul, MN

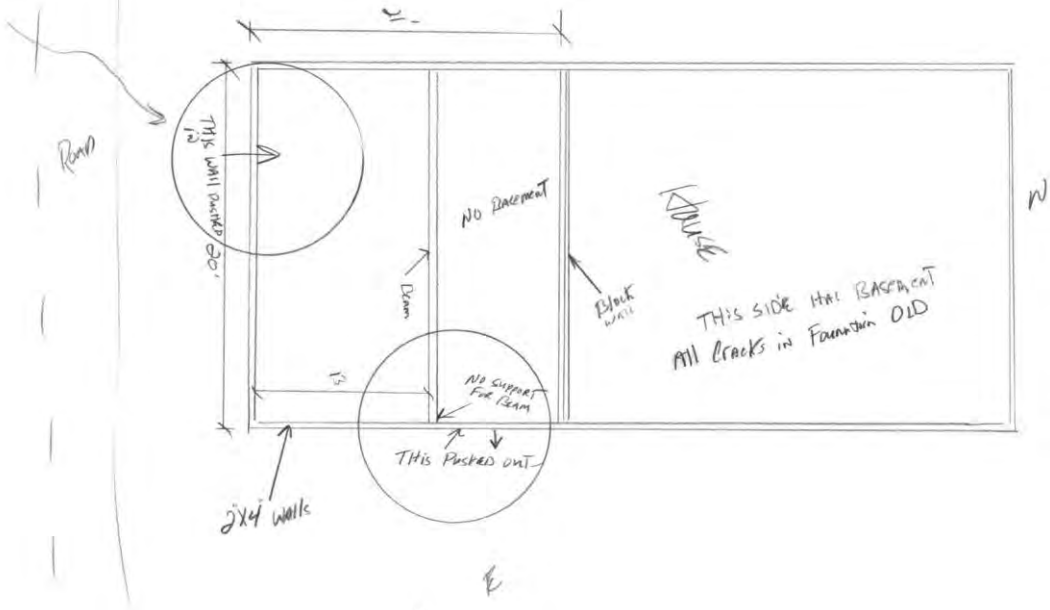
377 Maryland Ave West  
ST PAUL MN 55117

The home is on the north side of Maryland Ave. The south portion of the home is an attached garage. The vehicle impacted on the south side, off of Maryland Ave. The impact did extensive damage to south wall of home and to the east wall of home.

The south 21 feet of the home is damaged along with the party wall. The south 21 feet of home which is the garage and breezeway needs to have interior and exterior finishes and ceiling finishes removed. Framing can then be checked and repaired. The party wall between home and breezeway also needs to be stripped so framing can be checked and repaired.

Remove all interior, exterior and ceiling finishes from the south 21 feet (garage & breezeway) of the home. Repair the foundation on the east side of home. Repair or replace framing as needed in attached garage and breezeway. Check framing anchorage to foundation, anchor bolts are required at 6 feet o.c. Move beams back into location and support with (4) studs at each end.
