CITY OF SAINT PAUL HERITAGE PRESERVATION COMMISSION STAFF REPORT

FILE NAME: 702 Third Street East

HPC SITE/DISTRICT: Dayton's Bluff Historic District

CATEGORY: Contributing CLASSIFICATION: Demolition

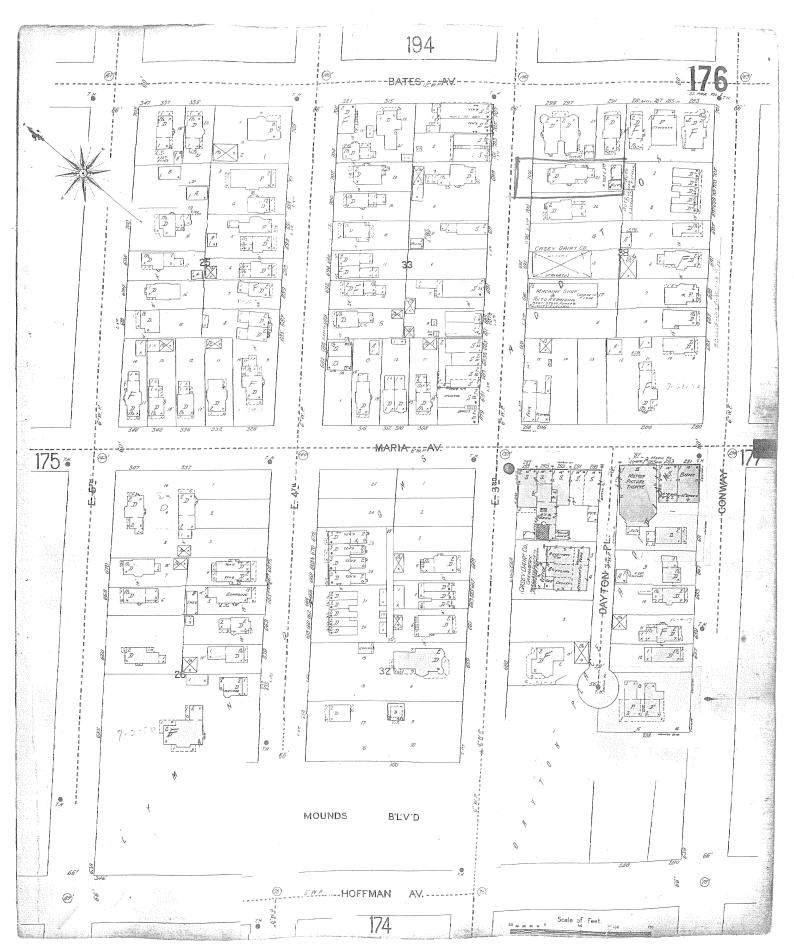
Insurance Maps of St. Paul, Minnesota - Volume 2 Publisher: Sanborn Map Co. 1903 revised through September 1925 Handwritten notations by St. Paul Planning Commission
