**From:** Hank Hanten <hank@travelheadquarters.us>  
**Sent:** Monday, September 07, 2015 1:31 PM  
**To:** Vang, Mai (CI-StPaul)  
**Cc:** Hank Hanten  
**Subject:** 929 7th St. west  
**Attachments:** CustomReport\_Wrapper2.jsp.pdf; DOC090115-09012015123134.pdf; Hanten Report 2015.doc

Hank, I took the measurements and created the existing plan also attached are the plans for the first pass at the floor plan for the renovation.

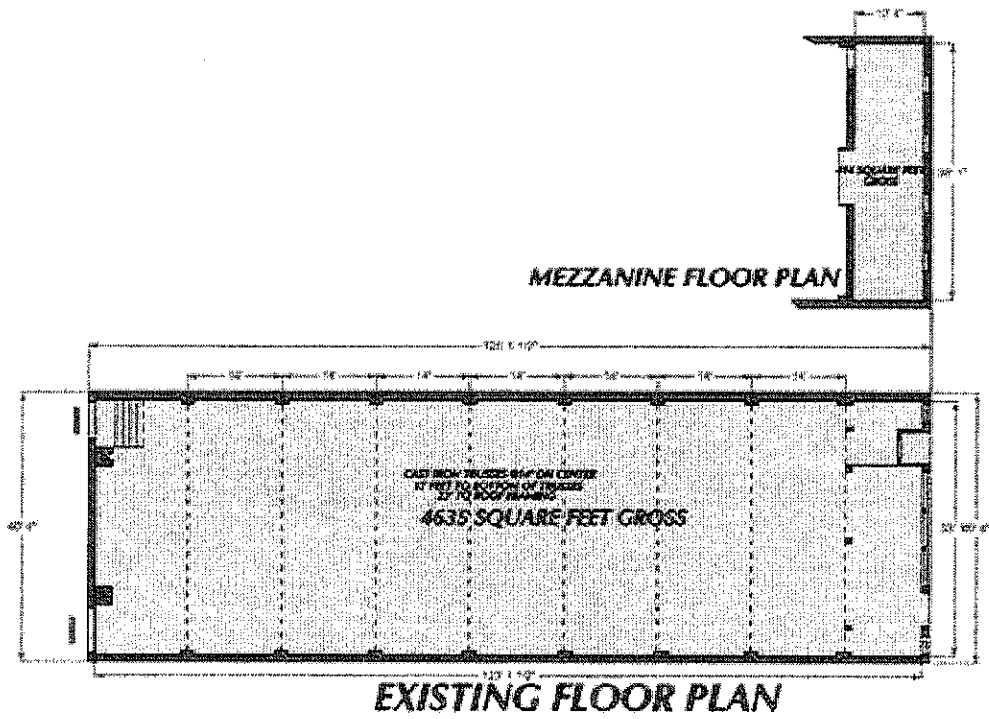
Please review as this layout and these square foot numbers are what I will use for the code review.

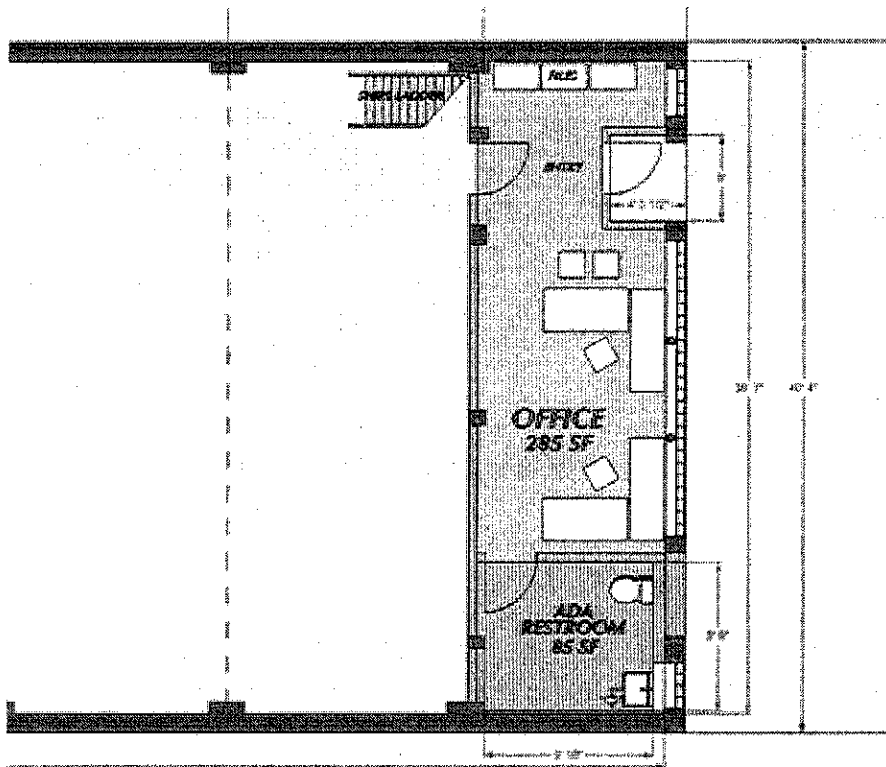
MEZZANINE FLOOR PLAN

I believe we will have to show the mezzanine space and a ships ladder to access it.
