REPORT OF INSPECTION PROCEDURES AND RESULTS  
FOR  
DETERMINING QUALIFICATIONS  
OF A  
TAX INCREMENT FINANCING DISTRICT

ST JOE'S HOSPITAL  
REDEVELOPMENT TIF DISTRICT

SAINT PAUL PORT AUTHORITY  
SAINT PAUL, MINNESOTA  
NOVEMBER 14, 2025

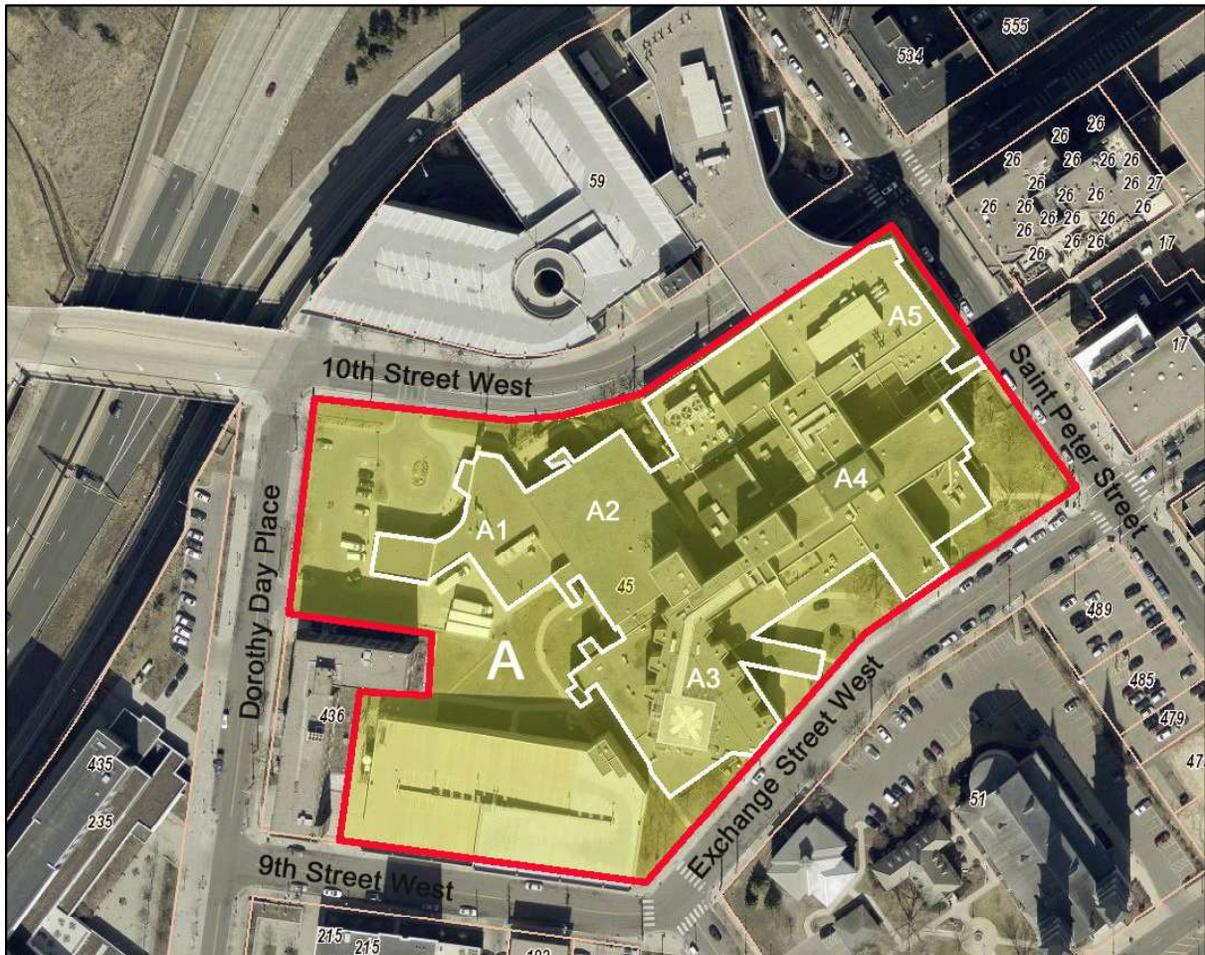
Diagram 1: Proposed TIF District

LHB was hired by the Saint Paul Port Authority to inspect and evaluate the properties within a Tax Increment Financing Redevelopment District (“TIF District”) proposed to be established by the Authority. The proposed TIF District is located at the corner of Saint Peter Street and Exchange Street West (Diagram 1). The purpose of LHB’s work is to determine whether the proposed TIF District meets the statutory requirements for coverage, and whether one building on one parcel, located within the proposed TIF District, meets the qualifications required for a Redevelopment District.

A portion of the de Paul Tower (labeled as addition A5 in Diagram 1) is included in this TIF District. We calculated the replacement value of this portion of the building but chose not to inspect the building for code deficiencies as it was not necessary to meet the thresholds required for this TIF District.

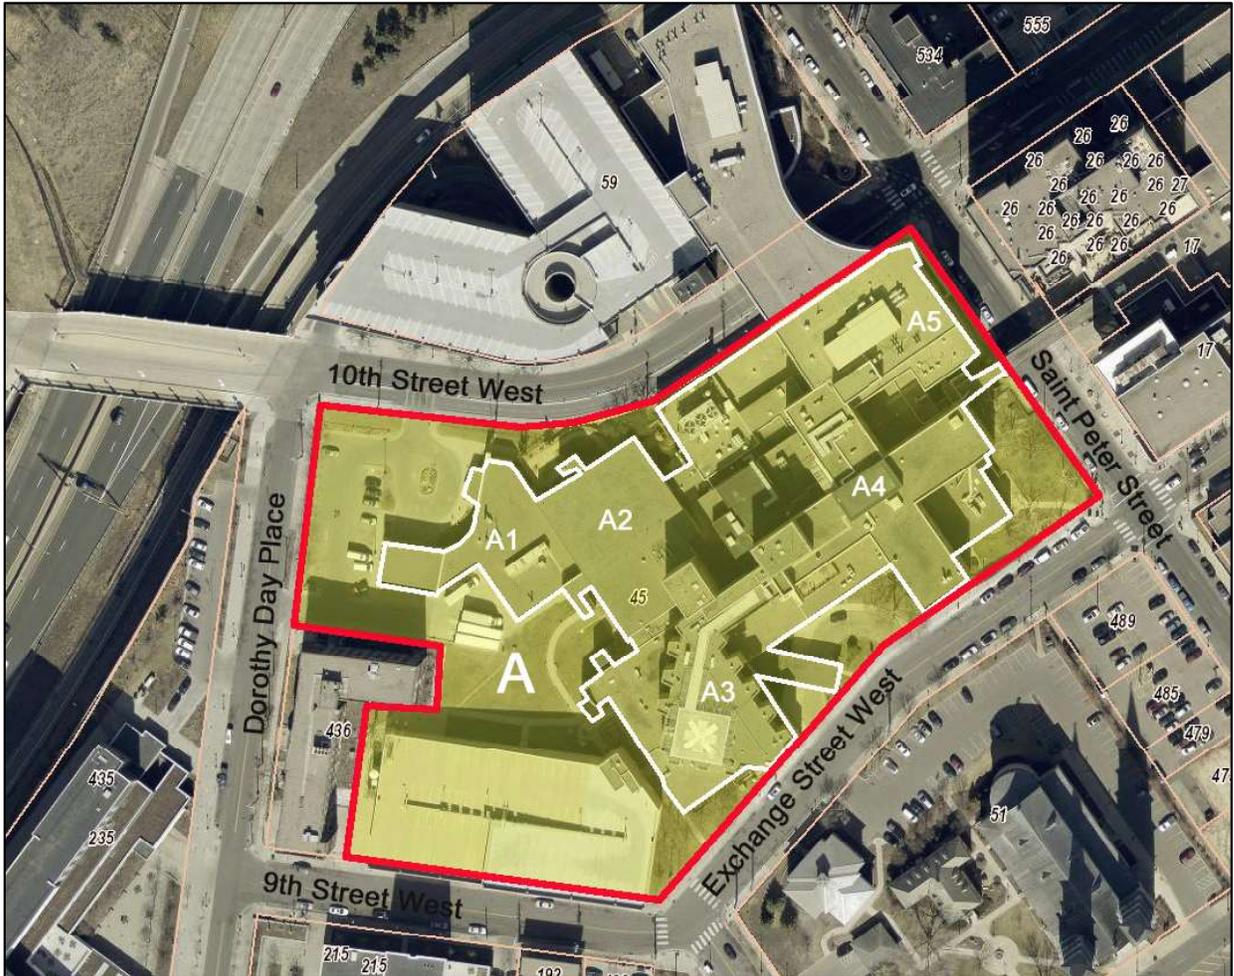
**Diagram 2 – Coverage Diagram**

Shaded area depicts a parcel more than 15 percent occupied by buildings, streets, utilities, paved or gravel parking lots or other similar structures

The proposed TIF District met the coverage test under *Minnesota Statutes, Section 469.174, Subdivision 10(e)*, which resulted in parcels consisting of 100 percent of the area of the proposed TIF District being occupied by buildings, streets, utilities, paved or gravel parking lots, or other similar structures (Diagram 2). This exceeds the 70 percent area coverage requirement for the proposed TIF District under *Minnesota Statutes, Section 469.174, Subdivision (a) (1)*.

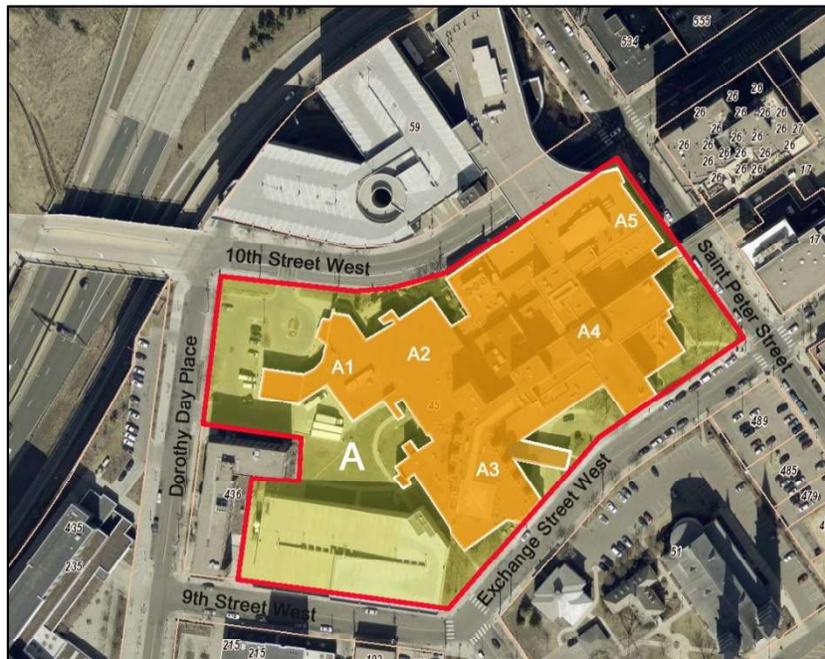
**Diagram 3 – Substandard Buildings**

Shaded yellow area depicts parcels with buildings.  
Shaded orange area depicts substandard buildings.

The parcels with substandard buildings are reasonably distributed compared to all parcels that contain buildings.
