Limited Structural Engineering Services Report
511 Minnehaha Avenue East, St. Paul, Minnesota 55130
SRC Project No. SRC24-302
January 2, 2025
for
Jerry Brashier

RE: Limited Structural Engineering Services Report
Building location: 511 Minnehaha Avenue East, St. Paul, Minnesota 55130
Via: Emailed this date.

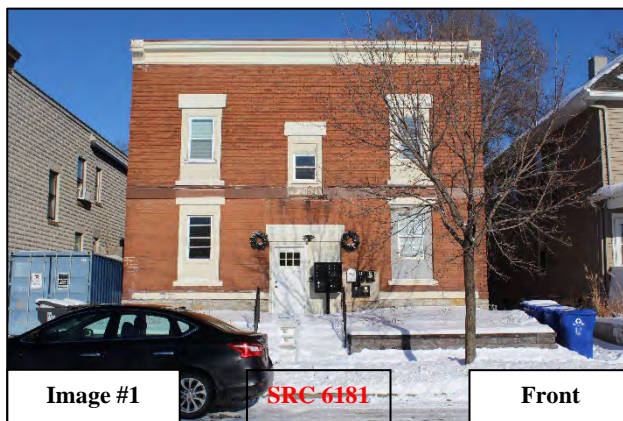
Per our December 11, 2024, consulting agreement accepted by you on that date, and your authorization, Structural Resource Center LLC (SRC) has been retained by you, (CLIENT) to provide structural engineering services relating to the multi-family residential property identified above. See **Image #1** for the front of the structure. You are the owner of the property.

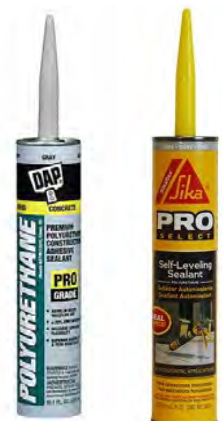
Any cracks/joints between concrete surfaces and the foundation walls should be sealed with a high-quality elastomeric sealant (caulking) and monitor for future changes. A foam backing rod may be required to be installed into the gap to allow a surface for the caulking to rest against until it sets. Patching with cementitious materials may crack in the future rather than move with the structure. Example material: Brand: DAP, Manufacturer Part Number:18814, Sealant Base: Polyurethane, Application: Multipurpose, For Use on Surface Material: Aluminum; Asphalt; Concrete; Fiber Cement; Glass; Metal; Mortar; Plastic; PVC; Stone; Stucco; Vinyl; Wood; Working Time: 3 hours, Full Cure Time: 5 days. Example material: Brand: Sika Self-Leveling Sealant: No tooling required, levels itself, able to bridge gaps up to 1.5 in. wide, flexible and

durable, paintable, stainable and sandable, water immersible & waterproof after cure. This one component polyurethane sealant meets Federal Specification TT-S-00230C, Type 1, Class A. Meets ASTM C-920, Type S, Grade P, Class 25. Available in 10.1 fl. oz. and 29 fl. oz. cartridge.

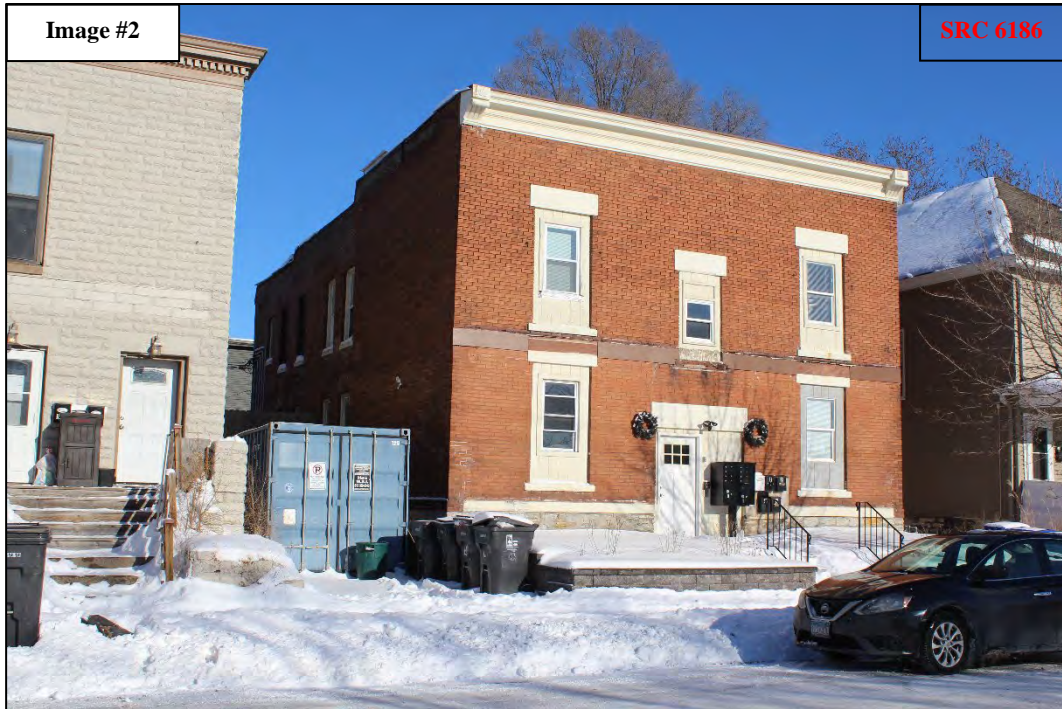
21. See **Image #2** for a view of the exterior of the front left corner of the structure taken from the front looking towards the front left corner of the structure.
