**From:** Hank Hanten <hank@travelheadquarters.us>  
**Sent:** Monday, September 07, 2015 1:31 PM  
**To:** Vang, Mai (CI-StPaul)  
**Cc:** Hank Hanten  
**Subject:** 929 7th St. west  
**Attachments:** CustomReport\_Wrapper2.jsp.pdf; DOC090115-09012015123134.pdf; Hanten Report 2015.doc

Hank, I took the measurements and created the existing plan also attached are the plans for the first pass at the floor plan for the renovation.

## **OBSERVATIONS AND RECOMMENDATIONS**

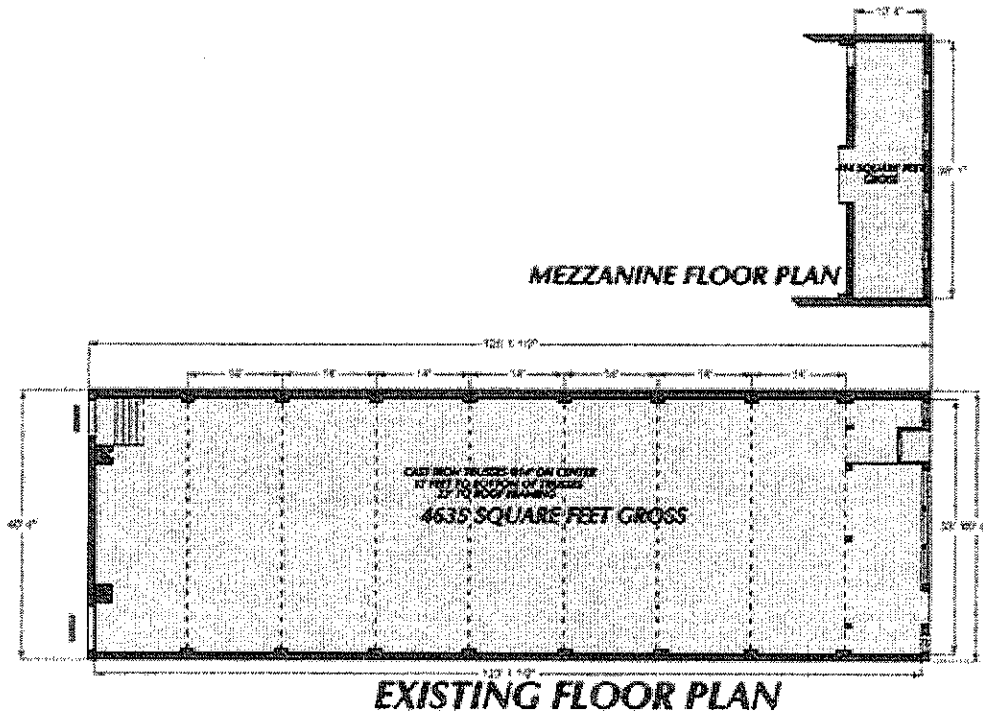
Please review as this layout and these square foot numbers are what I will use for the code review.

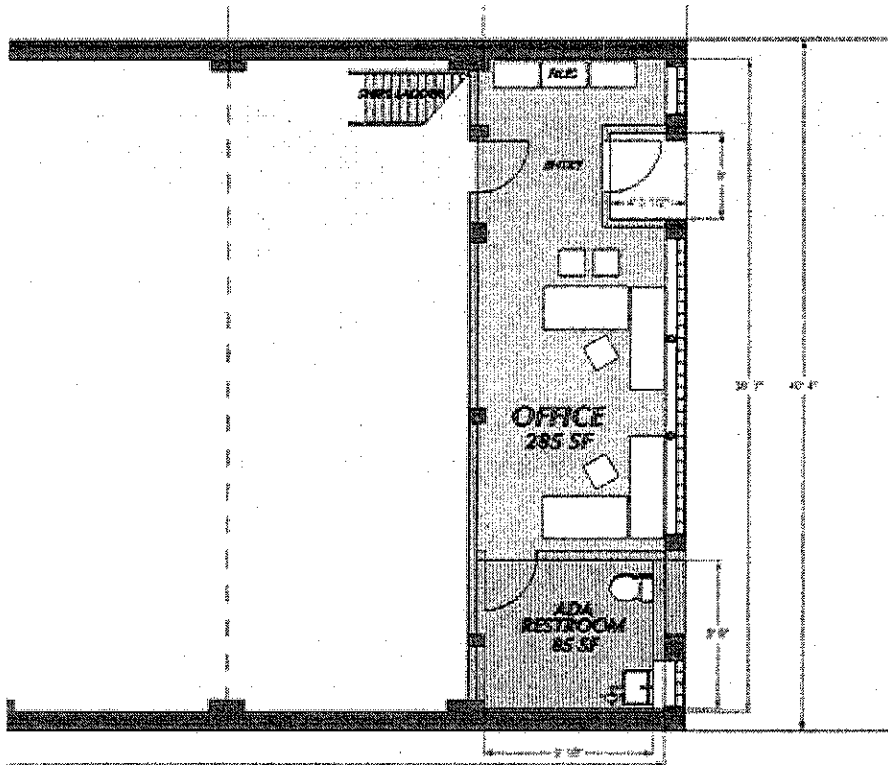
**MEZZANINE FLOOR PLAN**

I believe we will have to show the mezzanine space and a ships ladder to access it.
