REPORT OF INSPECTION PROCEDURES AND RESULTS  
FOR  
DETERMINING QUALIFICATIONS  
OF A  
TAX INCREMENT FINANCING DISTRICT

ST JOE'S HOSPITAL  
REDEVELOPMENT TIF DISTRICT

SAINT PAUL PORT AUTHORITY  
SAINT PAUL, MINNESOTA  
NOVEMBER 14, 2025

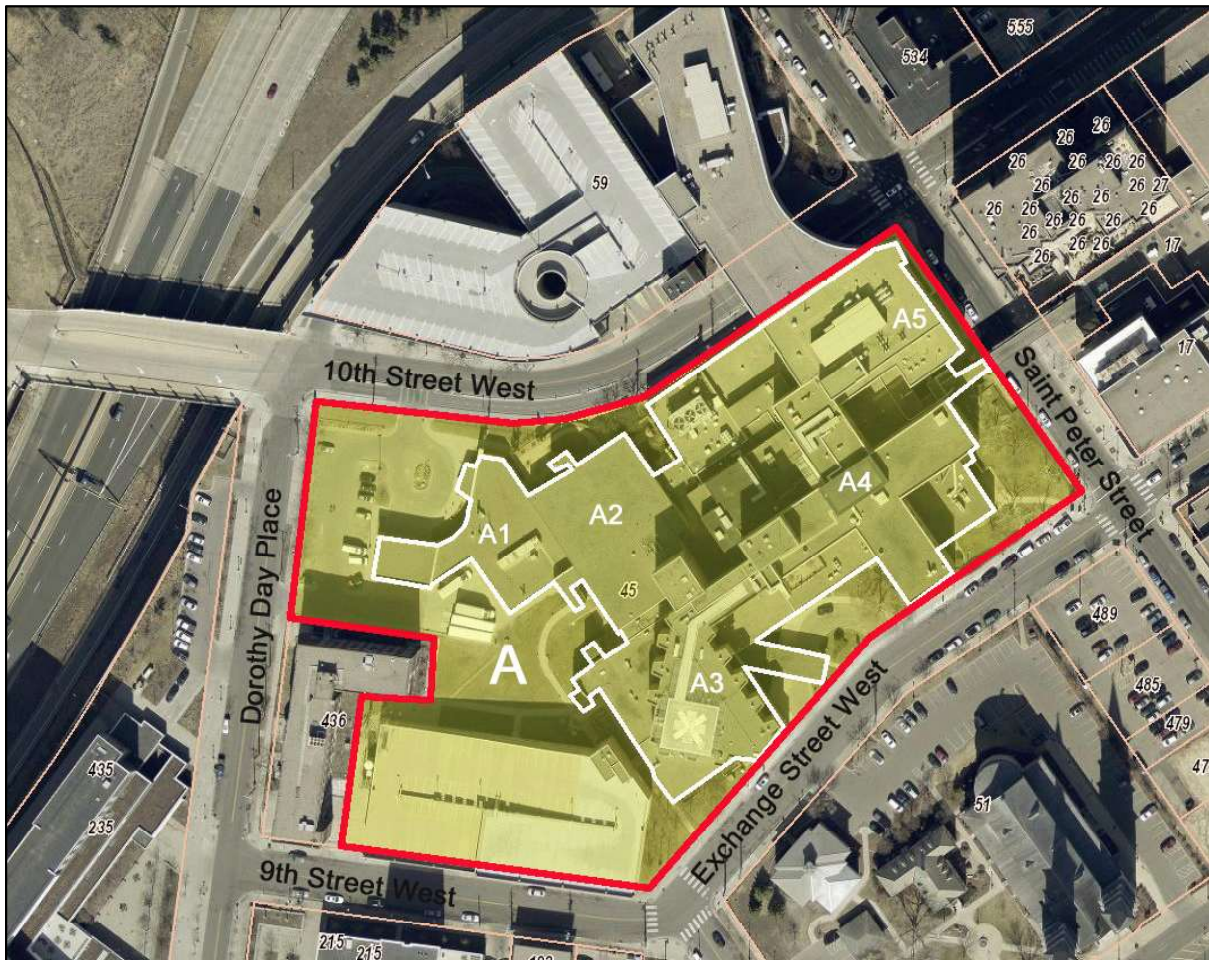
Diagram 1: Proposed TIF District

LHB was hired by the Saint Paul Port Authority to inspect and evaluate the properties within a Tax Increment Financing Redevelopment District (“TIF District”) proposed to be established by the Authority. The proposed TIF District is located at the corner of Saint Peter Street and Exchange Street West (Diagram 1). The purpose of LHB’s work is to determine whether the proposed TIF District meets the statutory requirements for coverage, and whether one building on one parcel, located within the proposed TIF District, meets the qualifications required for a Redevelopment District.

A portion of the de Paul Tower (labeled as addition A5 in Diagram 1) is included in this TIF District. We calculated the replacement value of this portion of the building but chose not to inspect the building for code deficiencies as it was not necessary to meet the thresholds required for this TIF District.
