REPORT OF INSPECTION PROCEDURES AND RESULTS  
FOR  
DETERMINING QUALIFICATIONS  
OF A  
TAX INCREMENT FINANCING DISTRICT

ST JOE'S HOSPITAL  
REDEVELOPMENT TIF DISTRICT

SAINT PAUL PORT AUTHORITY  
SAINT PAUL, MINNESOTA  
NOVEMBER 14, 2025

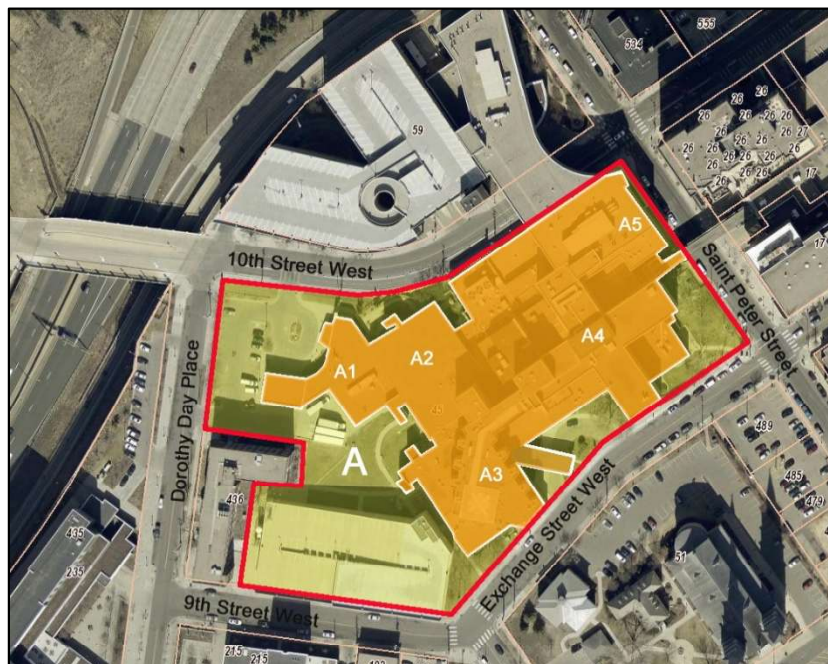
**Diagram 3 – Substandard Buildings**

The parcels with substandard buildings are reasonably distributed compared to all parcels that contain buildings.

Shaded yellow area depicts parcels with buildings.  
Shaded orange area depicts substandard buildings.
