Cherokee Heights Culvert Analysis and Erosion Control Feasibility Study

Prepared for
Lower Mississippi River Watershed Management Organization

April 8, 2015

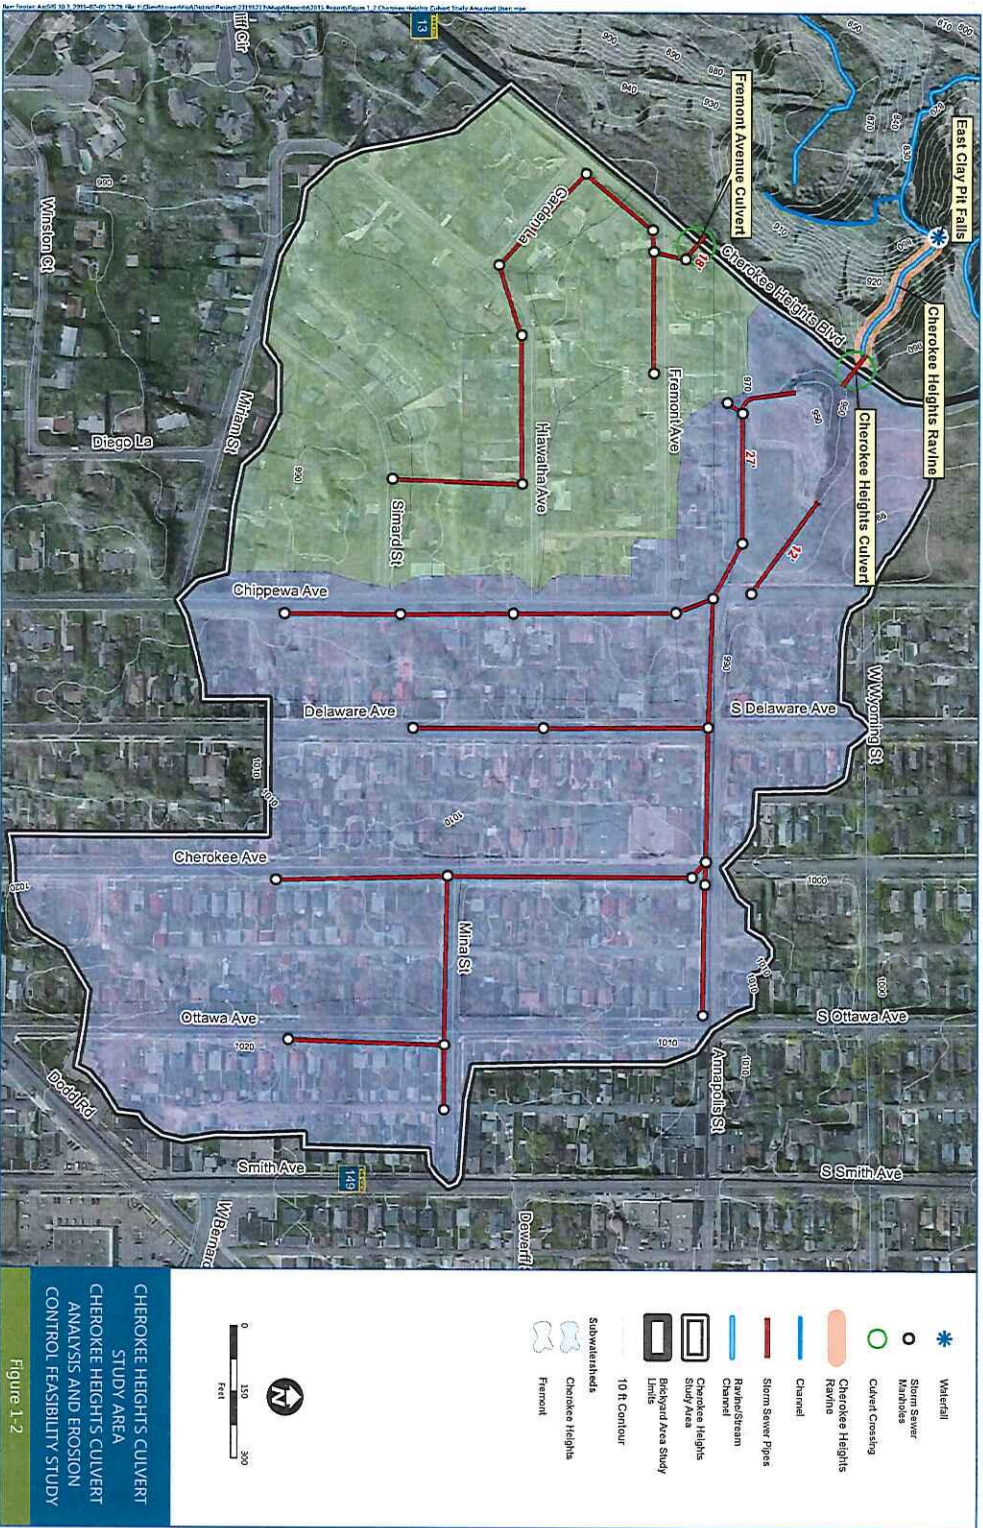
Figure 1-2 shows the area tributary to the 60-inch diameter Cherokee Heights culvert. As shown in the figure, there is a low area/ravine on the upstream side of the culvert, with significant elevation change from the nearby roadway and adjacent parkland. A 12-inch storm sewer from Chippewa Avenue discharges into the far northeast side of the low area/ravine. A 27-inch storm sewer system along Annapolis Street discharges to the low area/ravine on the southeast side. High velocities from this system have historically caused erosion issues at the downstream end of the culvert, as stormwater reflects off the existing energy dissipation structure and erodes the nearby bank (Photo 1-1). In 2013, the City of St. Paul conducted repairs to the existing system, which included reconstruction of the flared end section on the upstream side of the 60-inch culvert and installation of additional rip-rap protection, as well as placement of additional rip-rap at the outfall to reduce the erosion impacts. The 2013 City of St. Paul project also included installation of an 18-inch storm sewer and catch basins to convey runoff from Cherokee Heights Boulevard to the low area/ravine upstream of the 60-inch culvert and bulk heading of the storm sewer outfalls to the downstream ravine.

CHEROKEE HEIGHTS CULVERT
STUDY AREA
CHEROKEE HEIGHTS CULVERT
ANALYSIS AND EROSION
CONTROL FEASIBILITY STUDY

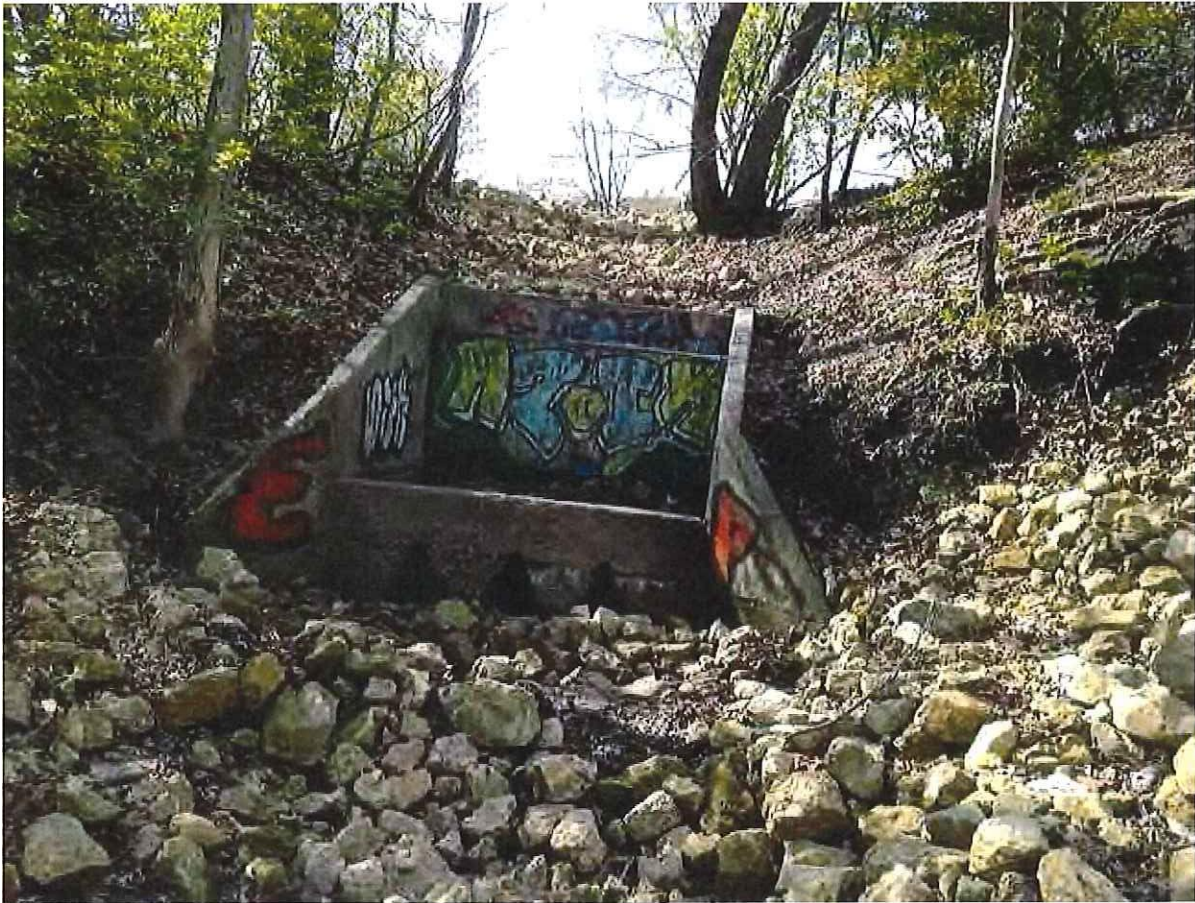
Photo 1-1 Energy dissipation structure downstream of the 27-inch outfall and erosion of adjacent side slope (May 2014 site visit)

High flow rates and velocities through the ravine downstream of the Cherokee Heights culvert, in combination with sandy, erodible soils have caused erosion that is contributing to the instability of the adjacent banks and delivering sediment to downstream Pickerel Lake, thereby degrading its water quality. The area directly downstream of the Cherokee Heights culvert was observed to be highly eroded, with significant scouring around the flared end section (Photos 1-2 and 1-3). The Cherokee Heights Ravine channel is steep, with about 30 feet of drop in the approximately 300 feet between the culvert and East Clay Pit Falls (see Figure 1-1). Observation of the channel revealed significant erosion along the channel bottom and side slopes, with the channel bottom scoured down to the underlying Decorah Shale bedrock at the downstream end of the ravine near the East Clay Pit Falls.

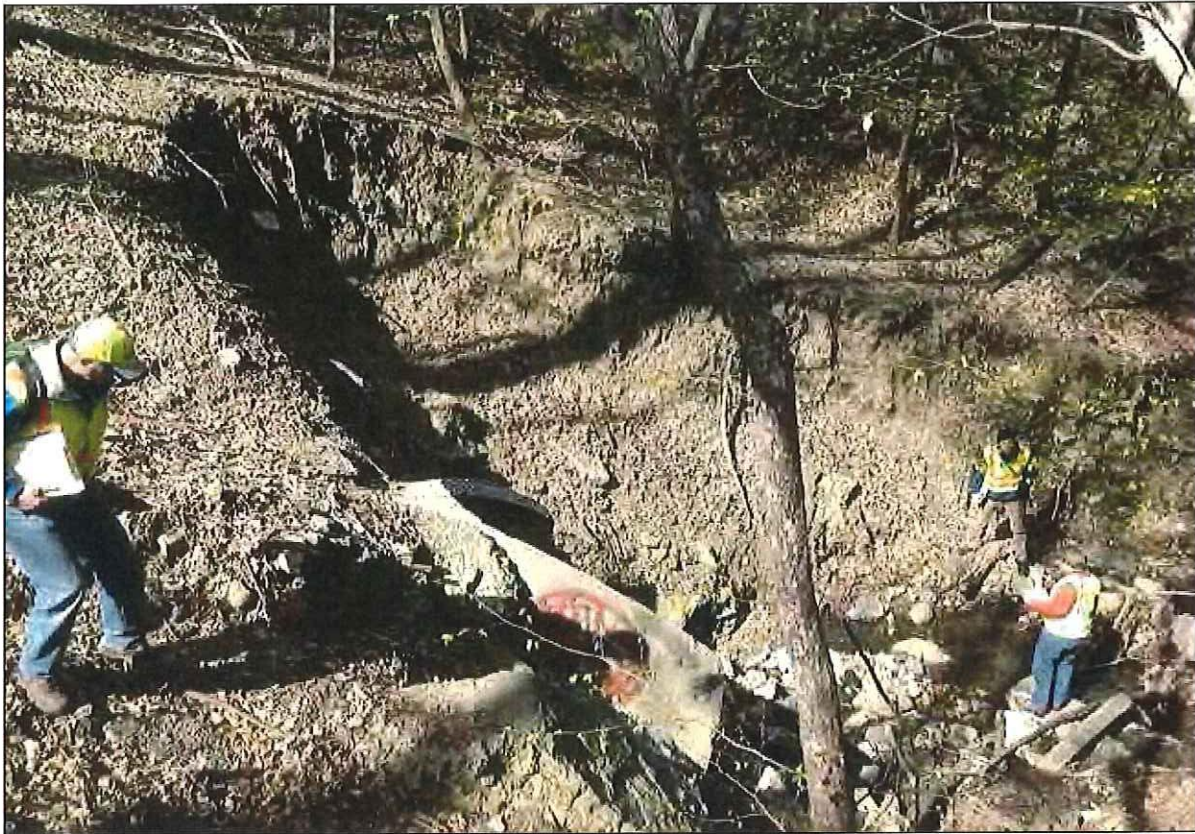
Photo 1-2 Erosion adjacent to the storm sewer outlet in Cherokee Heights ravine (May 2014 site visit)

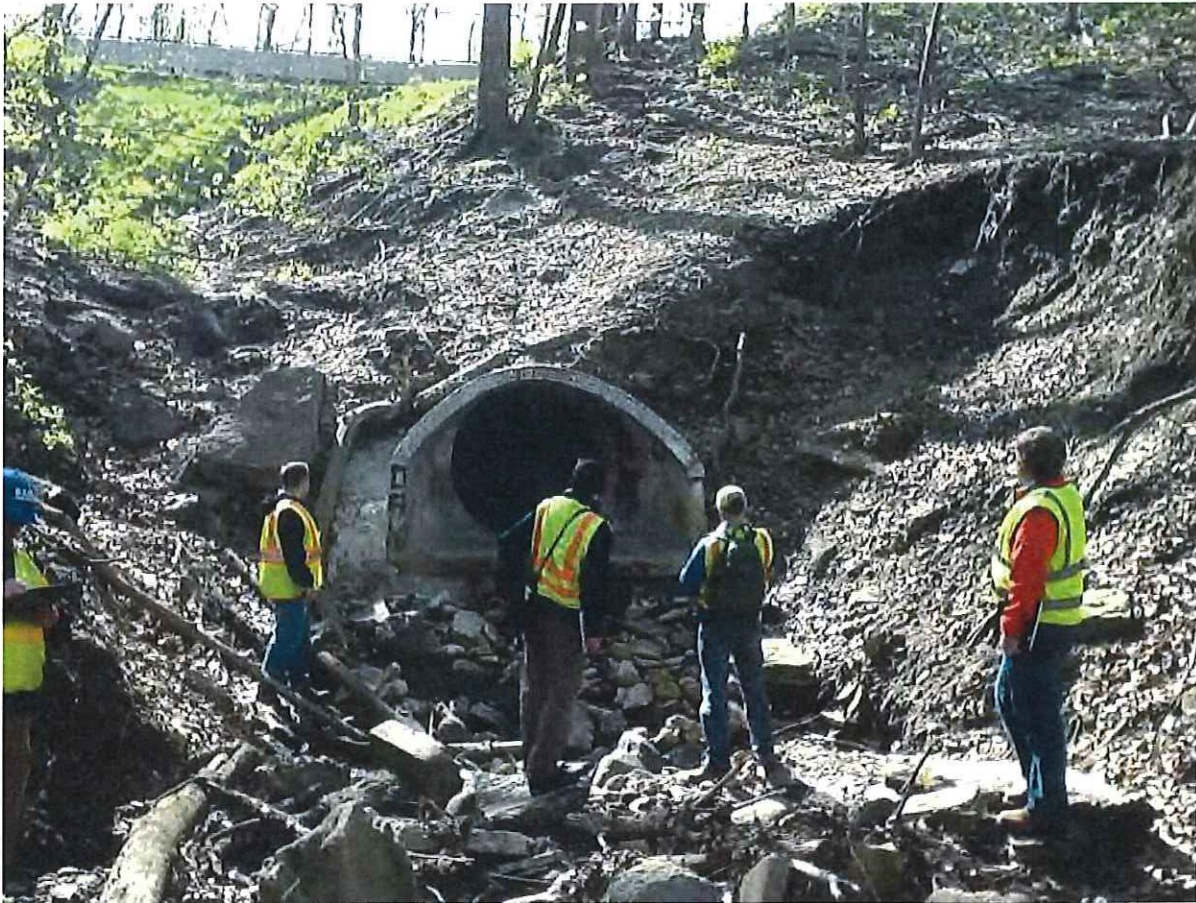
Photo 1-3 Erosion and scouring at the outfall of the Cherokee Heights culvert (May 2014 site visit)

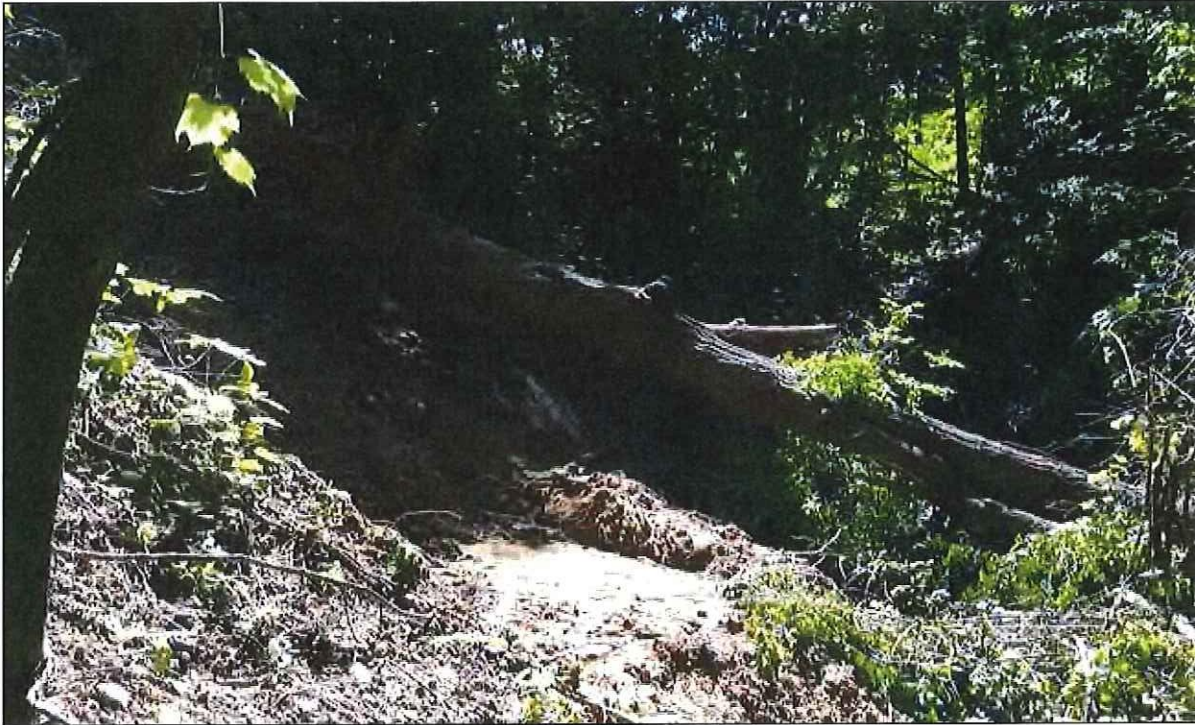
Photo 1-4 Cherokee Heights ravine slope failure (July 2014 site visit)

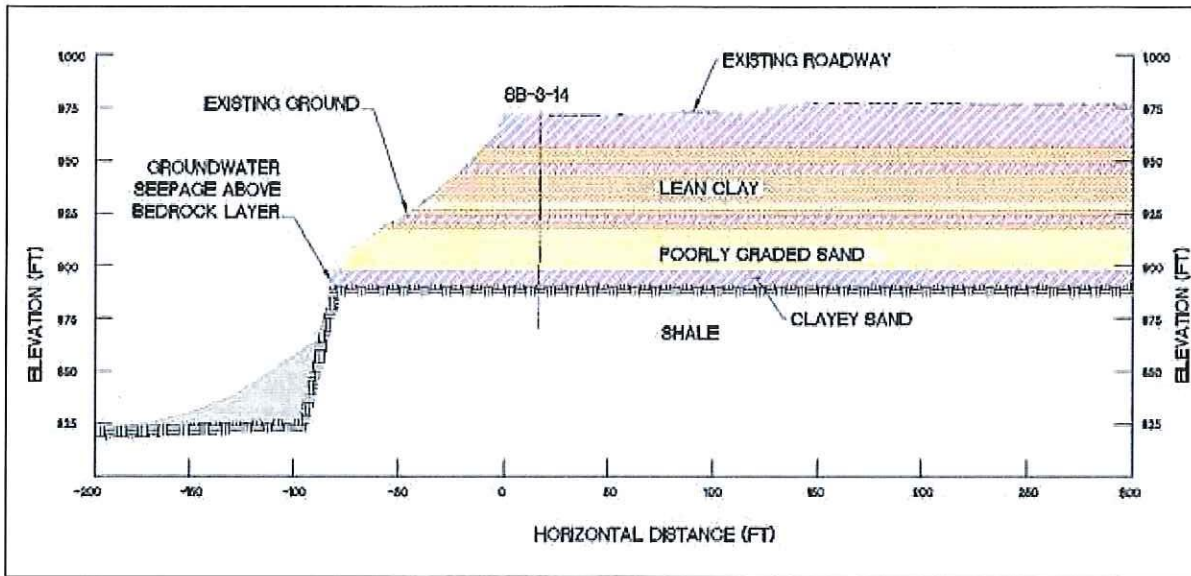
Figure 2-2 Example modeling cross section showing stratigraphy (Middle Clay Pit cross section in Brickyard Area)

Cross sections interpreted from the boring logs are provided in the *Brickyard Area of Lilydale Regional Park Stormwater Management and Slope-Stability Study Report* to illustrate the inferred subsurface conditions. As an example, [Figure 2-2](#) shows the stratigraphy for the Middle Clay Pit. The other cross sections are similar, but with soil layers varying in order and thickness. For modeling purposes the presence of the limestone layers inter-bedded with the shale was not included. Additional information on the stratigraphy of each cross section can be found in Appendix C of the Brickyard Area Study report.
