APPEAL FOR 283 Curtice St.

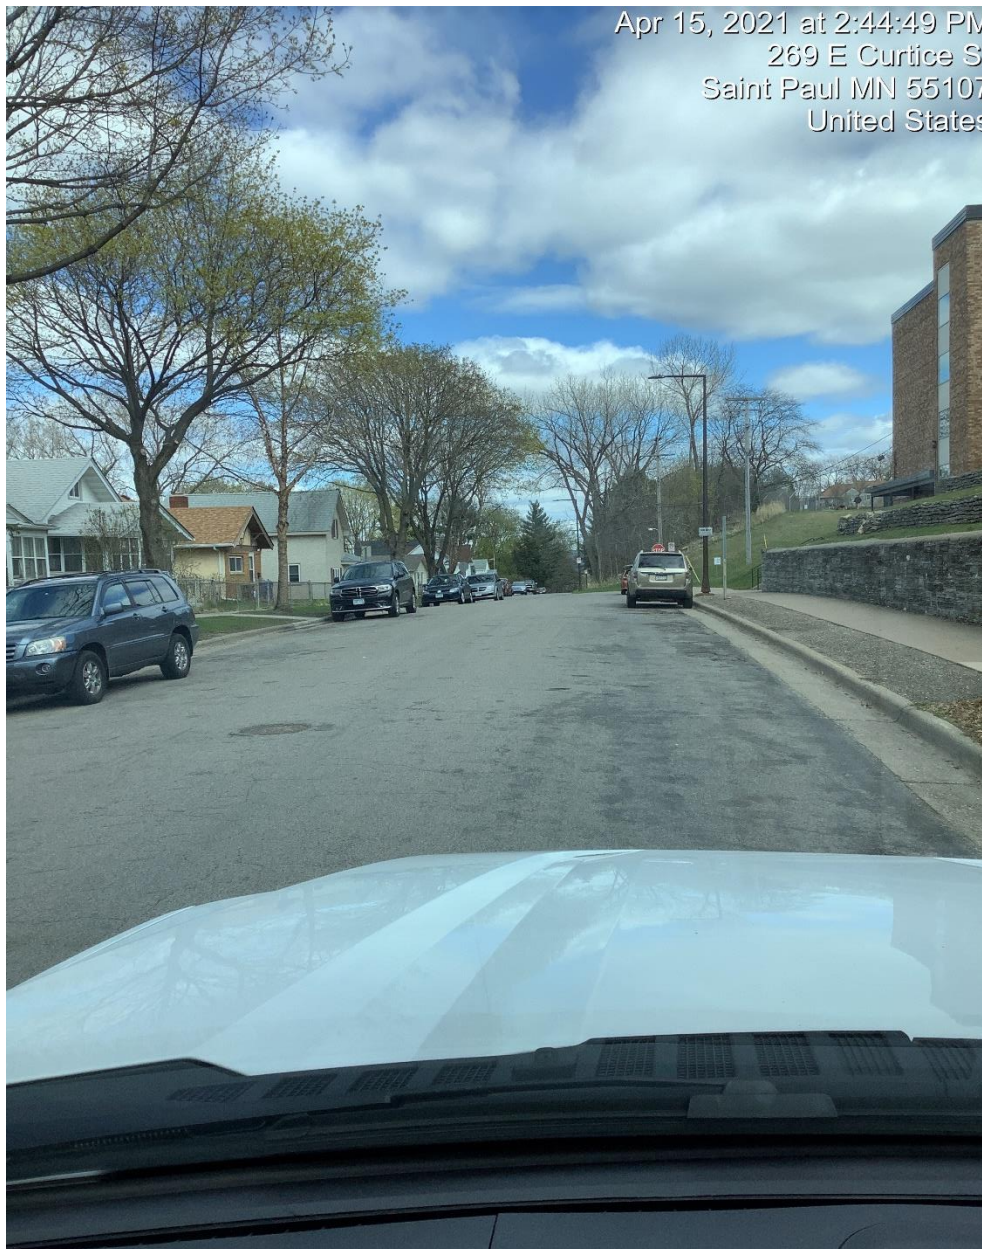
The Public Works Paving Supervisor reviewed the area and took photos on 4/15/2021 at 2:45 p.m. His report stated: I found the street to be in good shape. I found no potholes on the street or in the alley. The seal coating is holding up well. The photos show typical wear and usage in the parking lanes where some of the rock has been displaced from vehicles parking (turning wheels) and leaking oil onto the road surface. The rock chips may be missing in spots but the oil (CSR-2) still present.
