Mai Vang - re: 1180-1184 Seventh Street East

Becky Willging and I met Paul Scharf at 1180-1184 Seventh Street East on November 21.

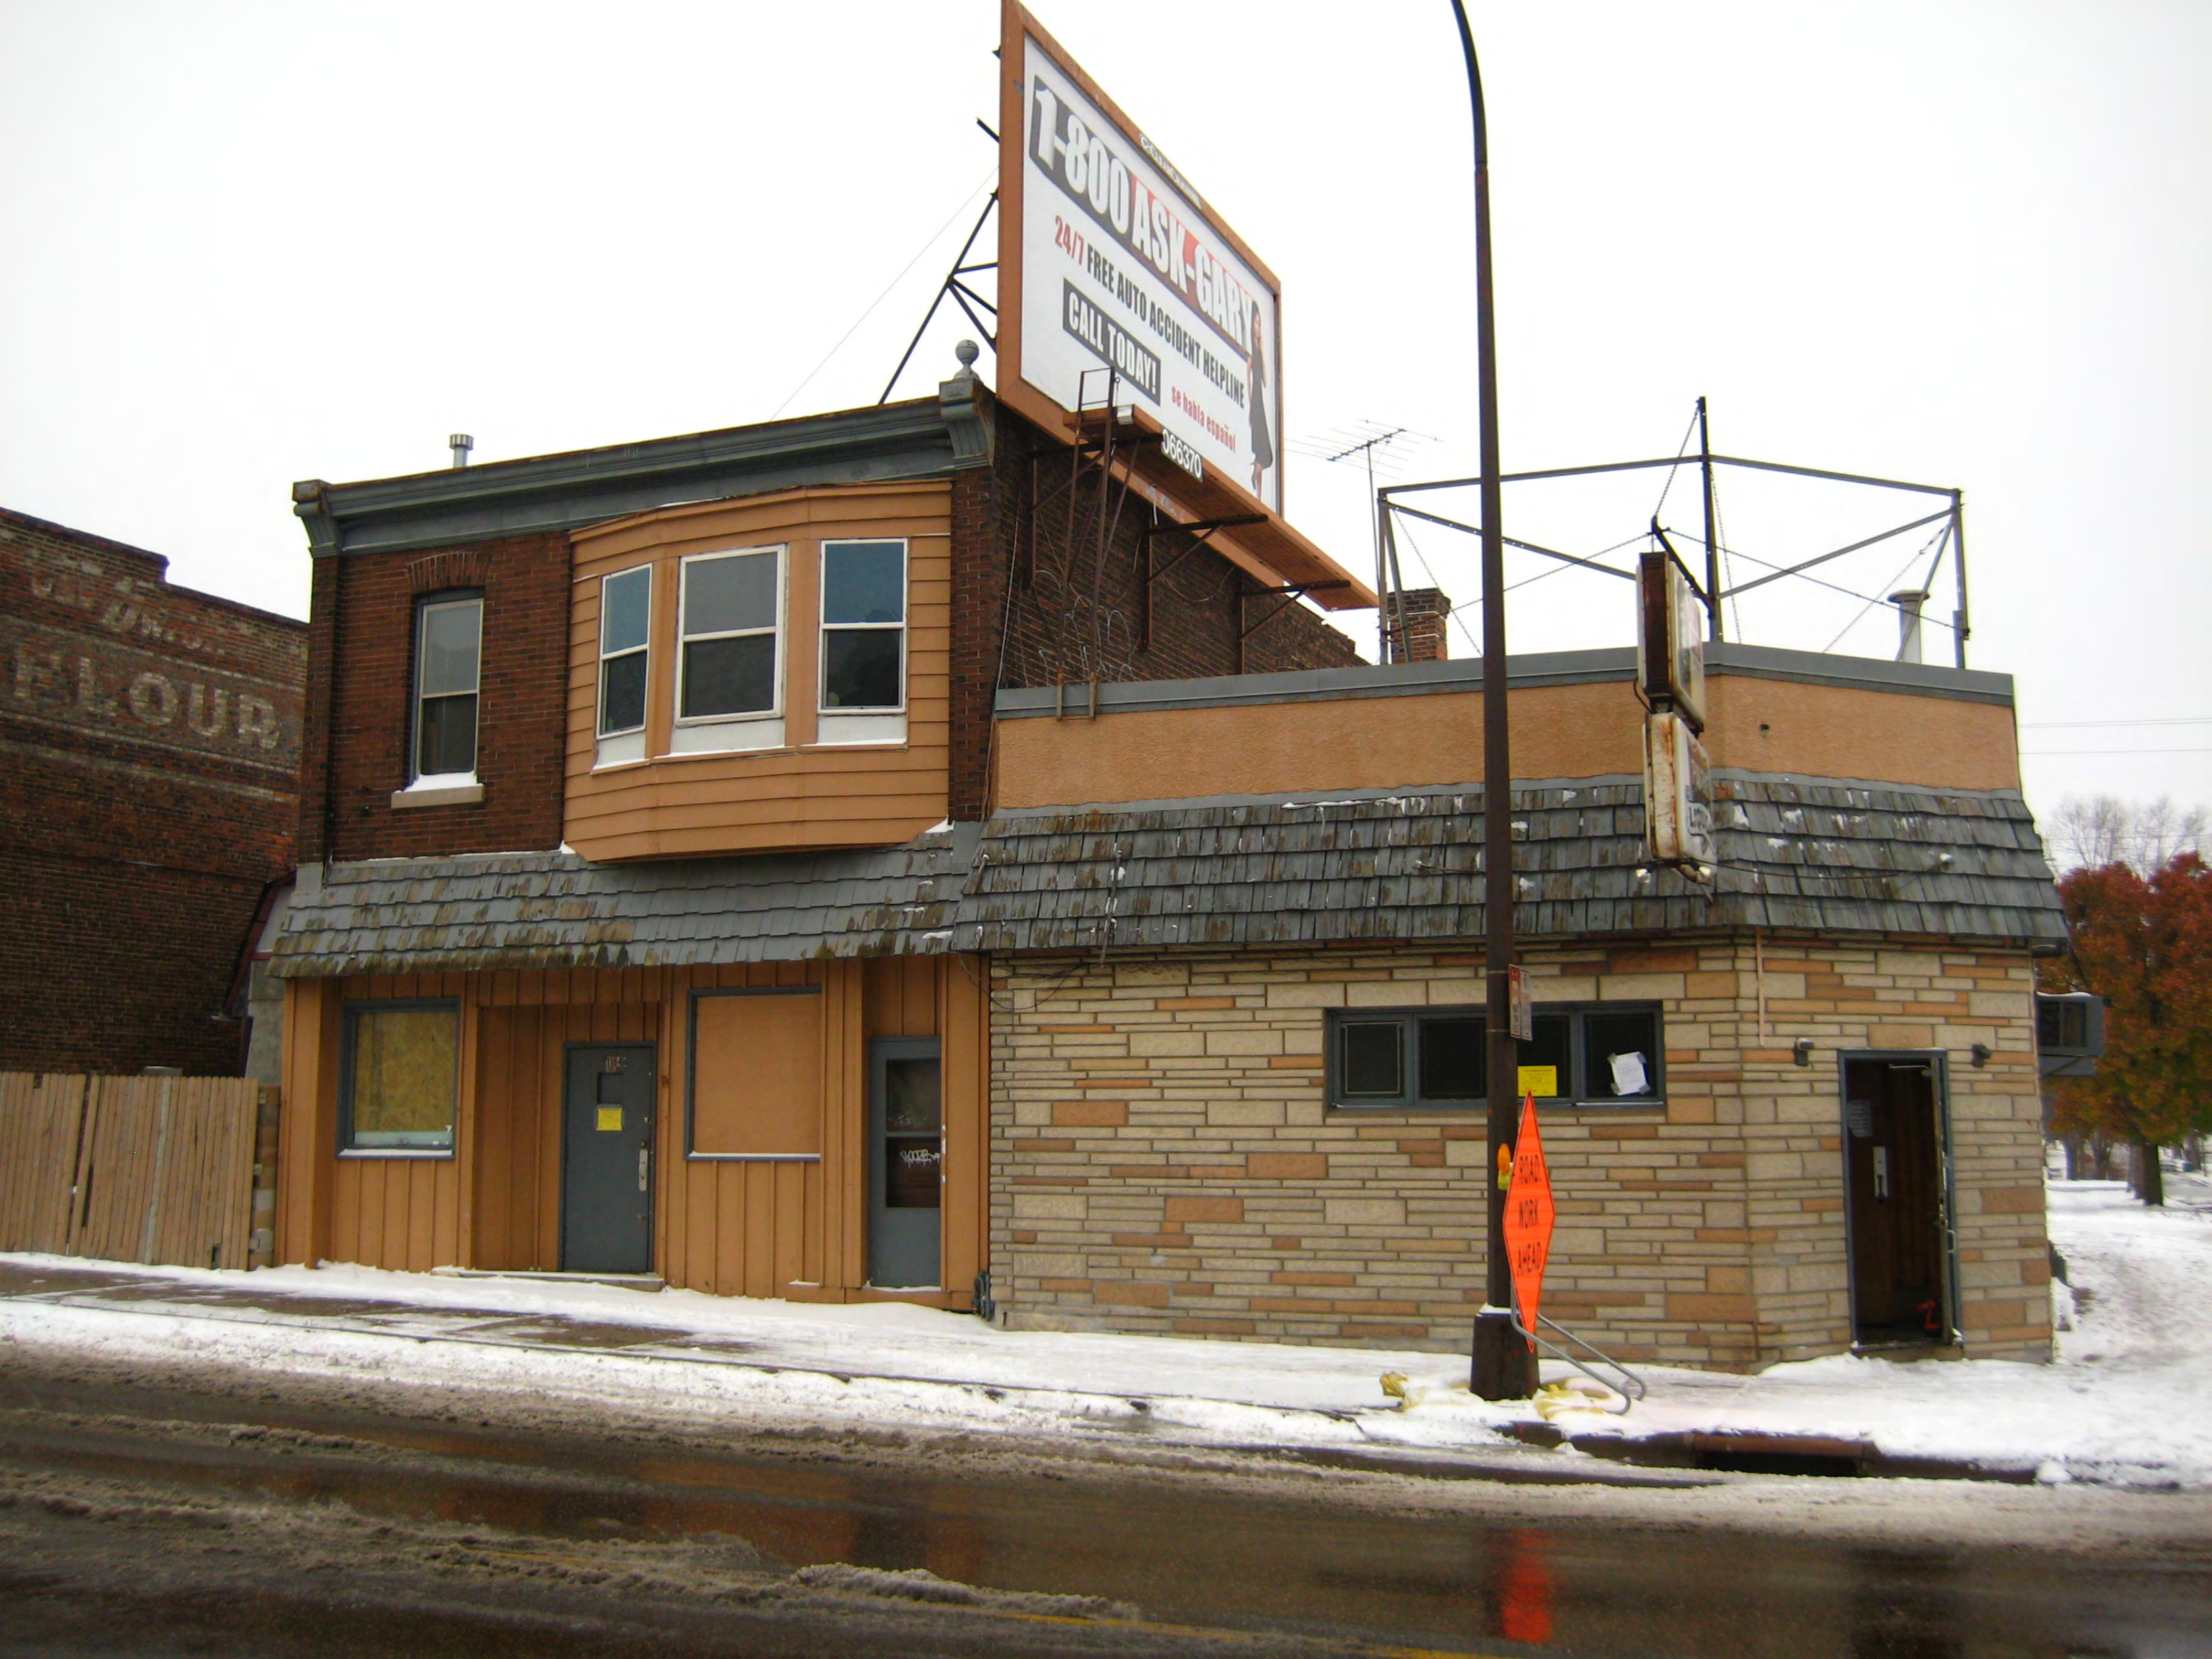
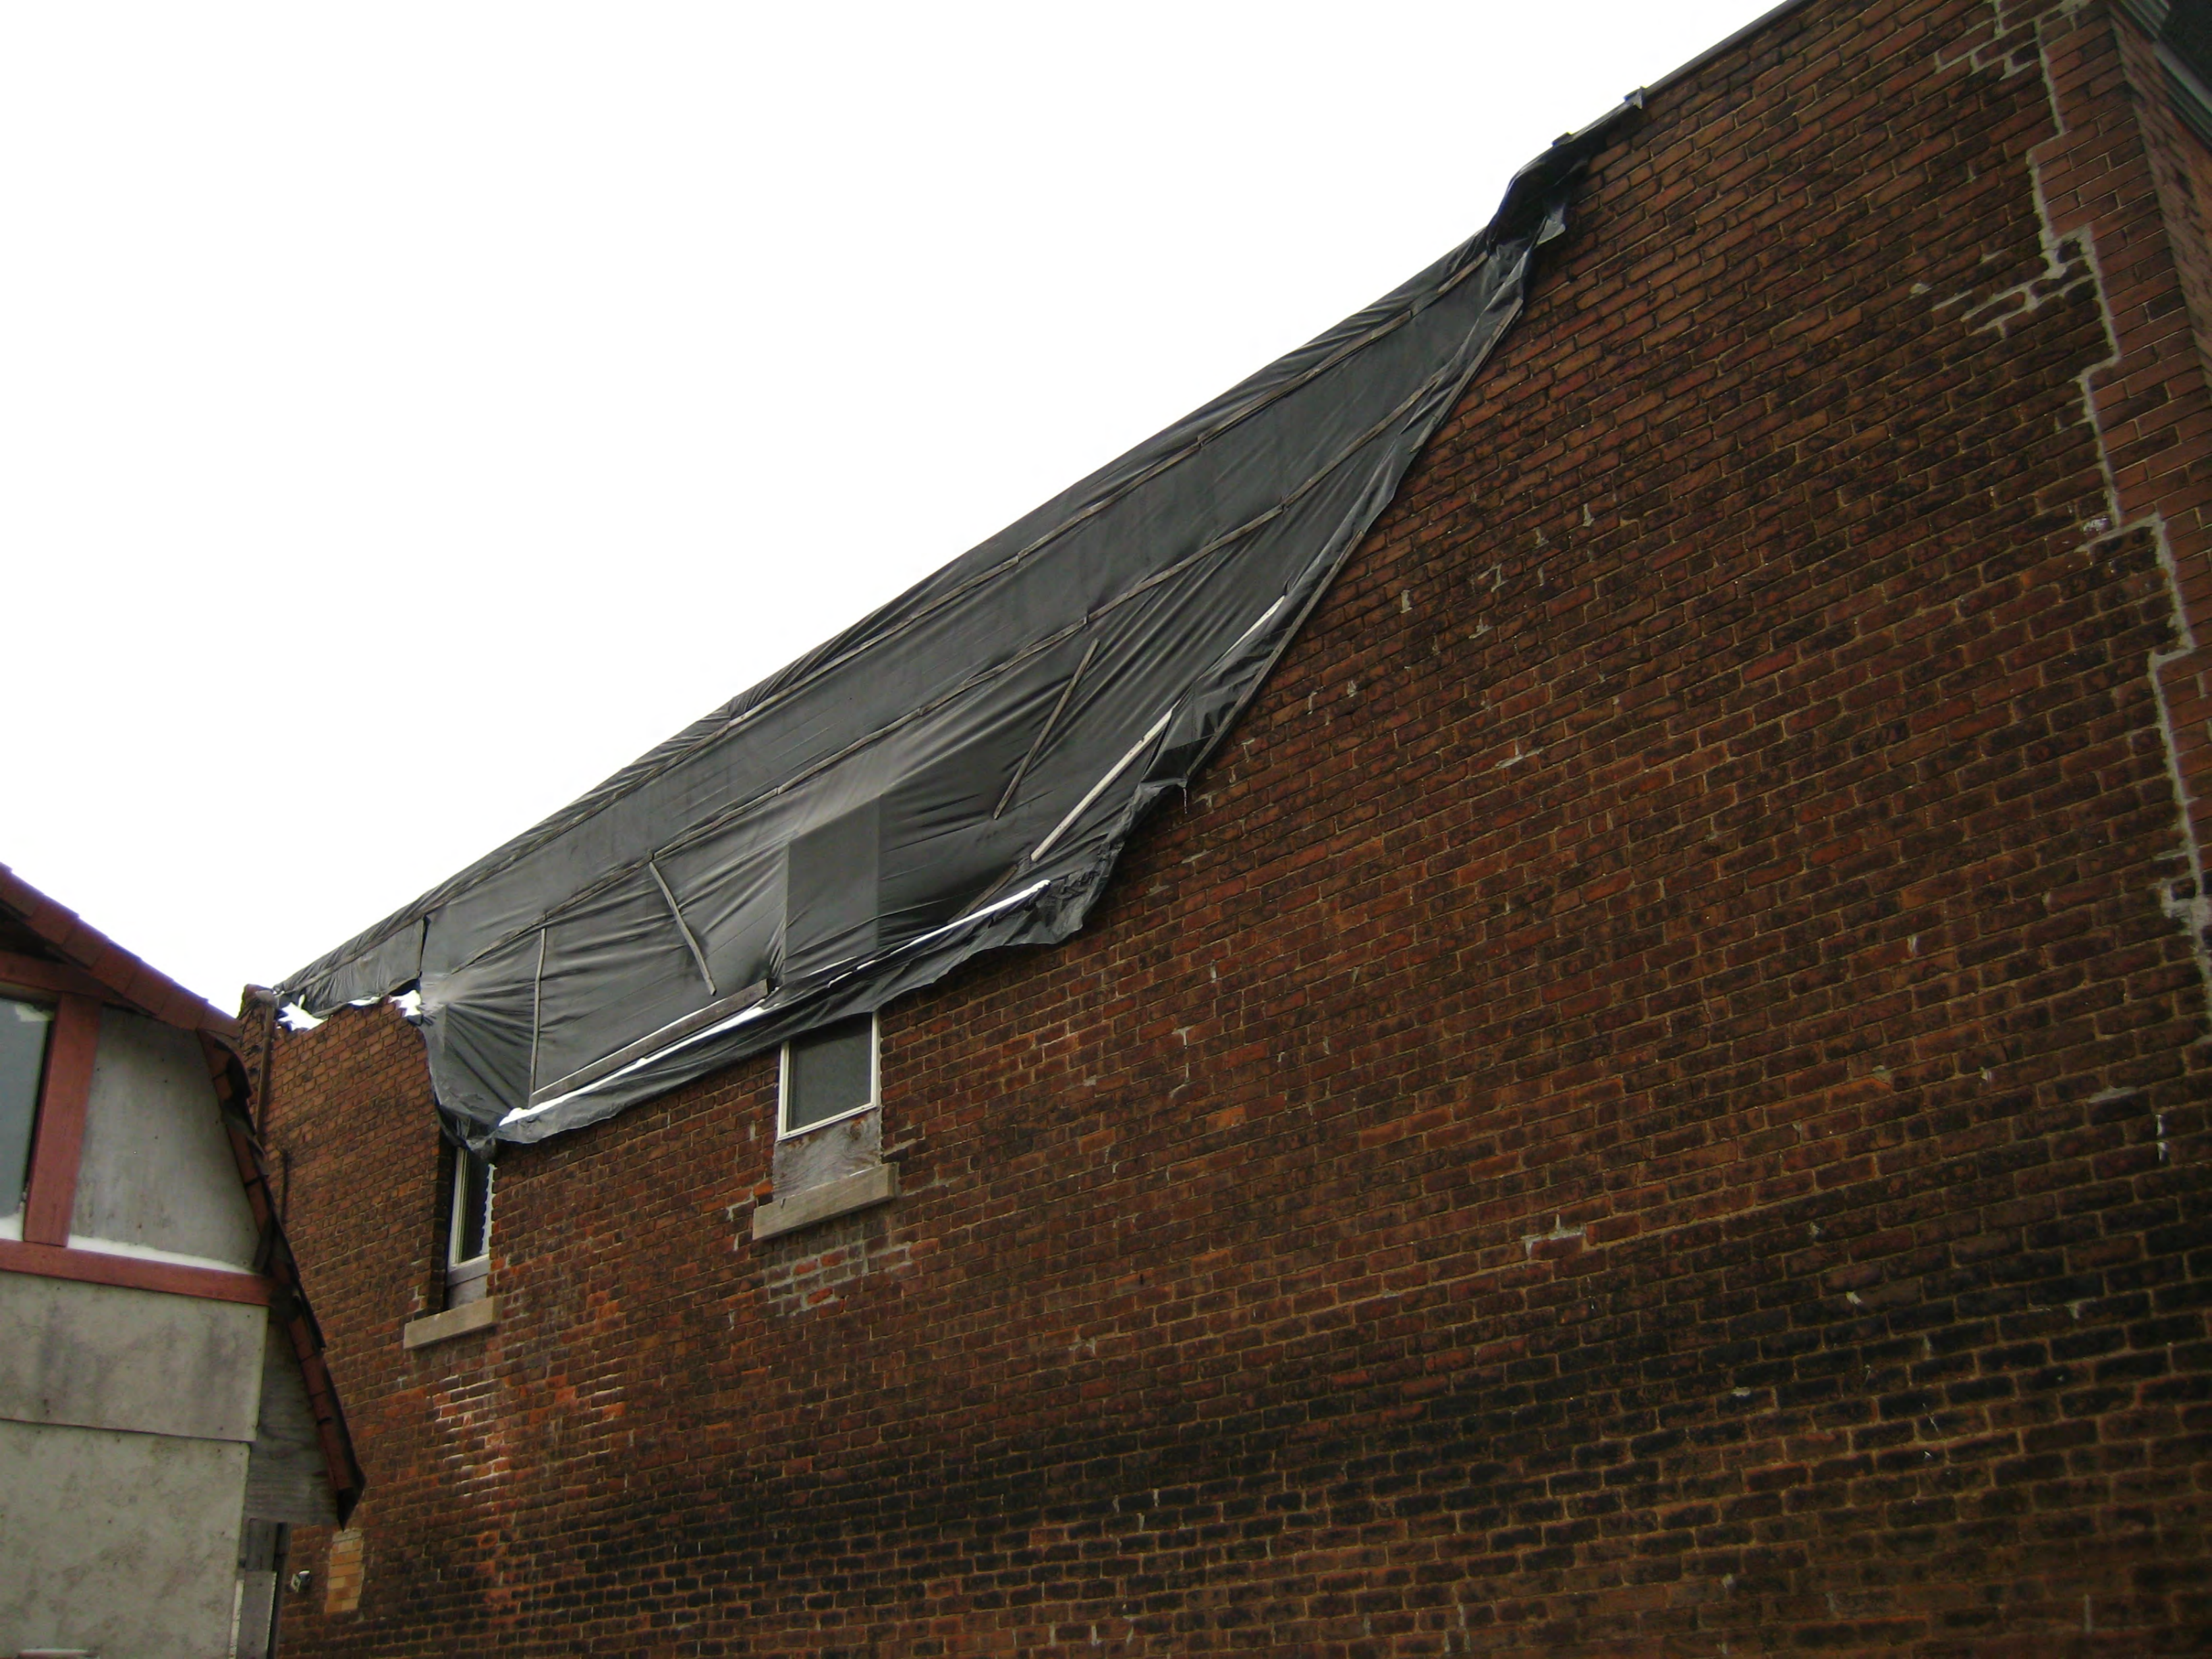
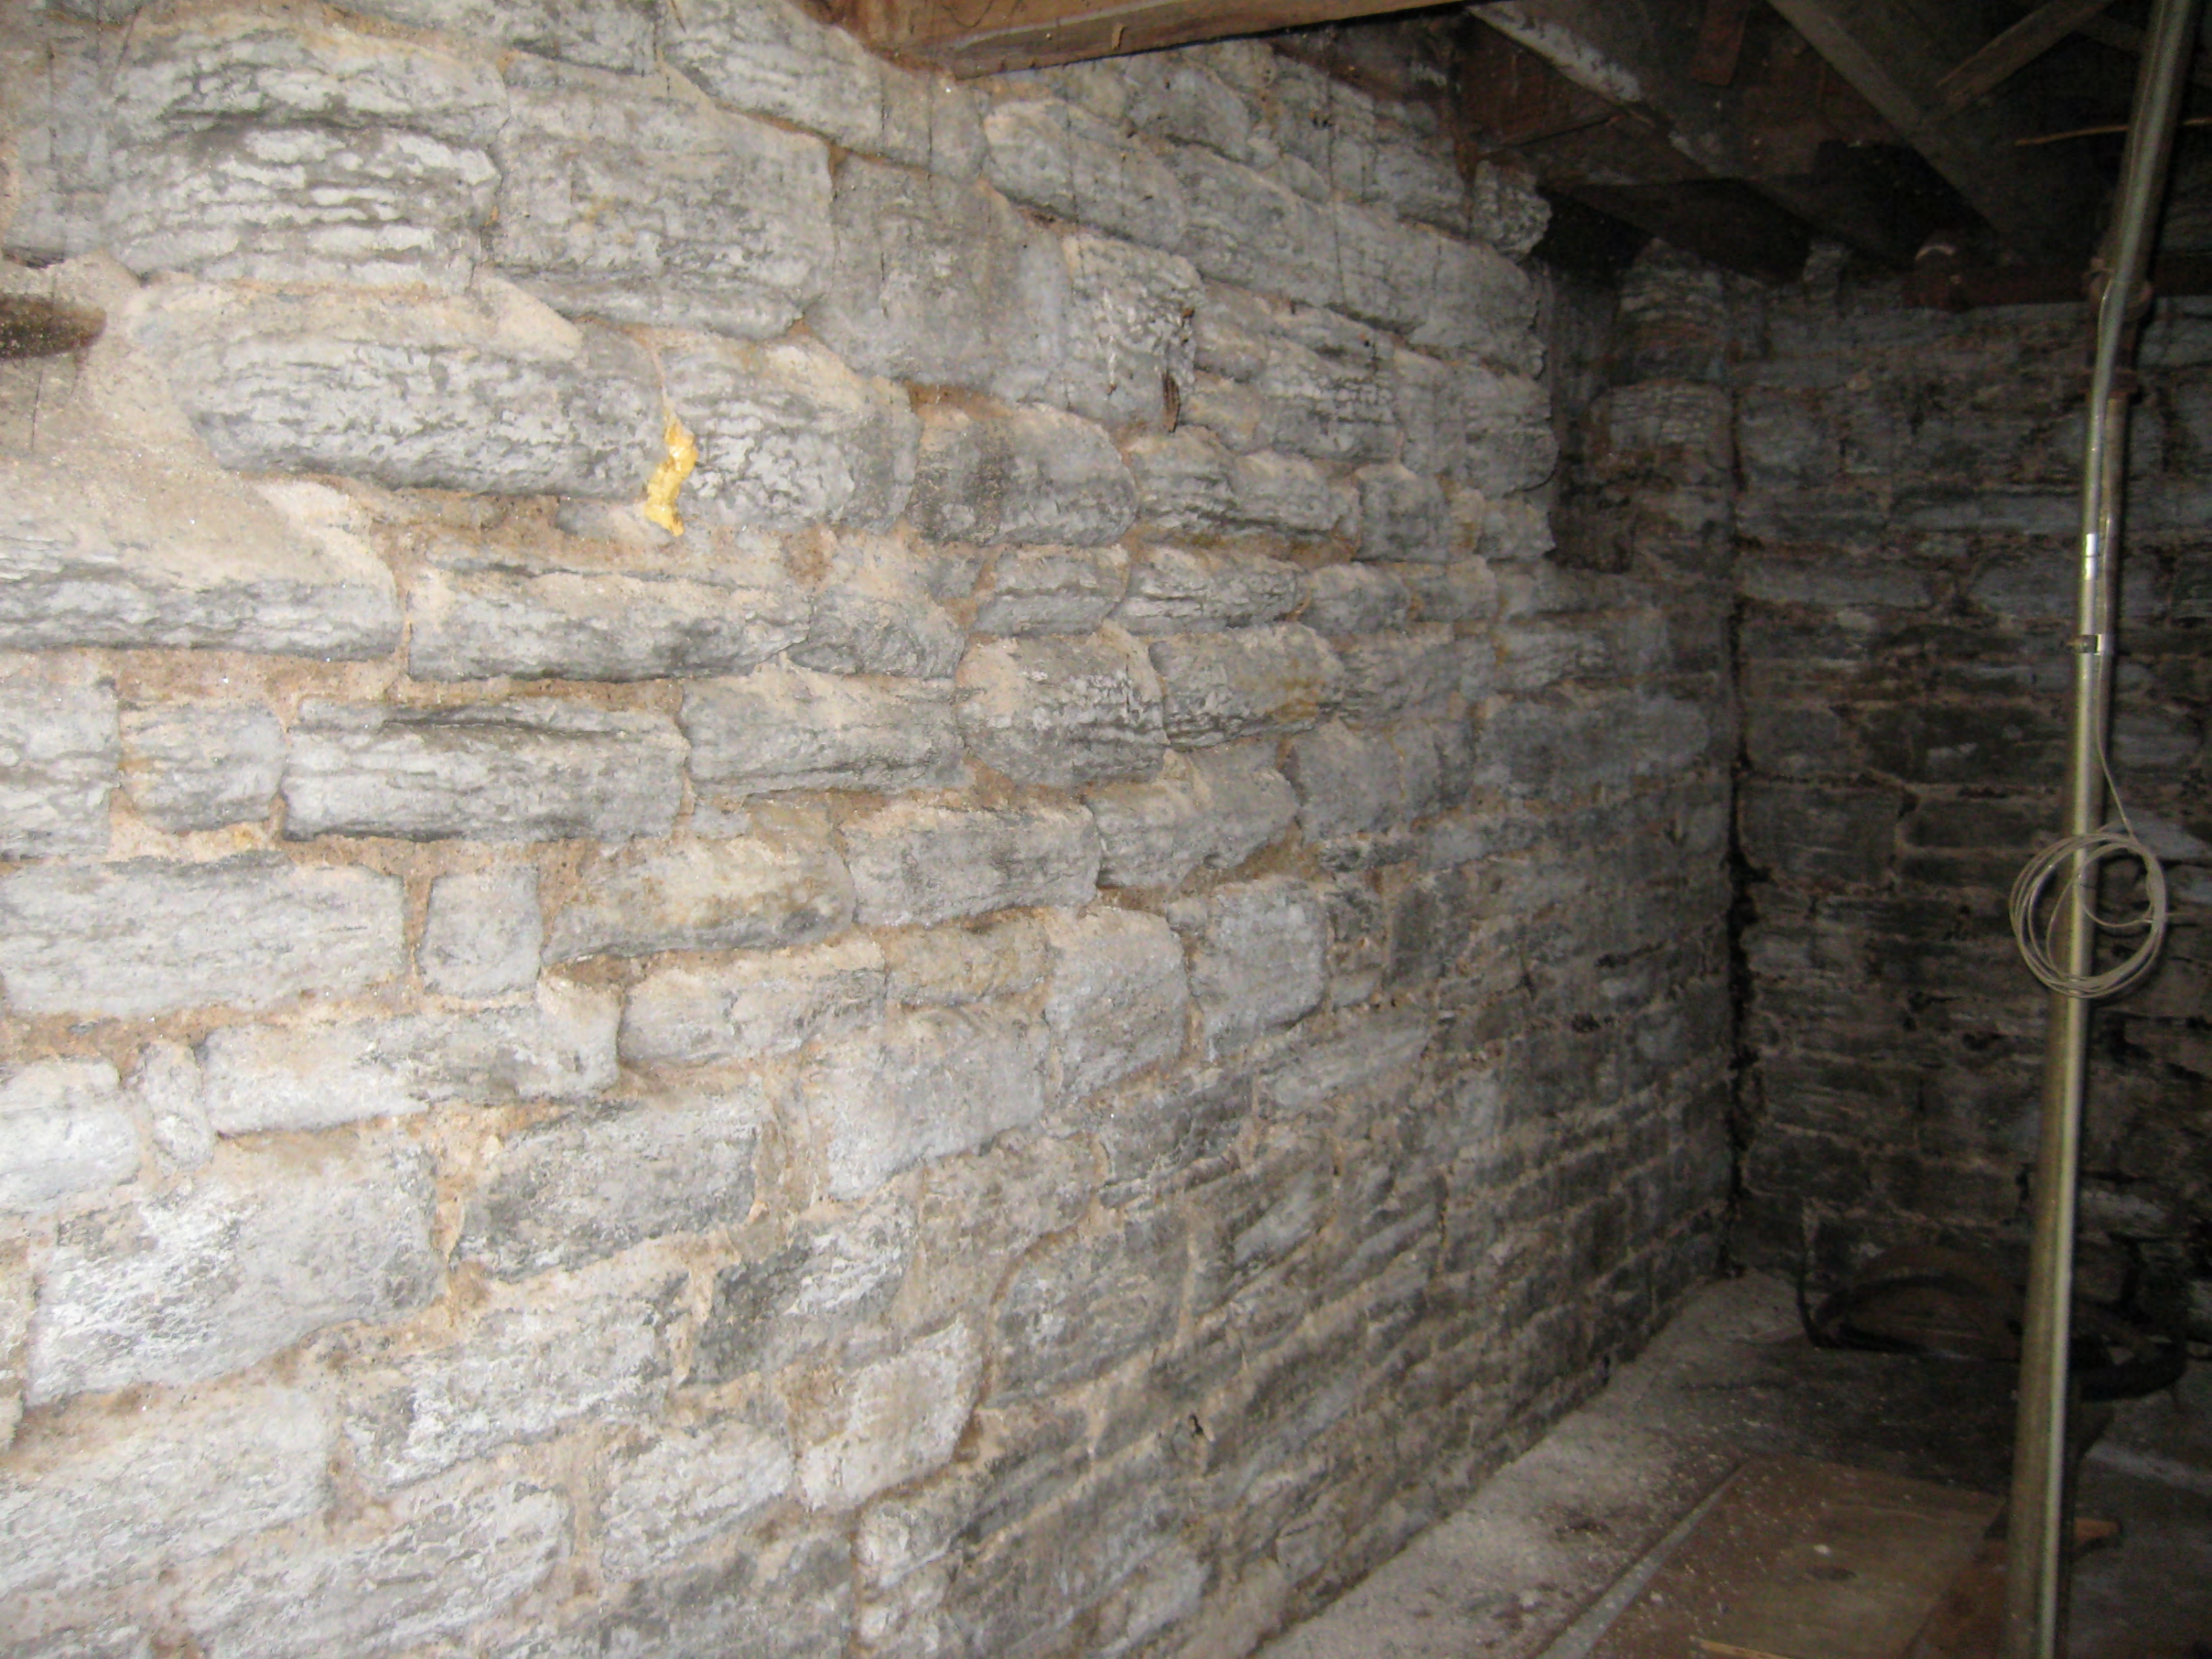
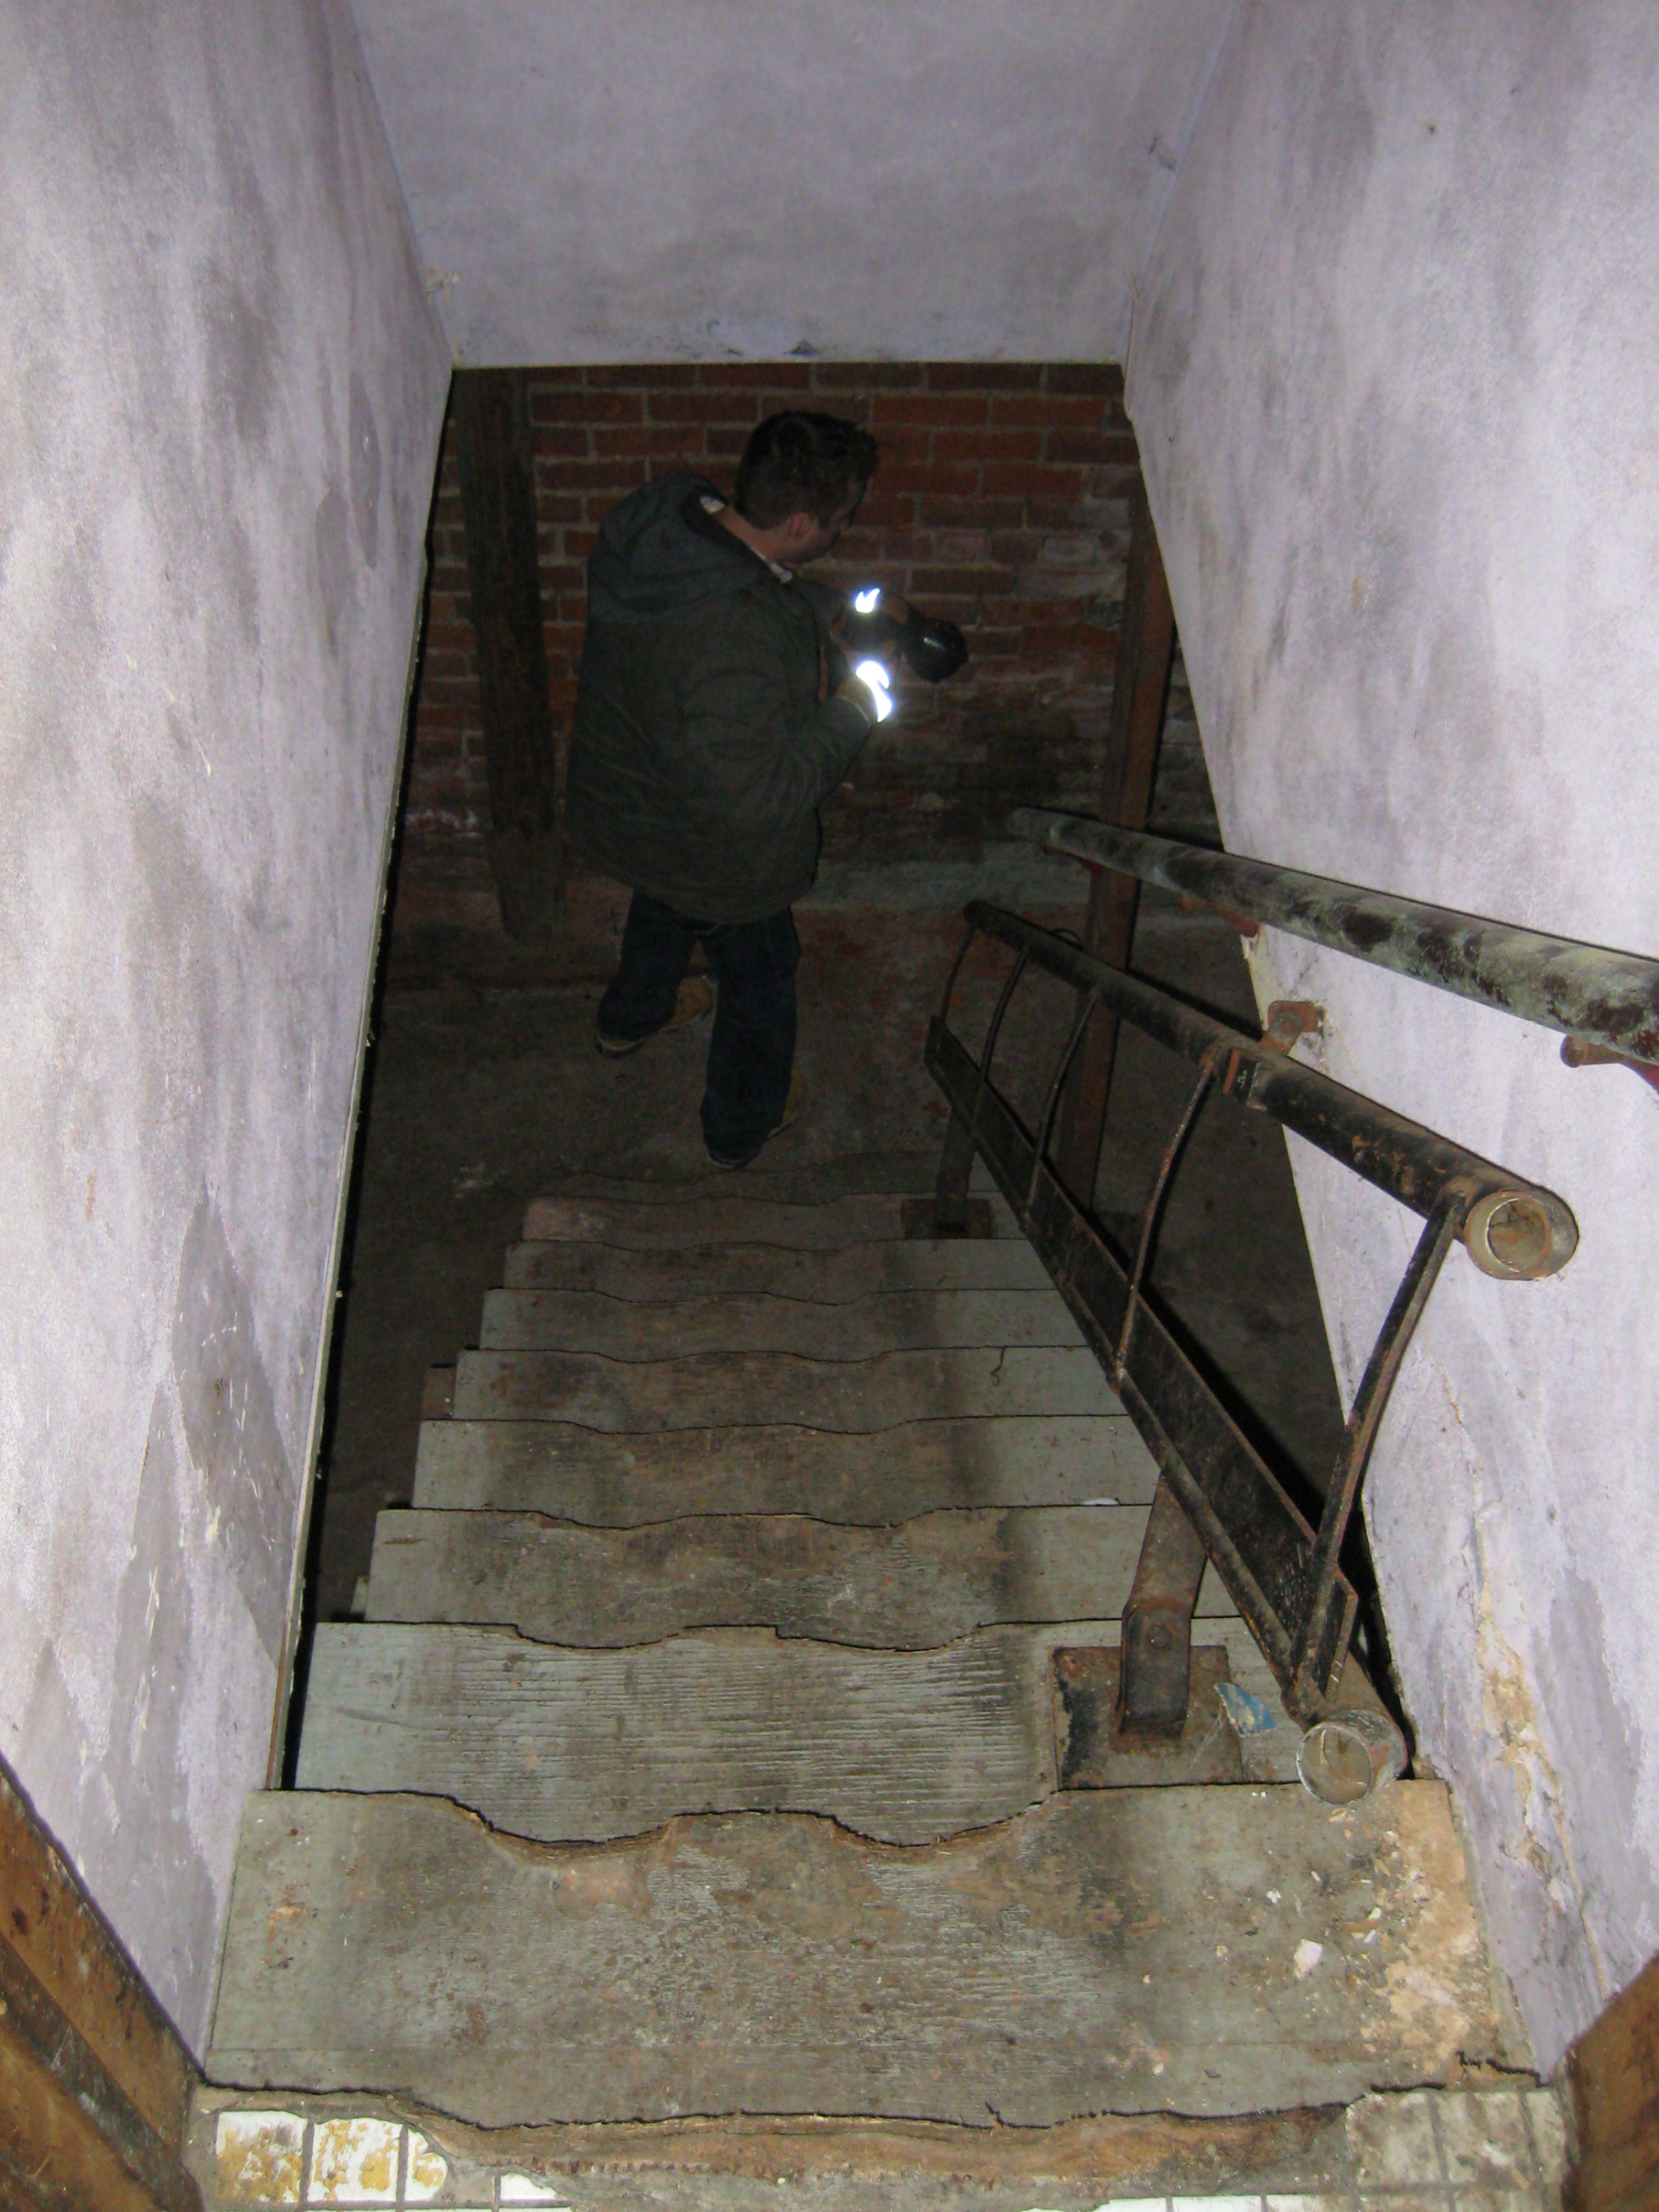
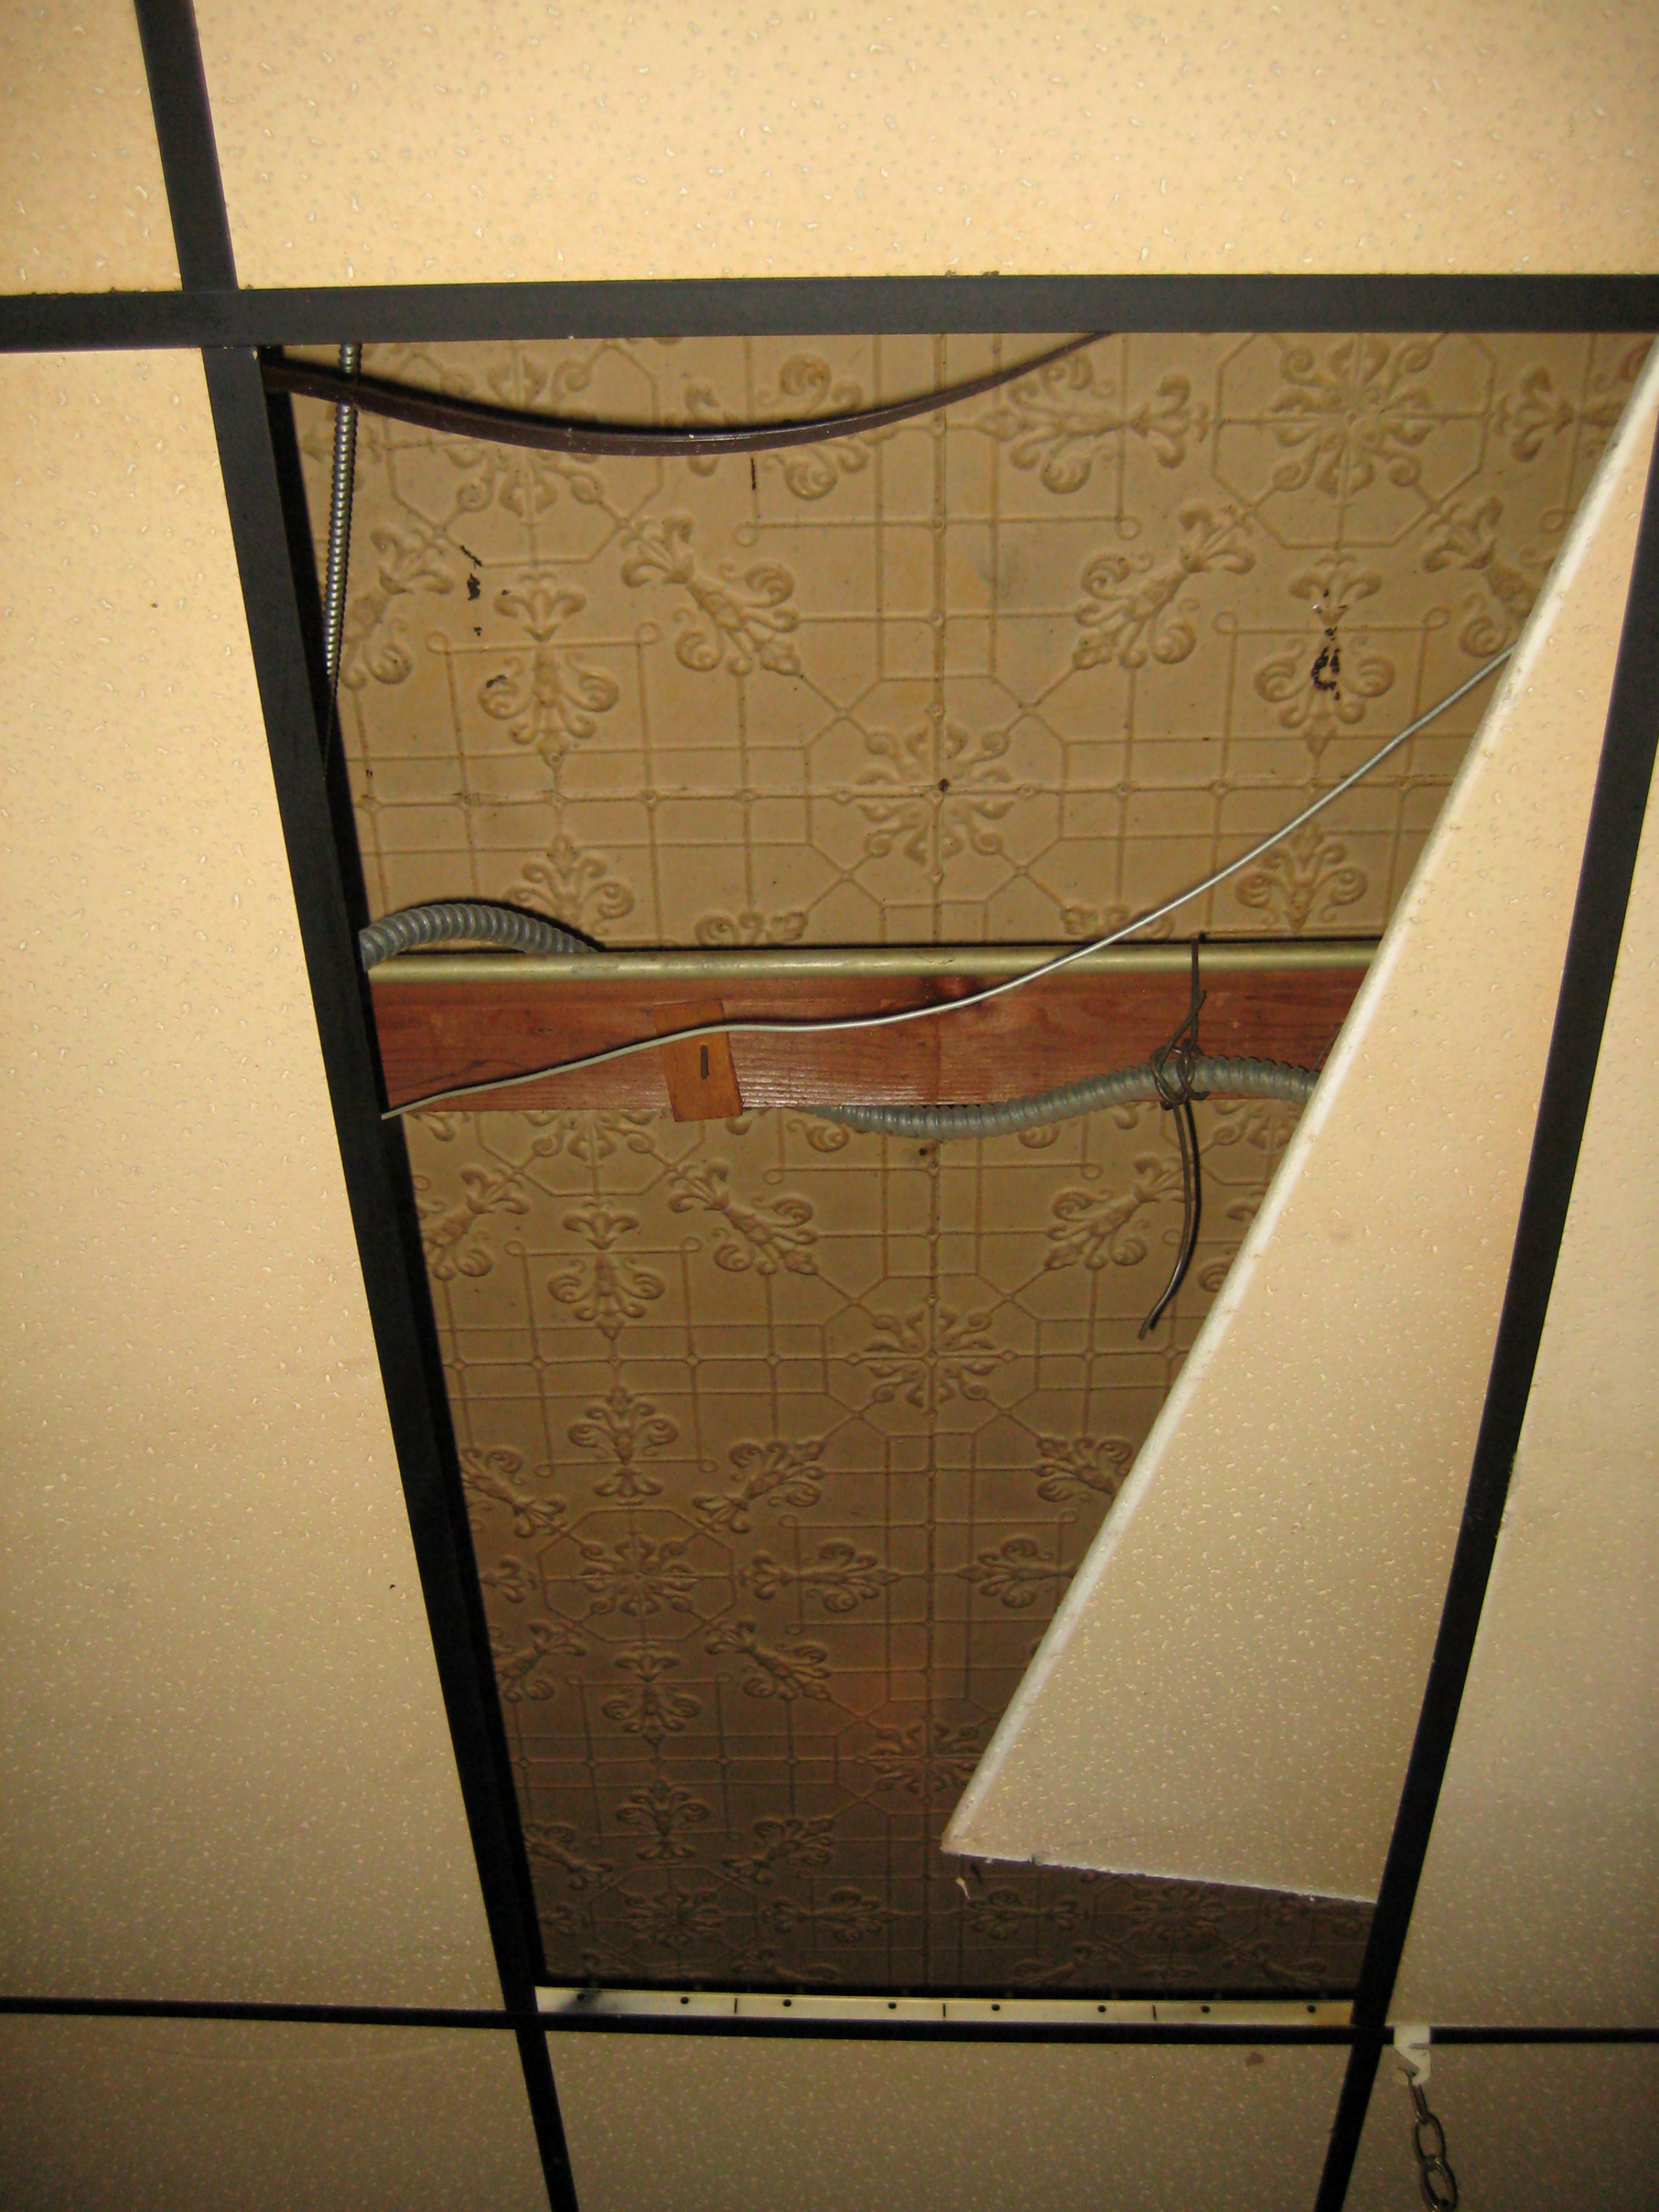
The one-story building on the corner has no integrity remaining. The two-story building, other than being opened up to the first floor of the corner building, still has some integrity on the upper portion of the facade, but the brick on the east elevation is pulling away and falling from the framing at the parapet and second floor.

There are no historic details visible in or on the one-story building.

The keg-rail at the stairs is an interesting feature and should be salvaged.

The two-story building has pressed tin ceilings hidden by a drop ceiling inside the first floor.

The basement foundation was limestone and in good condition.

The second floor has been gutted.

The framing in the upstairs is old-growth wood in good condition.
