Cherokee Heights Culvert Analysis and Erosion Control Feasibility Study

Prepared for
Lower Mississippi River Watershed Management Organization

April 8, 2015

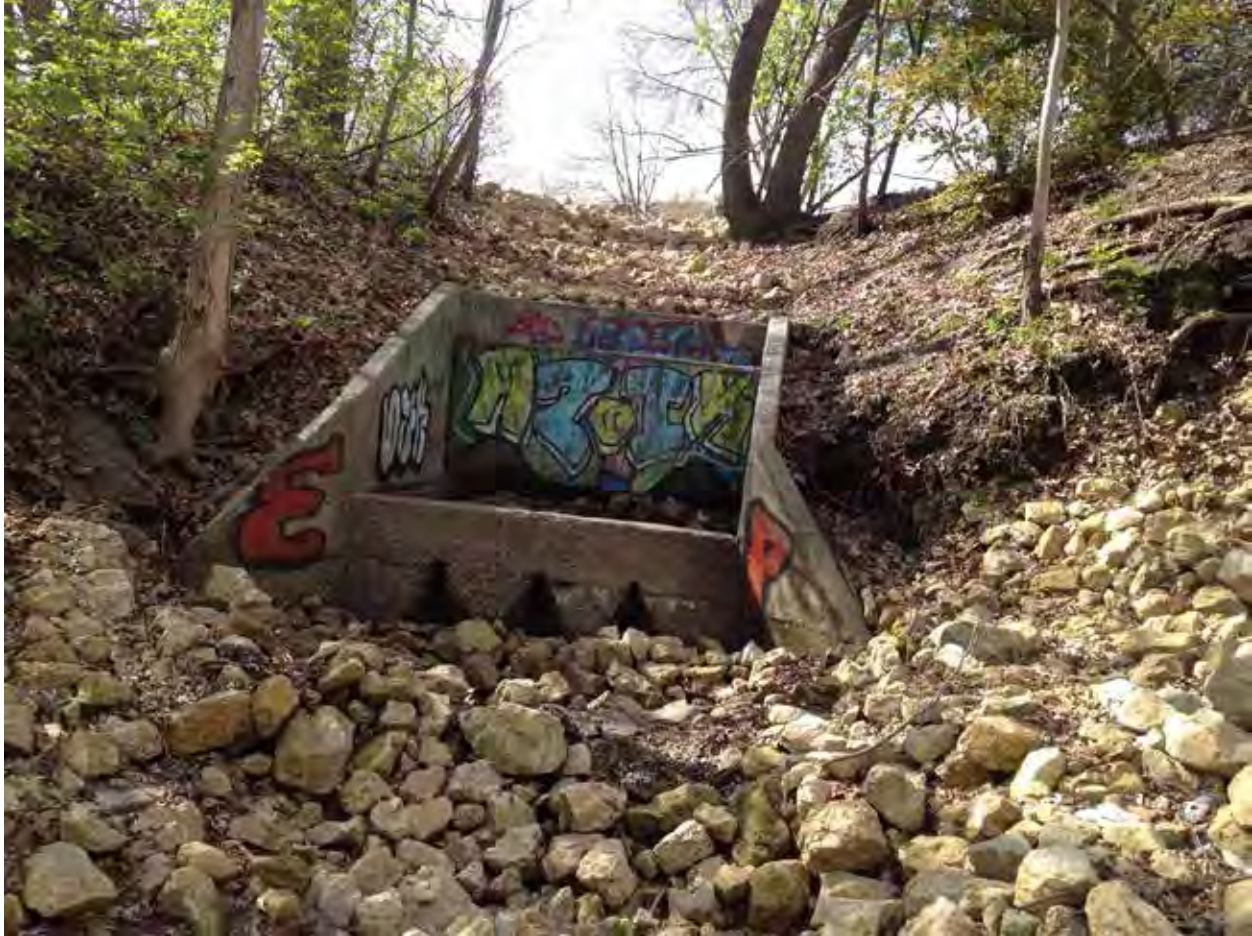
Photo 1-1 Energy dissipation structure downstream of the 27-inch outfall and erosion of adjacent side slope (May 2014 site visit)

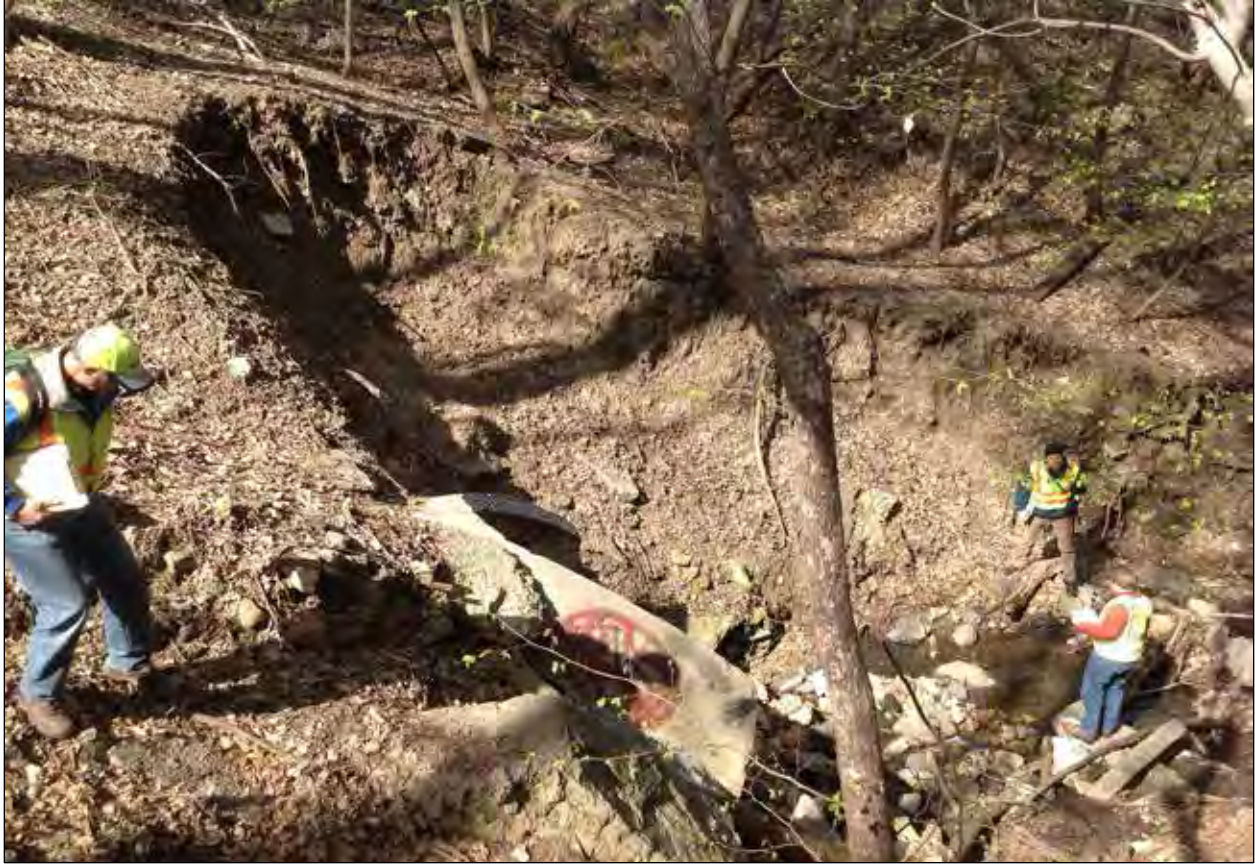
Photo 1-2 Erosion adjacent to the storm sewer outlet in Cherokee Heights ravine (May 2014 site visit)

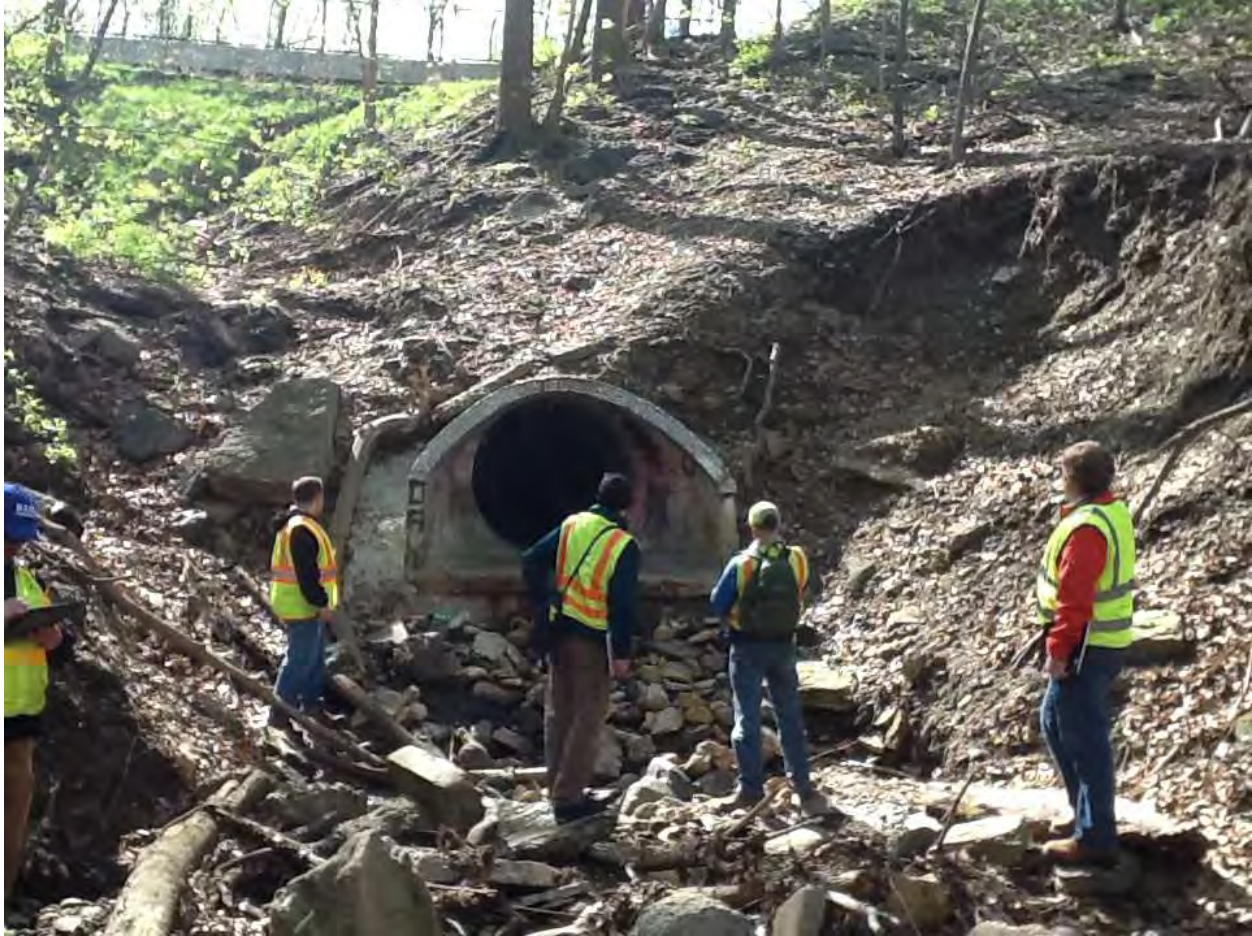
Photo 1-3 Erosion and scouring at the outfall of the Cherokee Heights culvert (May 2014 site visit)

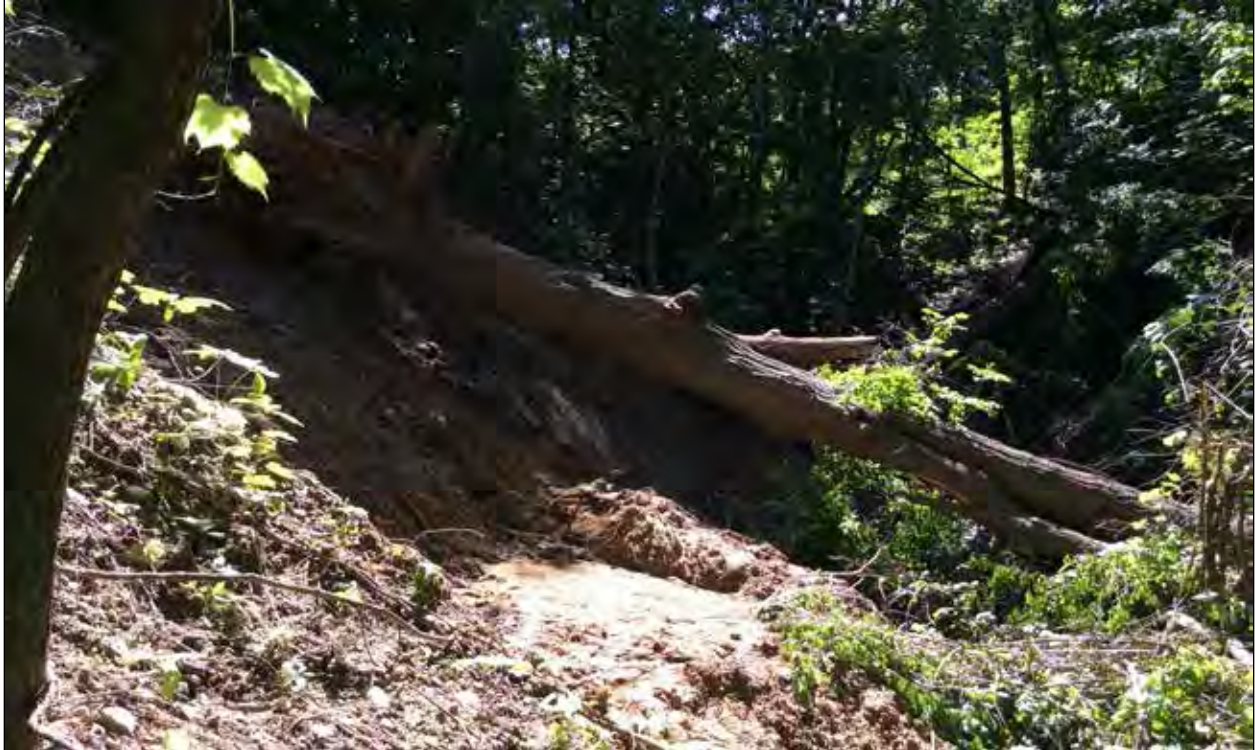
Photo 1-4 Cherokee Heights ravine slope failure (July 2014 site visit)

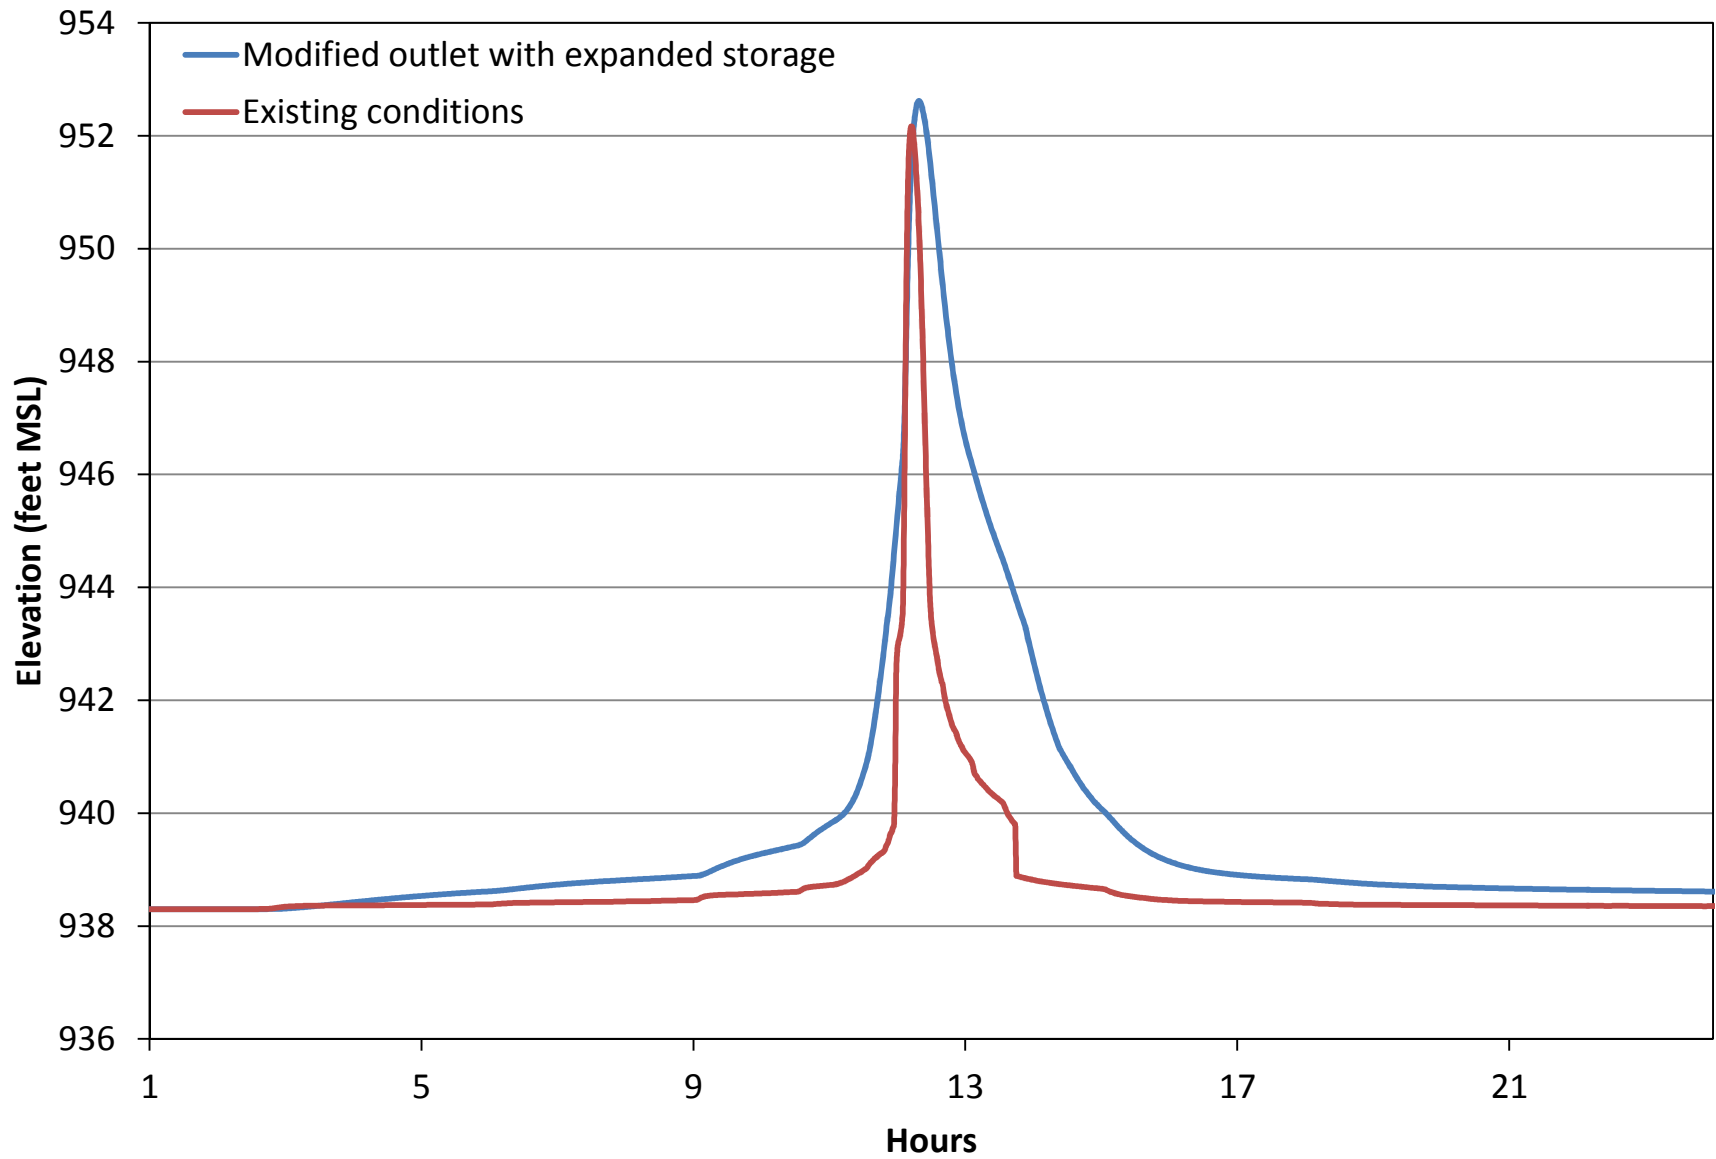
Figure 4-4: 100-year, 24-hour flood elevations within the upstream low area/ravine under existing conditions and the expanded storage/modified outlet conceptual design

For the conceptual design presented in this report, the outlet and additional storage were designed to reduce peak flows for a range of recurrence intervals, while minimizing increases in bounce as compared to existing conditions. For the 100-year, 24 hour event the high water elevation is increased by 0.6 feet under the expanded storage and modified outlet scenario, based on the assumption of 3.9 additional acre-feet of storage, with 1.3 acre-feet below the 2-year frequency high water elevation (943.3 feet MSL). [Table 4-2](#) summarizes the peak flows and high water elevations based on the outlet shown in [Figure 4-3](#) and the additional 3.9 acre-feet of storage. [Figure 4-4](#) compares the 100-year, 24-hour high water elevations within the upstream low area/ravine under existing conditions and the expanded storage/modified outlet conceptual design. As shown in [Figure 4-4](#), the duration of temporary water storage increases by 2 hours under the expanded storage/modified outlet scenario, as compared with existing conditions.
