RE: Demolition of 118 Manitoba Avenue  
St. Paul, Ramsey County  
SHPO Number: 2020-0490

# Historic Sites Survey

1. Street Address/Location: 118 W. Manitoba Avenue
2. District/village: 6
3. Common name: Hoffman House
4. Historic name: Hiller Hoffman House
5. Original use: House

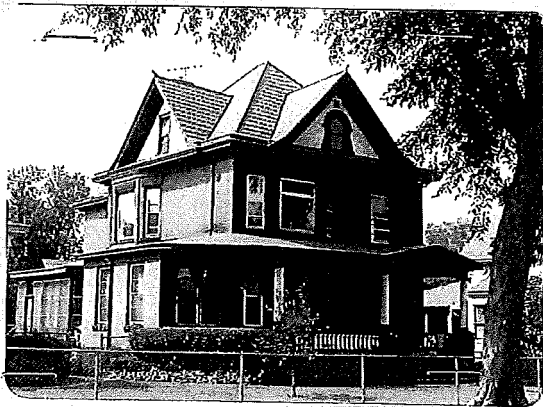
Photographs

19. Other significant details:  
Ornate house with open porch across main facade supported by round columns with 4 volute Ionic capitals. Pediment at porch entrance, dentils and exposed purlins at eaves. Porch balusters are turned. Rounded arched window with unusually flared window frame in gable end. Two story bay window with leaded glass transom on main facade. Doorway has leaded glass sidelights. Oval leaded glass in door. Gable ends covered with clapboard. Interior woodwork is largely intact. Rockfaced stone sills and lintels.

21. Physical condition of building: ☐ Excellent ☒ Good ☐ Fair ☐ Poor ☐ Deteriorated
22. Additions and alterations:  
New windows, rear porch altered, front porch altered, house converted to a duplex ca. 1925.
