On behalf of nineteen residents, please see the attached letter to City Council regarding the proposed Mill & Overlay assessment for Montrose Lane.

Honorable Council Members,

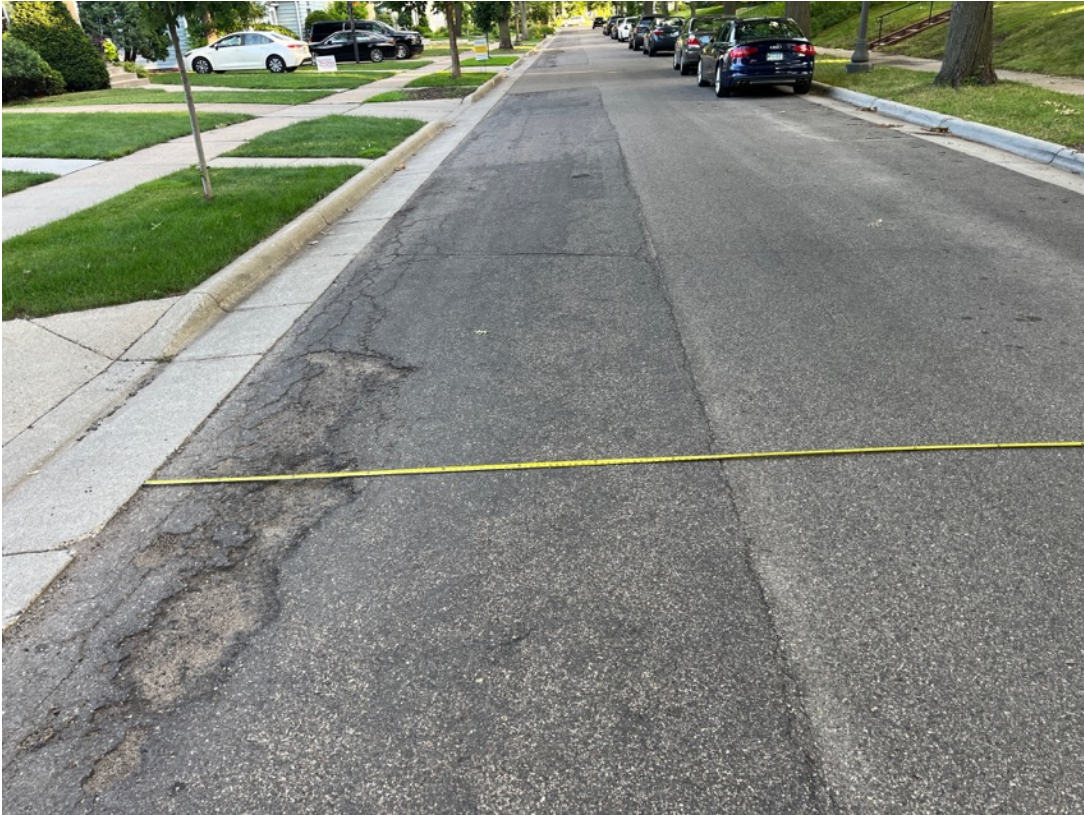
**1) View looking south at unreconstructed east lane of pavement (the driving lane), which is full of potholes. Full-width reconstruction is visible at each manhole.**

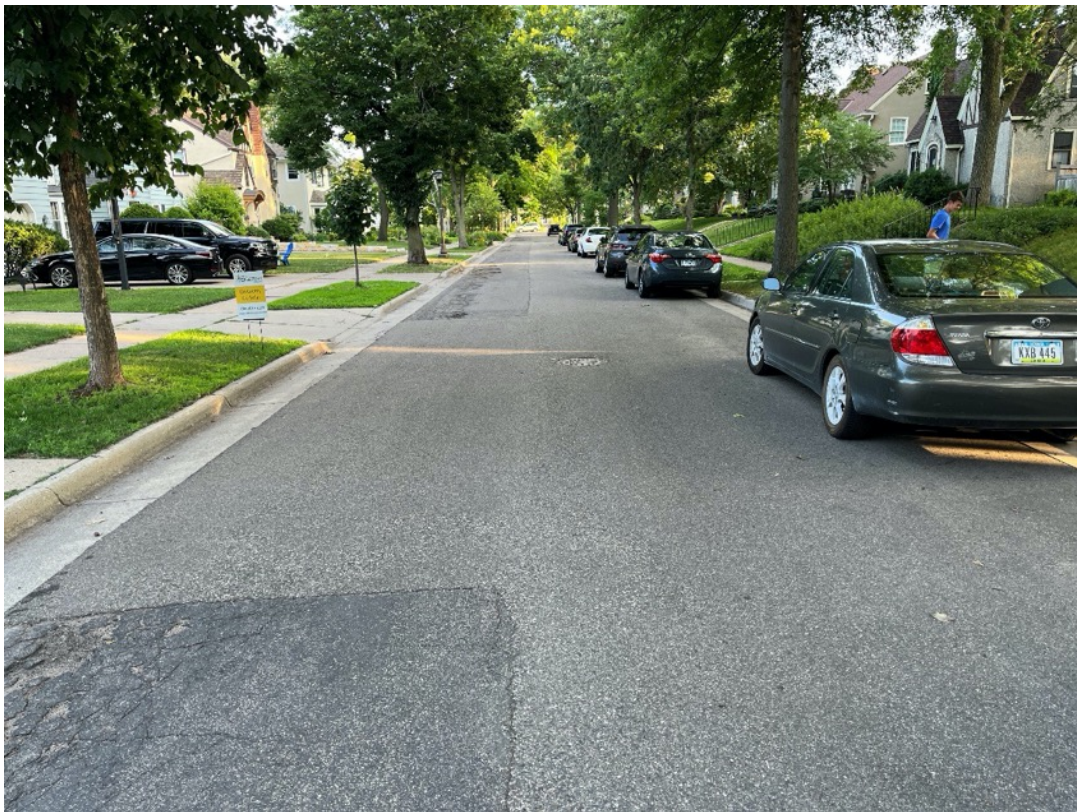
**2) View looking south at fully reconstructed pavement around manhole in excellent condition, preceded and followed by unreconstructed pavement in poor condition.**

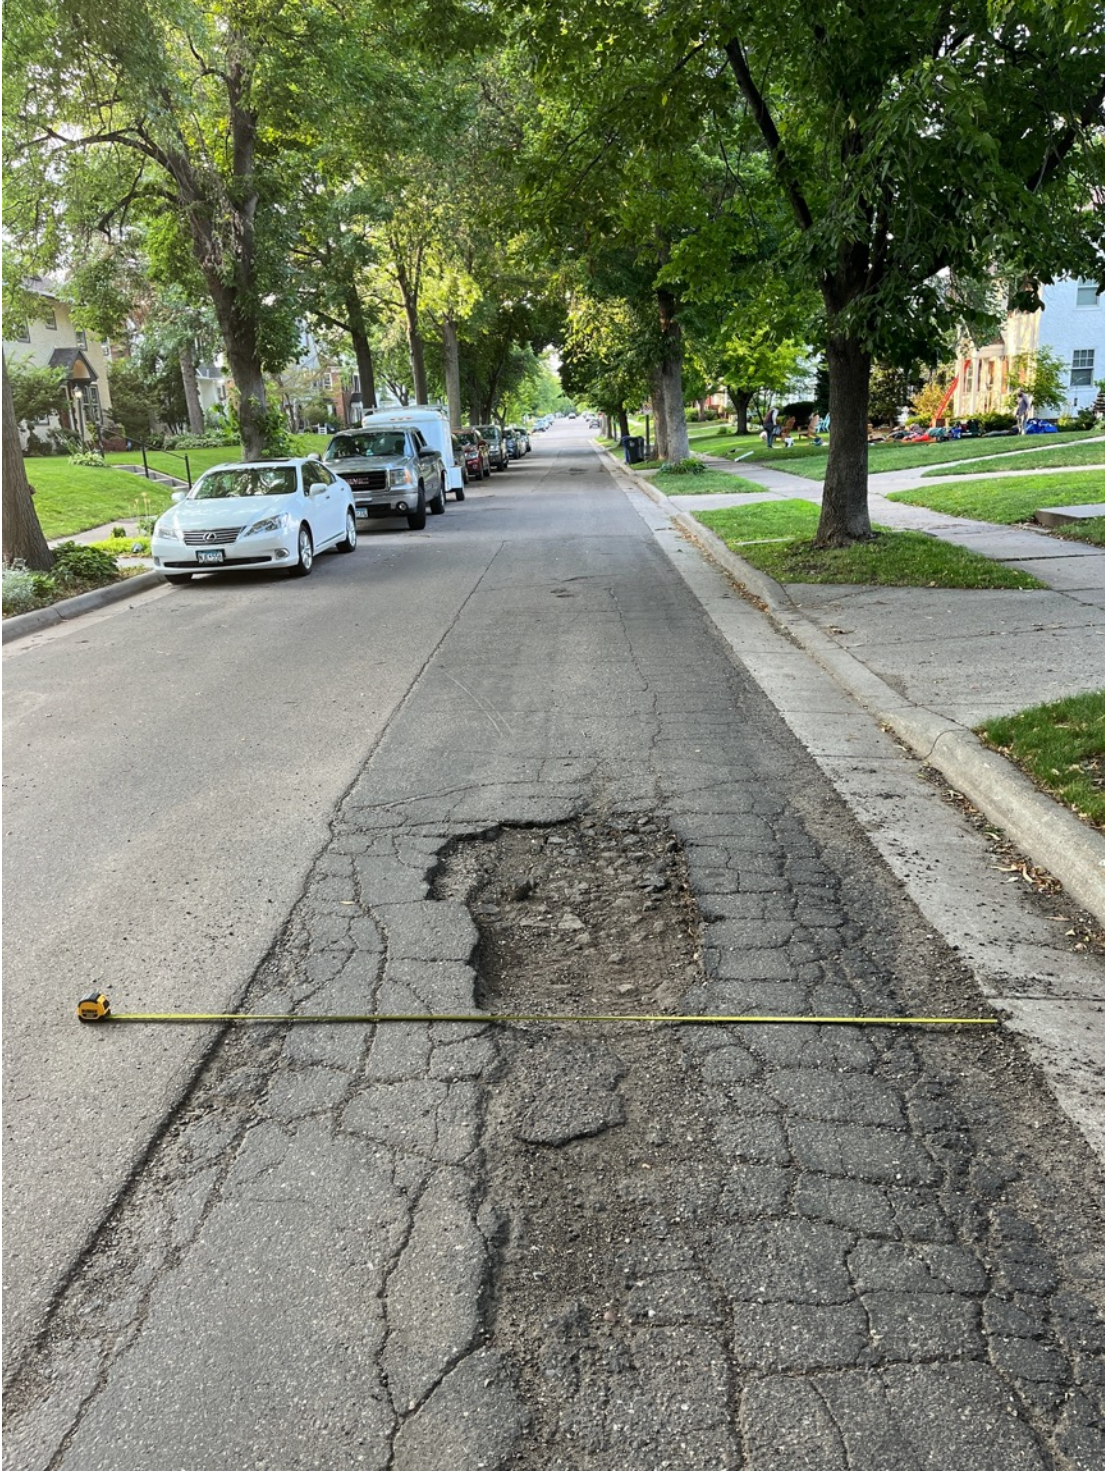
**3) View looking north at unreconstructed east lane of pavement (the driving lane due to parking restrictions), which is full of potholes. Full-width reconstruction is visible at each manhole.**
