City of Saint Paul
Smoke Testing Inspection Report

Record No: 211

Project No: 127489

Address: 1442 Berkley Ave

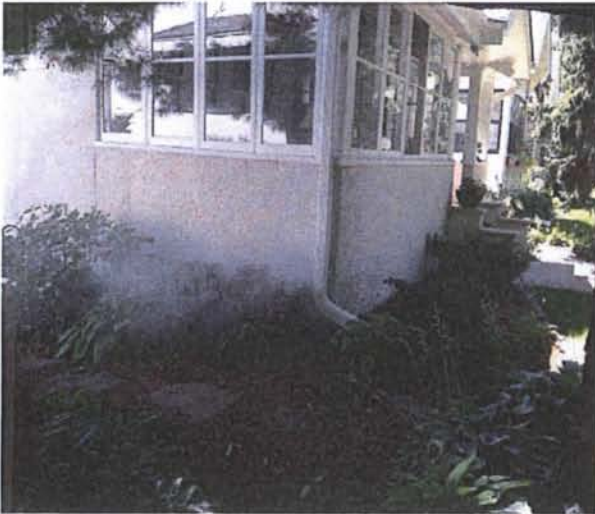
Photo 1 : Photo1.jpg

Defect Notes: Downspout connection under bricks

Smoke Density: Heavy

Smoke Source: Downspout Connection

Smoke Source Location Notes: NE corner of house
