**From:** Moermond, Marcia (CI-StPaul)  
**Sent:** Thursday, December 20, 2018 4:41 PM  
**To:** Karpen, Brian (CI-StPaul)  
**Cc:** gwuckland59@comcast.net; Ubl, Stephen (CI-StPaul); Perucca, James (CI-StPaul)  
**Subject:** RE: 779 Carrol - Structure

**From:** Karpen, Brian (CI-StPaul)  
**Sent:** Thursday, December 20, 2018 4:30 PM  
**To:** Moermond, Marcia (CI-StPaul) <marcia.moermond@ci.stpaul.mn.us>  
**Cc:** gwuckland59@comcast.net; Ubl, Stephen (CI-StPaul) <stephen.ubl@ci.stpaul.mn.us>; Perucca, James (CI-StPaul) <james.perucca@ci.stpaul.mn.us>  
**Subject:** 779 Carrol - Structure

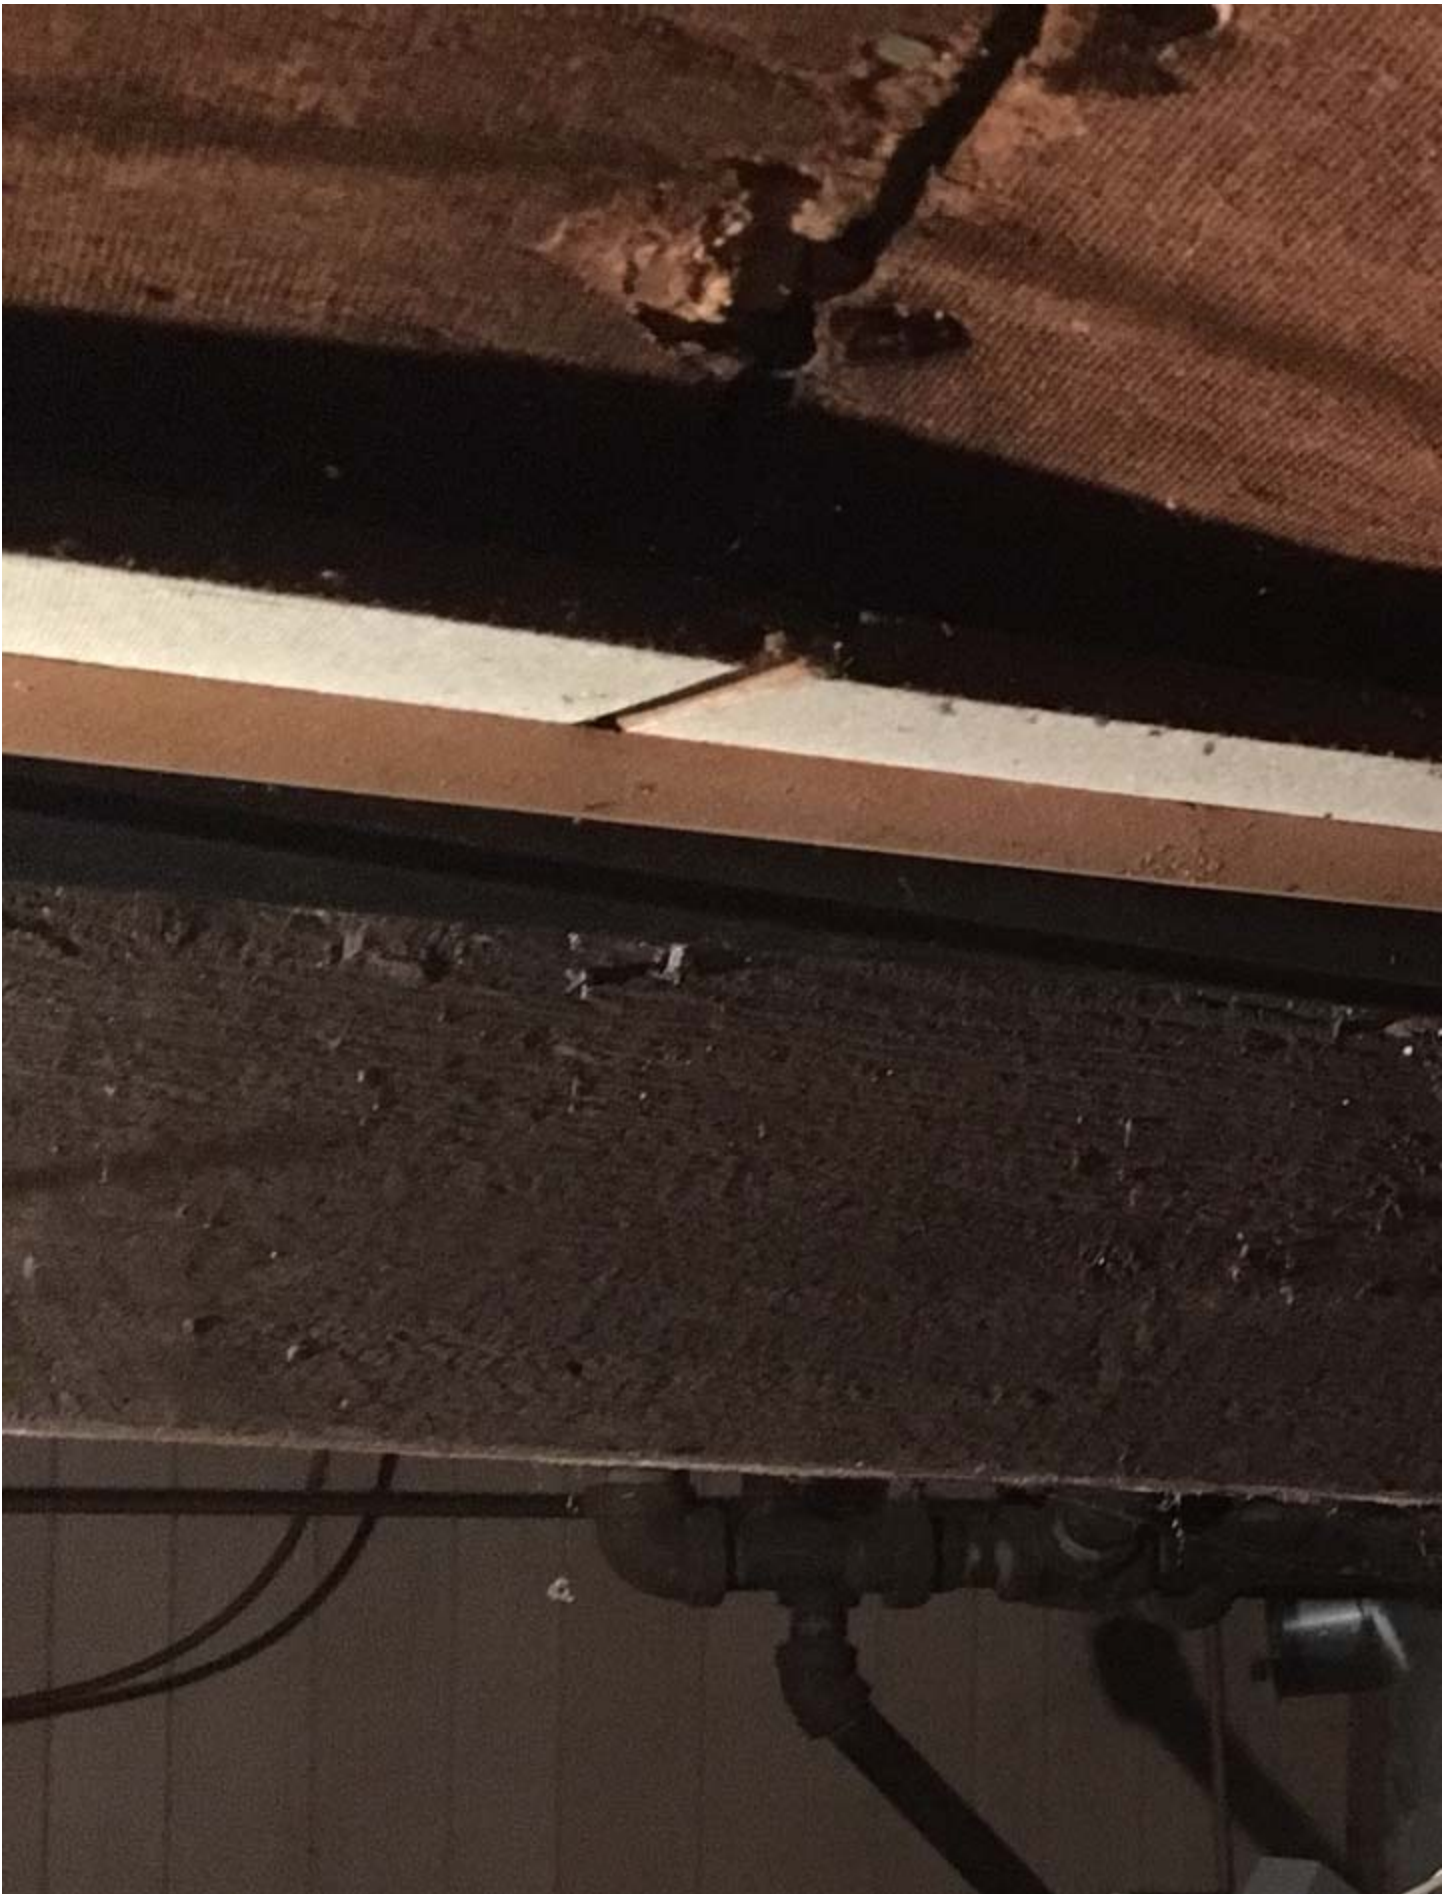
As the Fire Inspector noted the floor is deflecting significantly, especially evident on the first floor of the house. There is also extensive cracking in the wall finishes throughout the house which is further evidence of settlement in the structure.

I believe the cause of this settlement is in the main structure line of the house in the basement. However, the root cause is not immediately apparent. The deflection is centered above on fo the main support posts in the house. The beam is not deflecting between support points and still bears fully on all the support points. There is no evidence of settlement in the slab of the basement either.

At this point it appears that the structure is stable in its current condition. Though full occupancy should only be allowed after a complete assessment by an engineer registered in the State of Minnesota and any repairs are performed under their direction; I see the risk to those entering to begin clean up as minimal.
