## 1657 MINNEHAHA ST. PAUL

### Structural Observations and Report

1657 Minnehaha Ave,  
St. Paul, MN

August 15, 2022

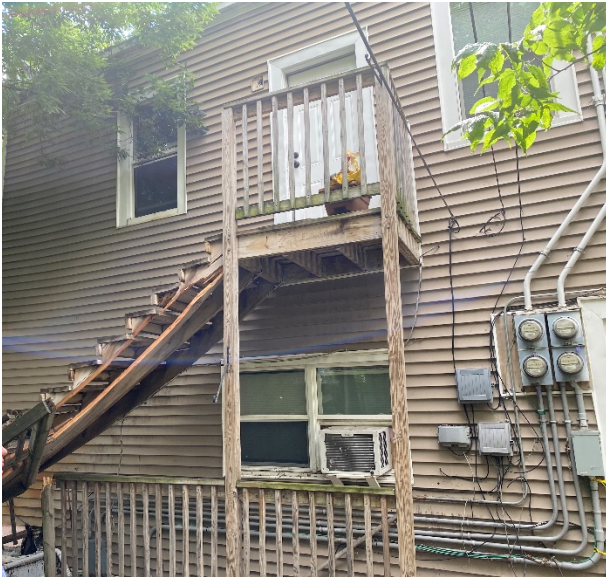
The stairs and landing were also affected by the vehicle impact. Damage to the stairs and landing was significant and they will need to be replaced.

Stairs were significantly damaged.

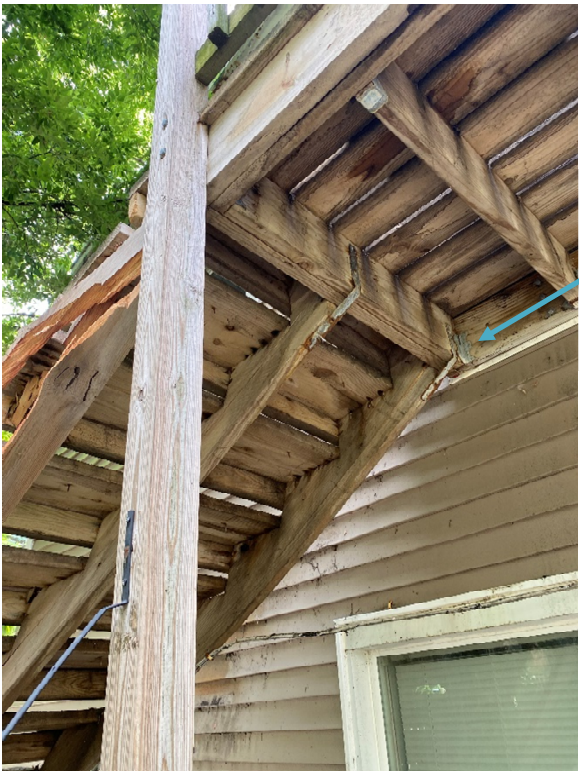
Landing pulled away from the second floor and should be re-placed
