1657 MINNEHAHA ST. PAUL

Structural Observations and Report

1657 Minnehaha Ave,
St. Paul, MN

August 15, 2022

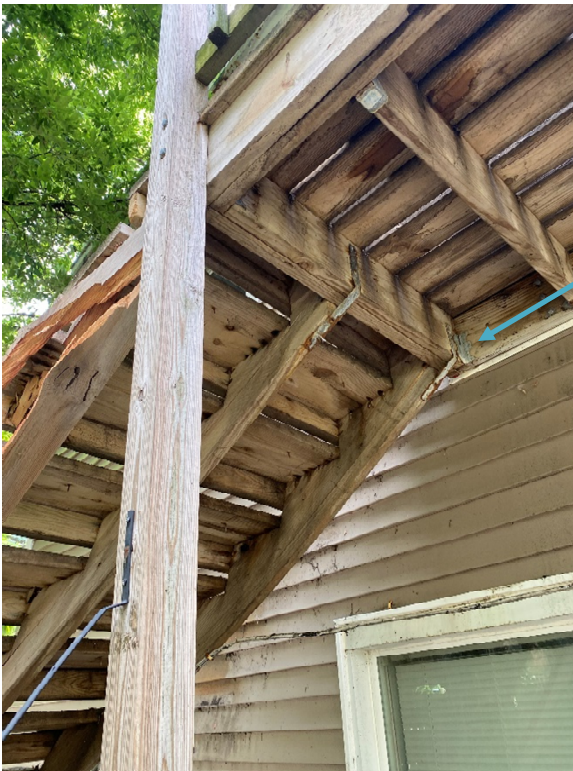
Landing pulled away from the second floor and should be re-placed
