APPLICATION FOR APPEAL

Saint Paul City Council – Legislative Hearings

CORRECTION NOTICE - COMPLAINT INSPECTION

Ref. # 86914

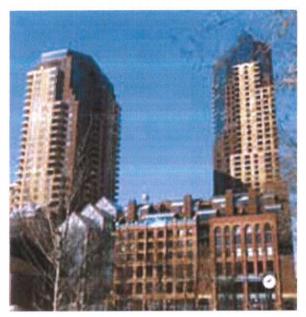
Galtier Plaza complex: The OTP condominiums are on the corner of Sibley and Sixth streets.

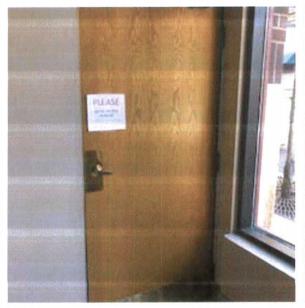
OTP condominiums are on the top floors of the building. The bottom three floors of the building and the underground garage is owned and managed by Bigos management.

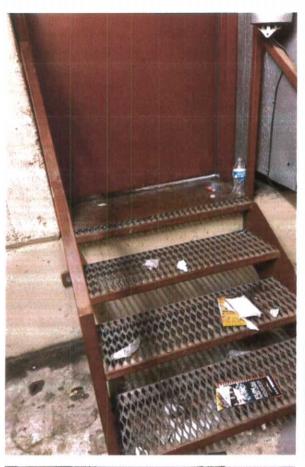
Door from the lobby to the north stairwell

1. Stair A - Level 1 - MSFC 1010.1.9 - Remove unapproved locks from the exit doors. The door must be openable from the inside without the use of keys or special knowledge or effort.-The door at level 1 in Stair A is locked from the inside preventing egress from this stairwell.

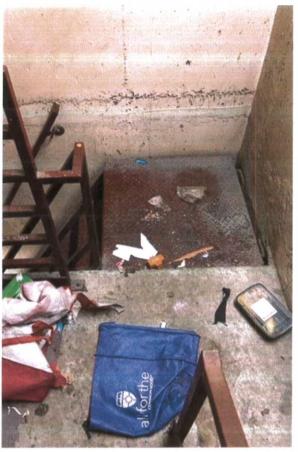
Interior of the north stairwell at ground floor level.

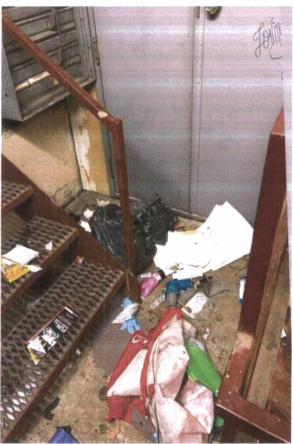
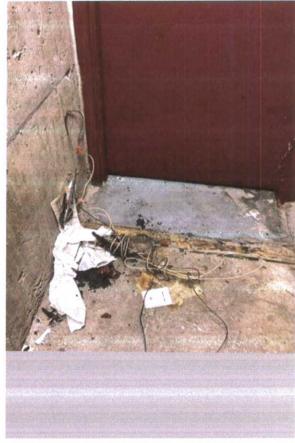
Photos, second page:

Even with these measures, residents and security guards continue to find evidence of intrusions into the north stairwell on a regular basis. For example, on April 10, 2023, a large amount of trash and debris was found on the 8th floor, indicating that intruders may have been living there for some time. If the door to the lobby had been unlocked, these intruders would have had free access into the

Trash and debris left by intruders on upper floors of north stairwell, discovered by residents April 10, 2023.
