The Americold facility located at 240 Chester Street, St. Paul, Minnesota was inspected for asbestos containing materials. The materials found to contain asbestos are listed below:

CENTER OFFICE ABOVE DOCK
ASBESTOS INSPECTION FOR
AMERICOLD
240 CHESTER STREET
ST. PAUL, MINNESOTA 55107

RES Project #: 12237
Date: 09/11/2012
SHEET
A2
OF 2 SHEETS

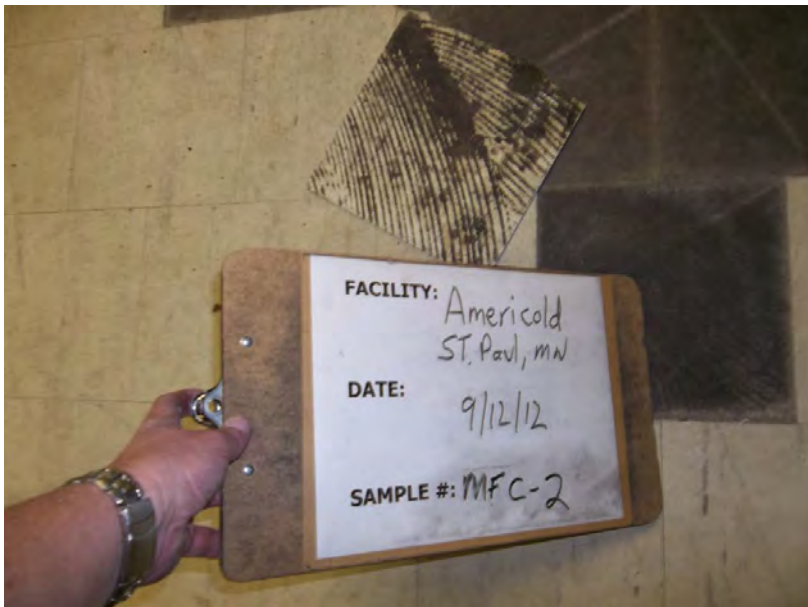
MFC-2

MFC – 9" X 9" floor tile and mastic, white with gray streaks, located in the Summit Foods/Madison Foods first floor offices contains 2-5% chrysotile asbestos as analyzed by Polarized Light Microscopy. This miscellaneous material was non-friable and in poor condition at the time of sampling. The inspector observed loose and missing tiles and areas of exposed floor tile mastic.

9" X 9" FLOOR TILE AND MASTIC, WHITE WITH GRAY STREAKS

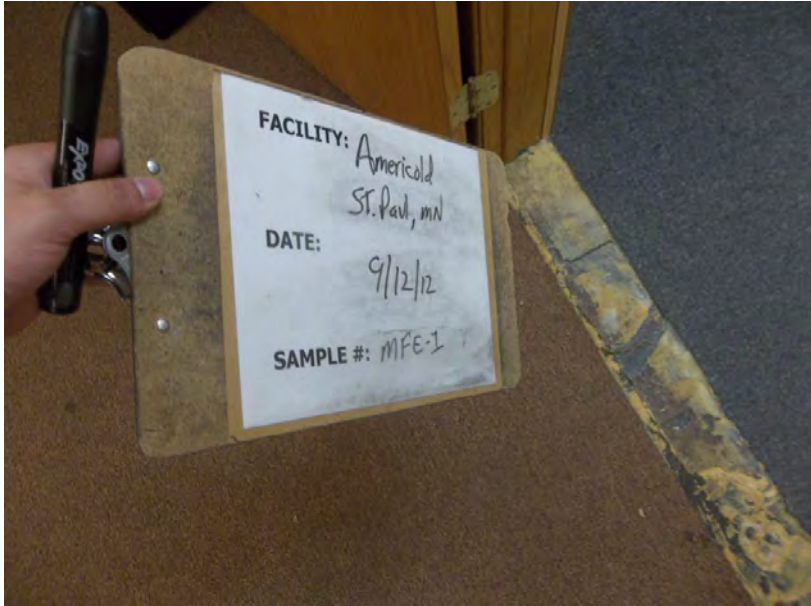
MFE-1

MFE – 9" X 9" floor tile and mastic, tan (beneath carpet), located in the second floor center offices contains 3-5% chrysotile asbestos as analyzed by Polarized Light Microscopy. This miscellaneous material was non-friable and in good condition at the time of sampling.

9" X 9" FLOOR TILE AND MASTIC, TAN (BENEATH CARPET)

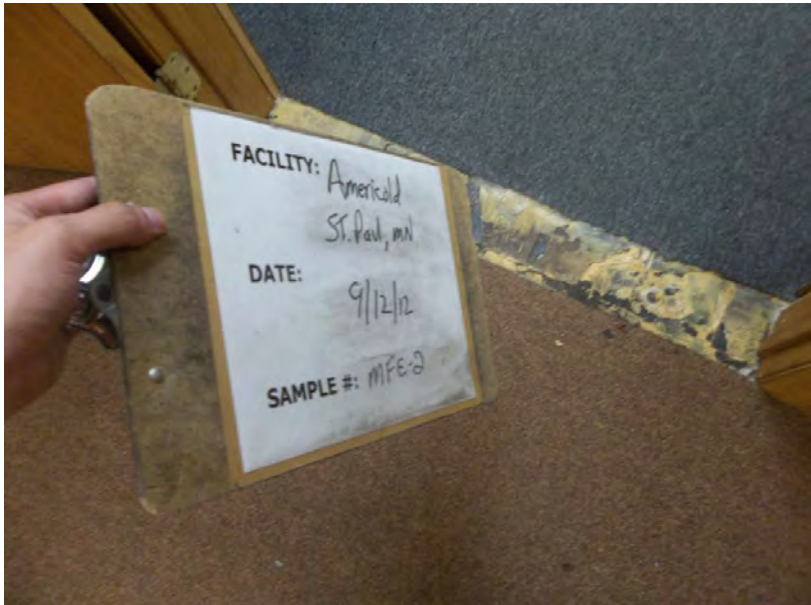
MFE-2

9" X 9" FLOOR TILE AND MASTIC, TAN (BENEATH CARPET)

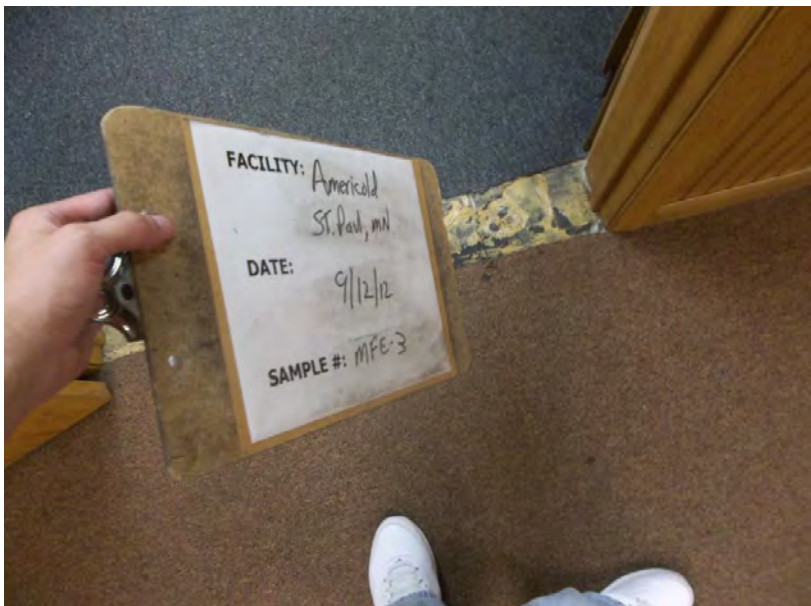
MFE-3

9" X 9" FLOOR TILE AND MASTIC, TAN (BENEATH CARPET)

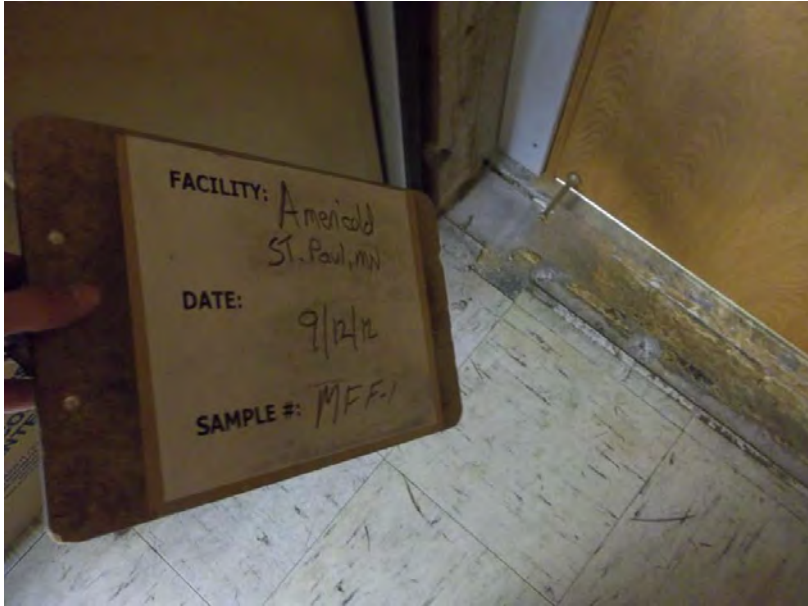
MFF-1

MFF – 12" X 12" floor tile and mastic, white with gray streaks, located in the north Schwans storeroom of the second floor center offices contains 2-3% chrysotile asbestos as analyzed by Polarized Light Microscopy. This miscellaneous material was non-friable and in good condition at the time of sampling.

12" X 12" FLOOR TILE AND MASTIC,
WHITE WITH GRAY STREAKS

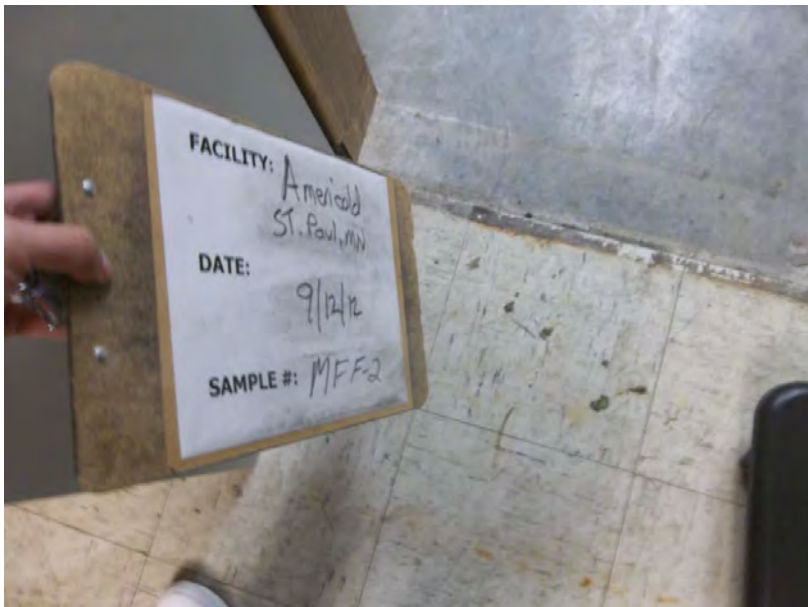
MFF-2

12" X 12" FLOOR TILE AND MASTIC,
WHITE WITH GRAY STREAKS

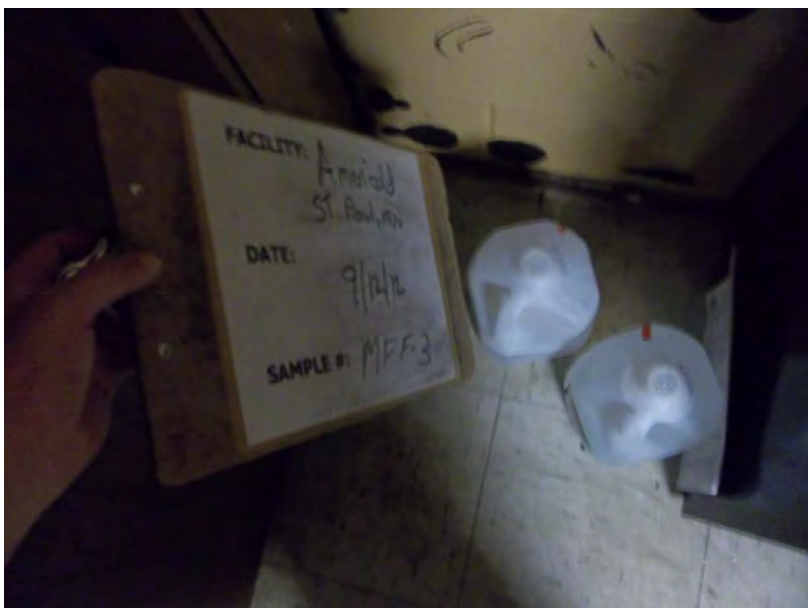
MFF-3

12" X 12" FLOOR TILE AND MASTIC,
WHITE WITH GRAY STREAKS

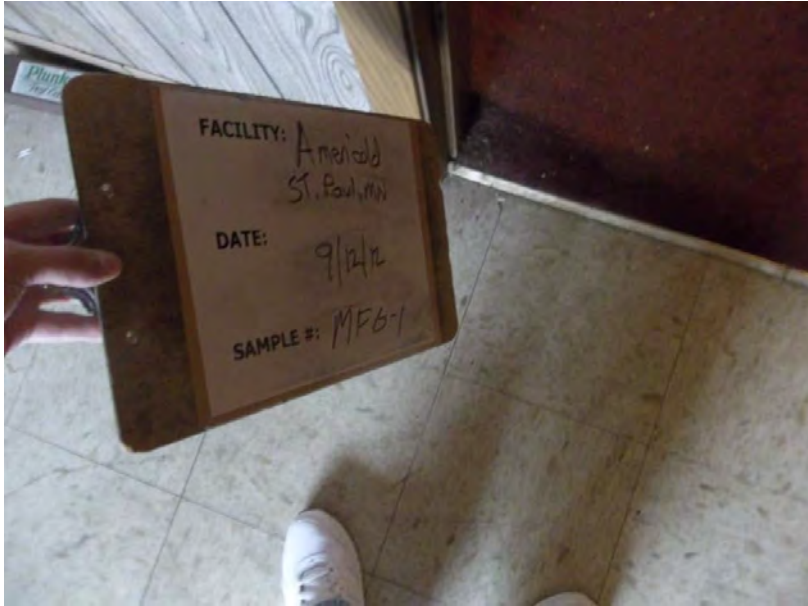
MFG-1

MFG – 12" X 12" floor tile and mastic, white with tan specks, located at the north end of the second floor center offices and in the south offices area contains 3% chrysotile asbestos as analyzed by Polarized Light Microscopy. This miscellaneous material was non-friable and in good condition at the time of sampling.

12" X 12" FLOOR TILE AND MASTIC,
WHITE WITH TAN SPECKS

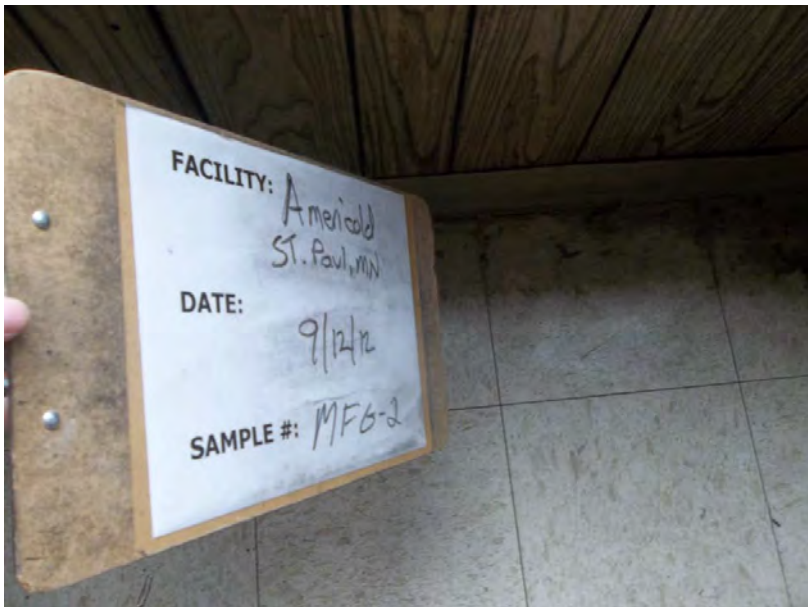
MFG-2

12" X 12" FLOOR TILE AND MASTIC,
WHITE WITH TAN SPECKS

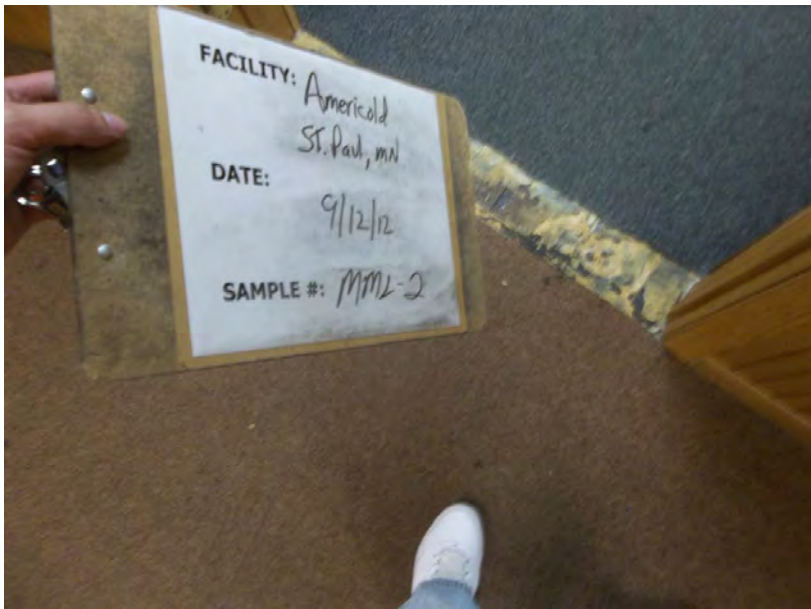
MML-2

MML – Carpet mastic, located in the second floor center offices and south offices contains 3% chrysotile asbestos as analyzed by Polarized Light Microscopy. This miscellaneous material was non-friable and in good condition at the time of sampling.

CARPET MASTIC

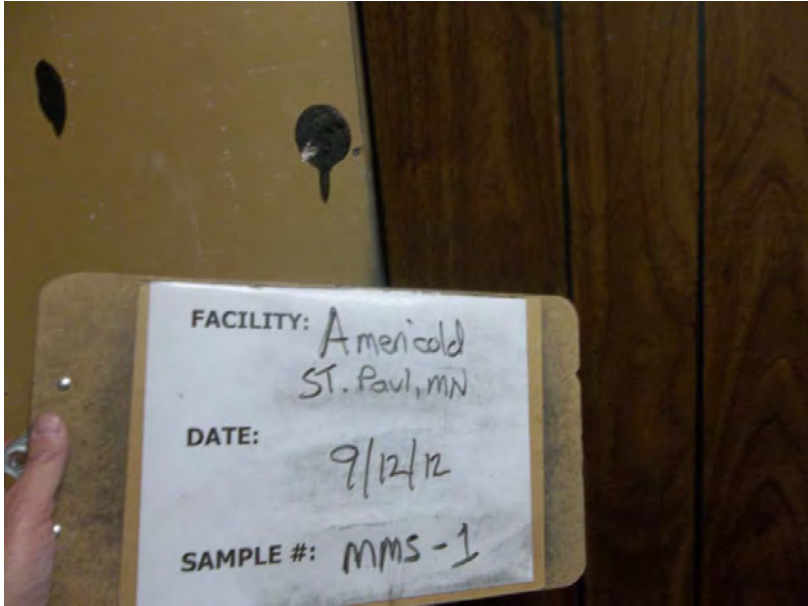
MMS-1

MMS – Glue pucks, black, located on paneled walls in the second floor center offices north hallway contains 5% chrysotile asbestos as analyzed by Polarized Light Microscopy. This miscellaneous material was non-friable and in fair condition at the time of sampling.

GLUE PUCKS, BLACK (ON PANELED WALLS)

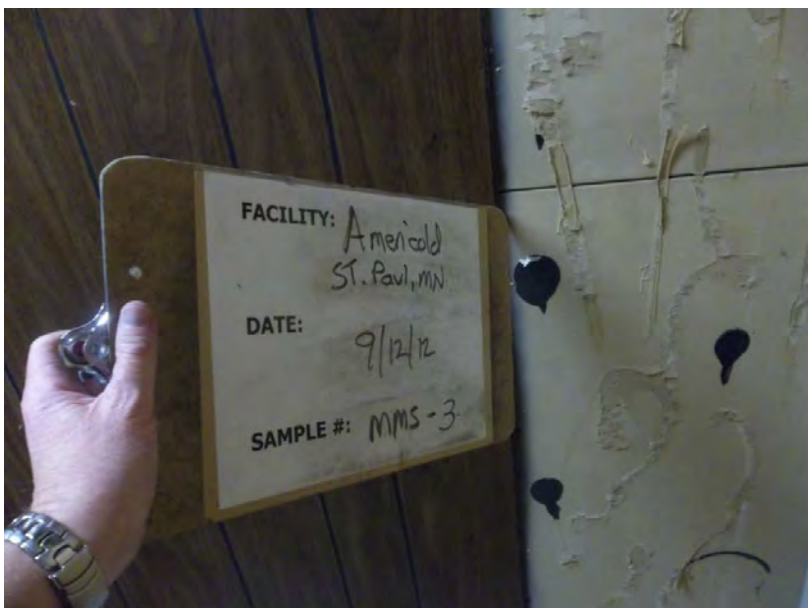
MMS-3

GLUE PUCKS, BLACK (ON PANELED WALLS)

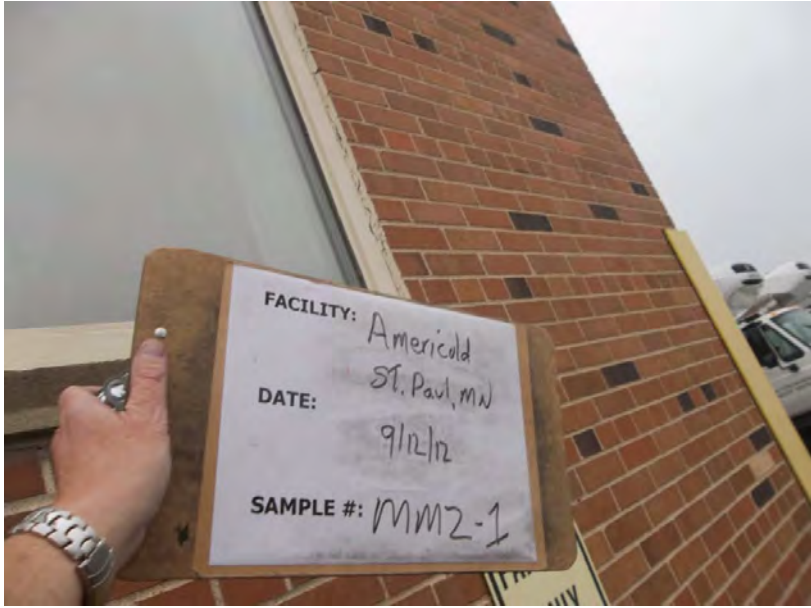
MMZ-1

MMZ – Exterior caulk, tan, located around windows and doors of the center offices contains 3% chrysotile asbestos as analyzed by Polarized Light Microscopy. This miscellaneous material was non-friable and in good condition at the time of sampling.

EXTERIOR CAULK, TAN (ON WINDOWS)

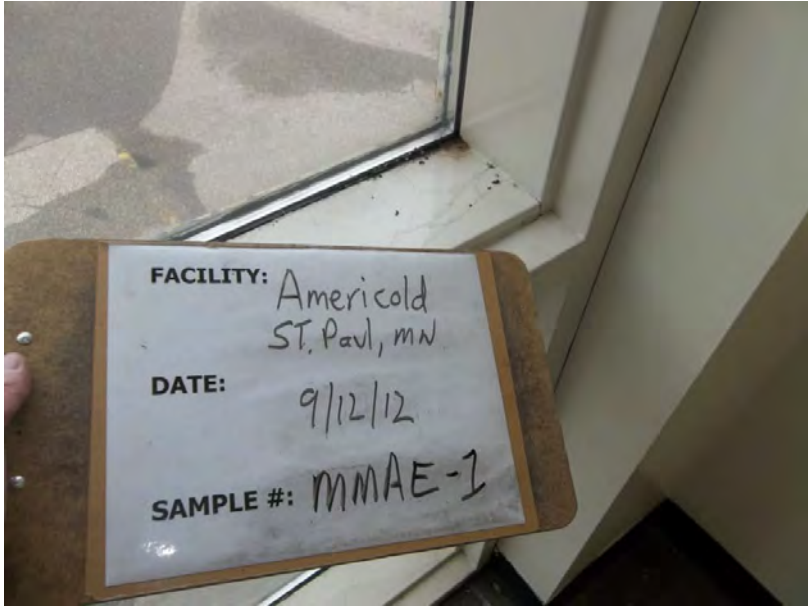
MMAE – Window glazing, black, located around windows in the second floor of the former Baldinger's Bakery offices contains 5% chrysotile asbestos as analyzed by Polarized Light Microscopy. This miscellaneous material was non-friable and in good condition at the time of sampling.

MMAE-1
WINDOW GLAZING, BLACK

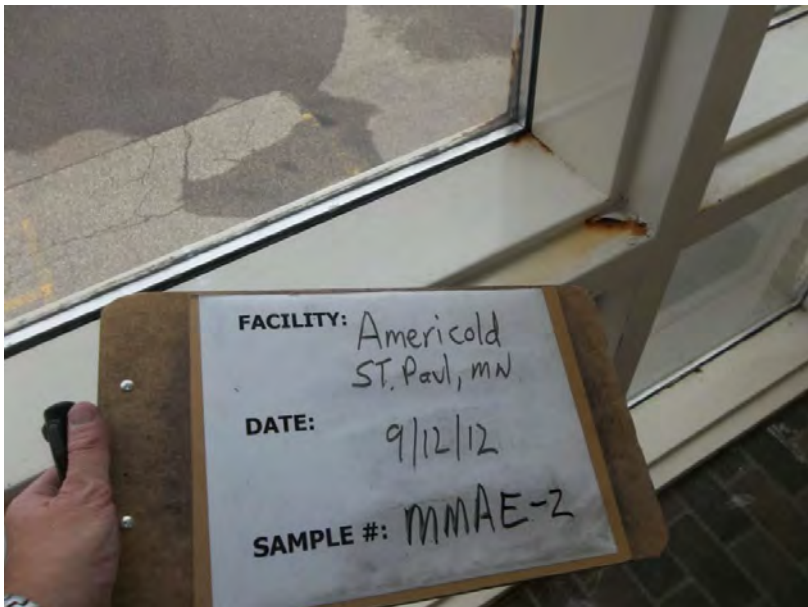
MMAE-2
WINDOW GLAZING, BLACK

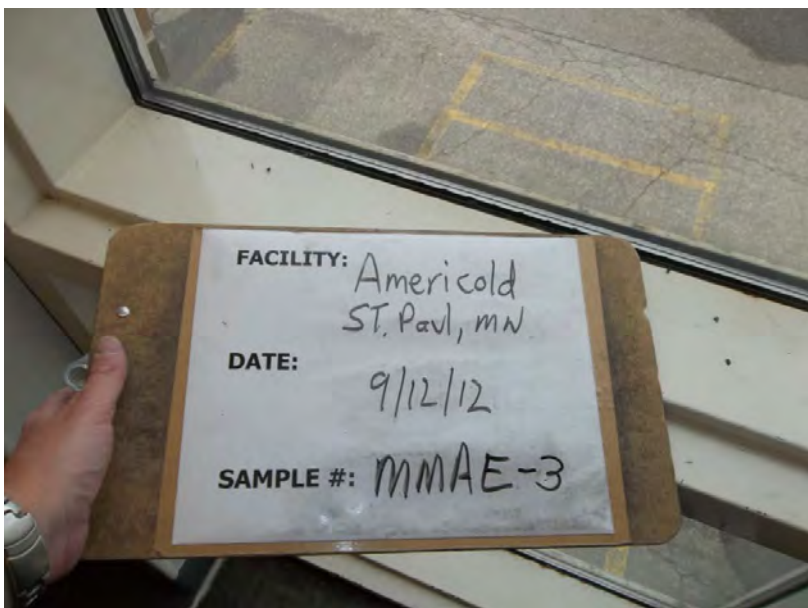
MMAE-3
WINDOW GLAZING, BLACK

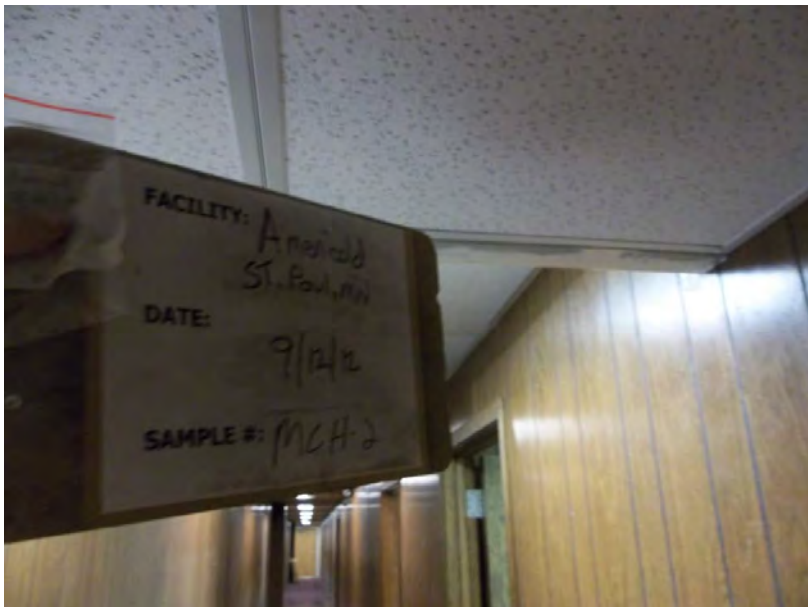
MCH-2

2' X 4' CEILING TILE, VARIOUS
PINHOLES

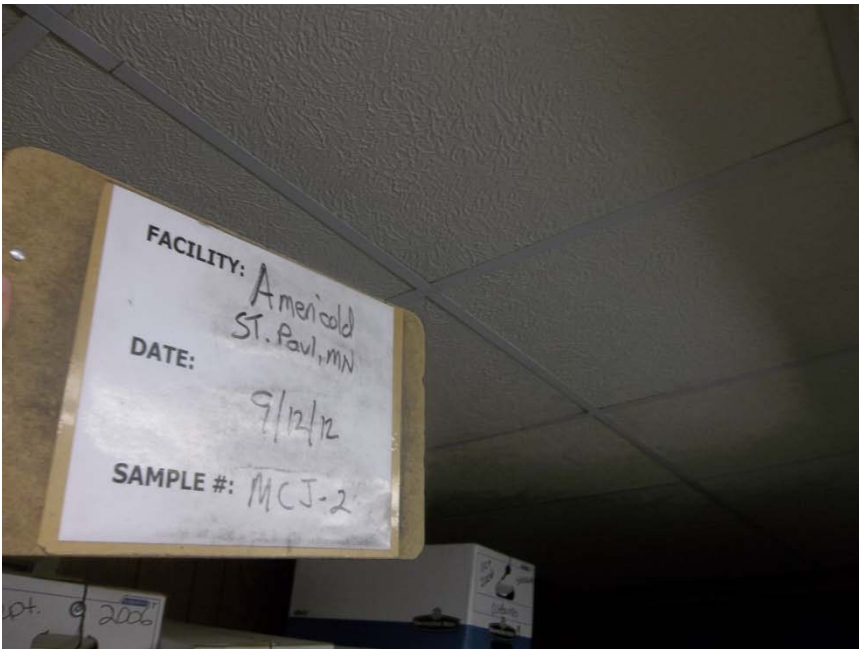
MCJ-2

2' X 4' CEILING TILE, LARGE TEXTURED PATTERN

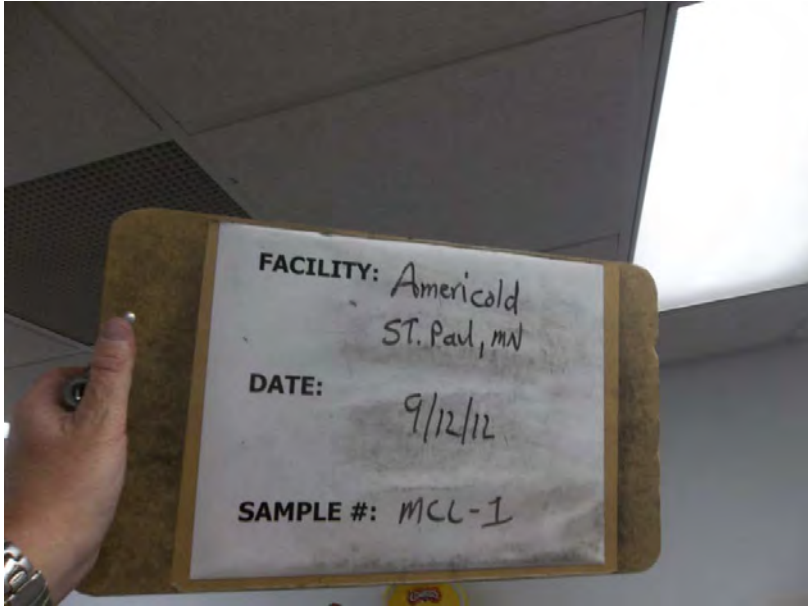
MCL-1

2' X 2' CEILING TILE, TEXTURED
(RECESSED)

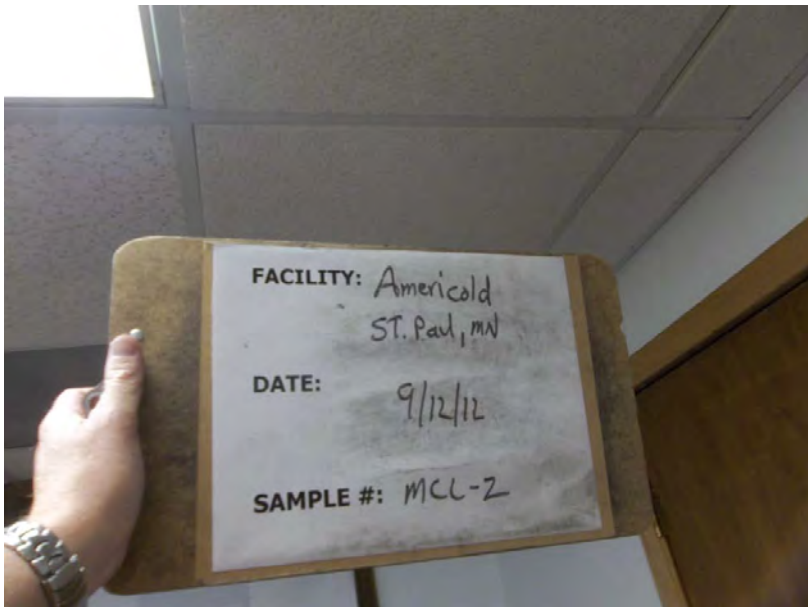
MCL-2

2' X 2' CEILING TILE, TEXTURED
(RECESSED)

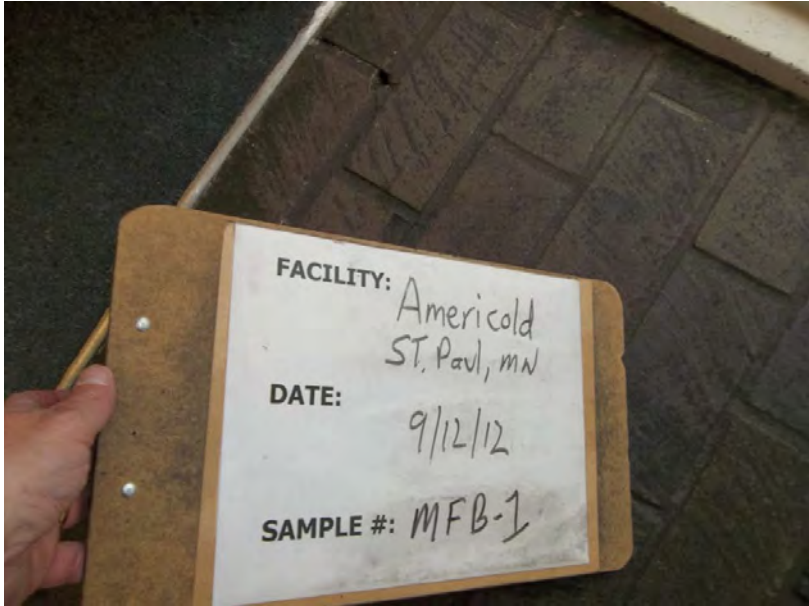
MFB-1

CERAMIC FLOOR TILE, BROWN BRICK
PATTERN (MORTAR BED)

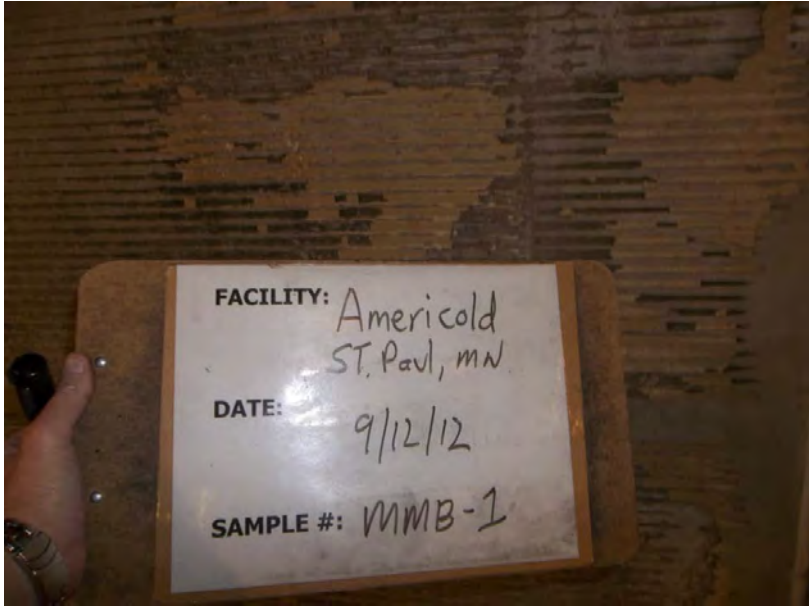
MMB-1

WALL ADHESIVE, TAN

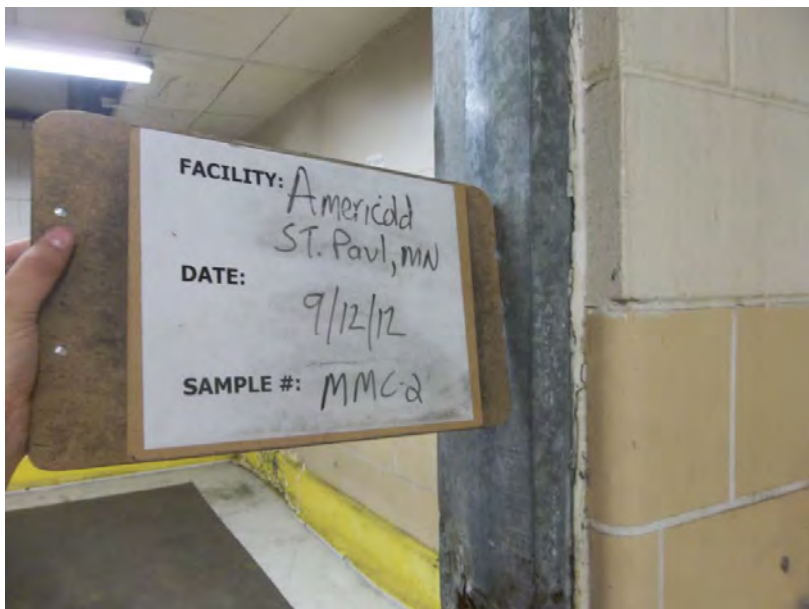
MMC-2

INTERIOR CAULK, WHITE (ON DOORS)

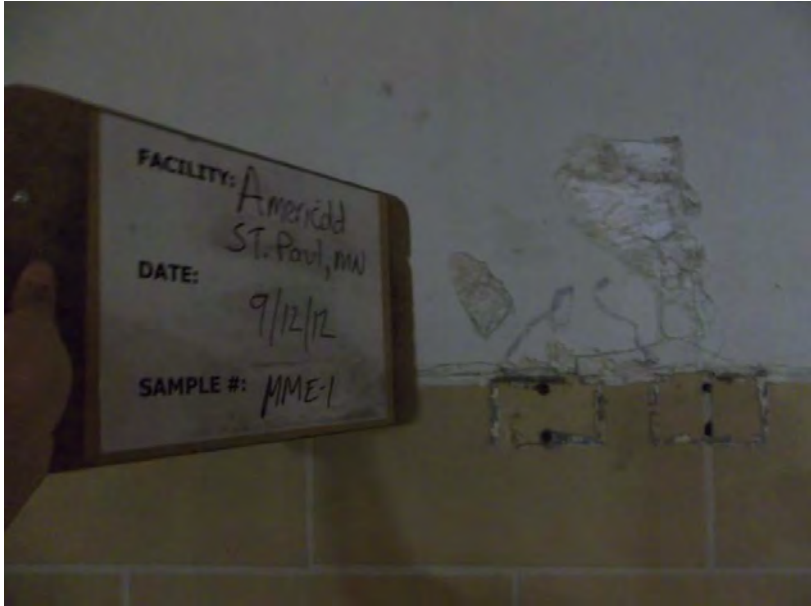
MME-1

WALLBOARD (OVER FOAM INSULATION)

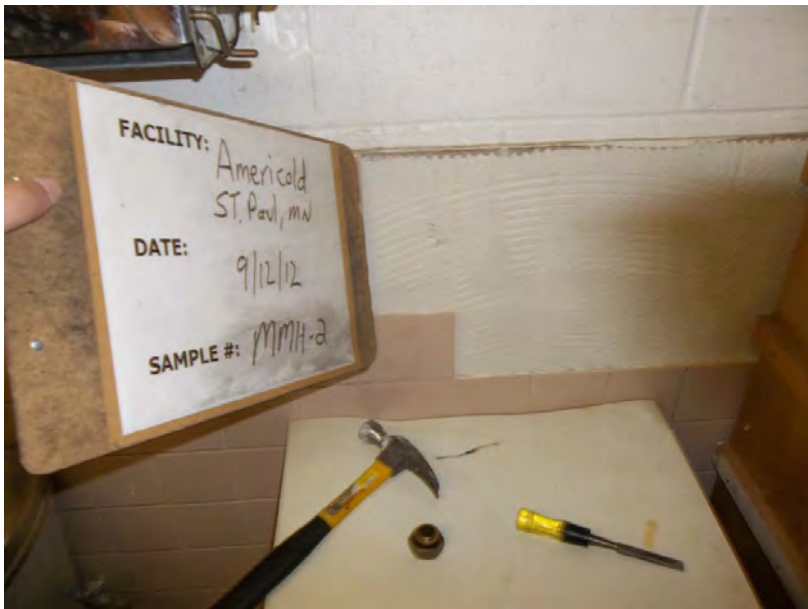
MMH-2

4" X 4" CERAMIC WALL TILE, PINK
(ADHESIVE)

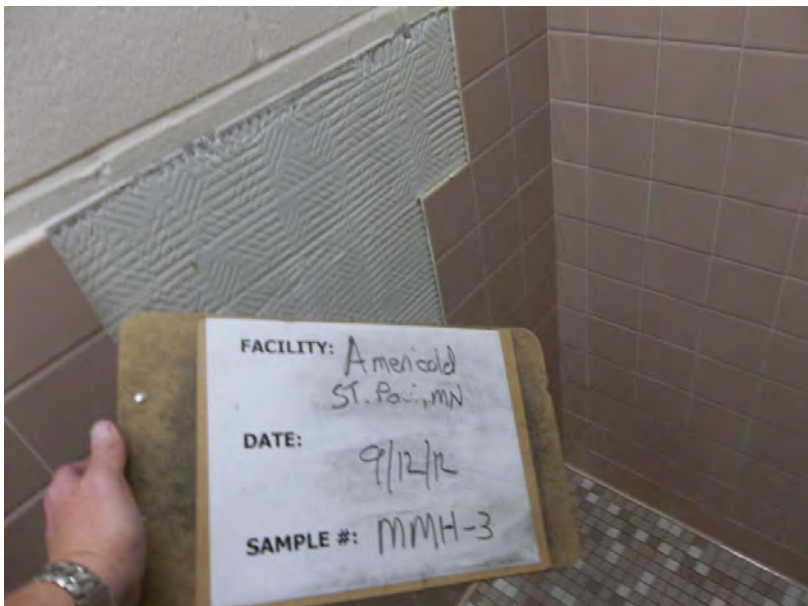
MMH-3

4" X 4" CERAMIC WALL TILE, PINK
(ADHESIVE)

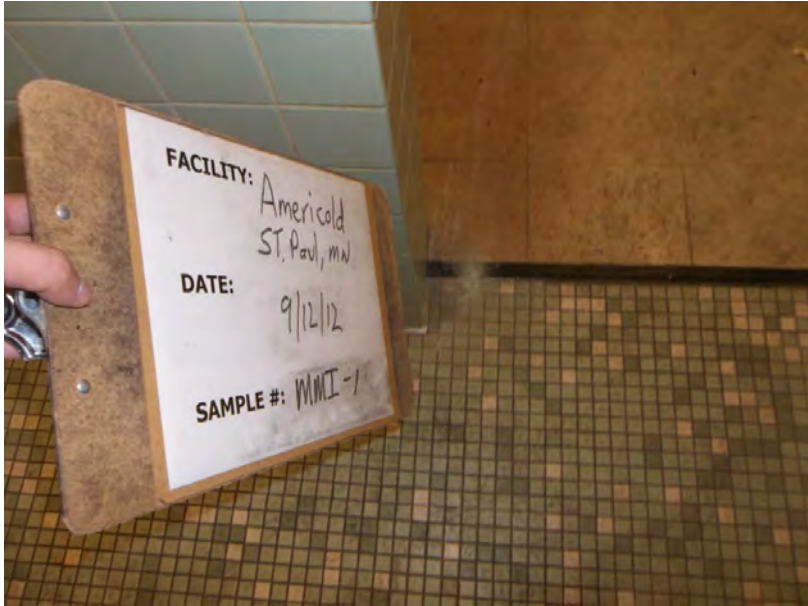
MMI-1

1" X 1" CERAMIC FLOOR TILE, GREEN
(MORTAR BED)

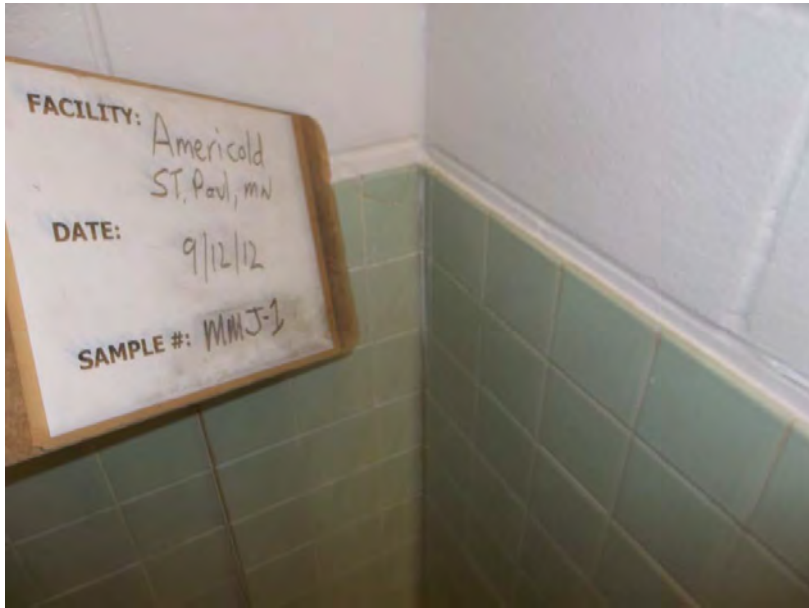
MMJ-1

4" X 4" CERAMIC WALL TILE, GREEN
(ADHESIVE)

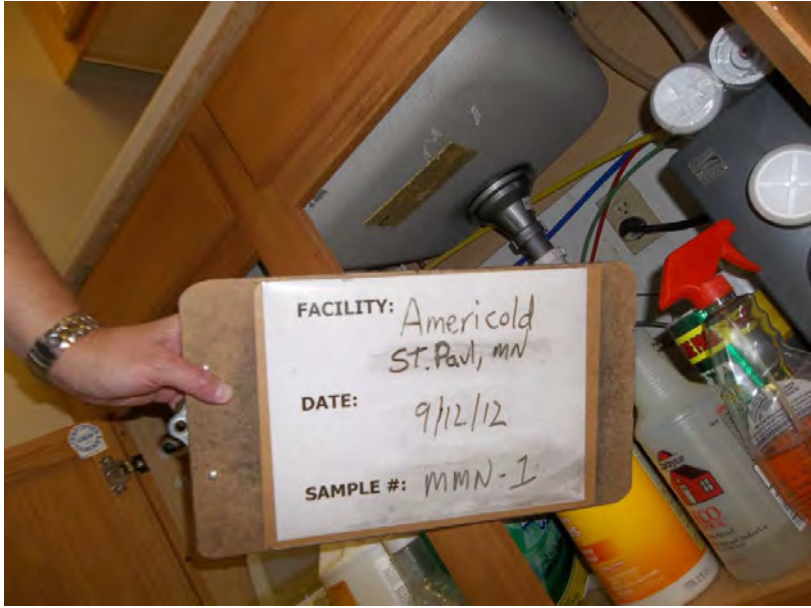
MMN-1
SINK COATING, WHITE

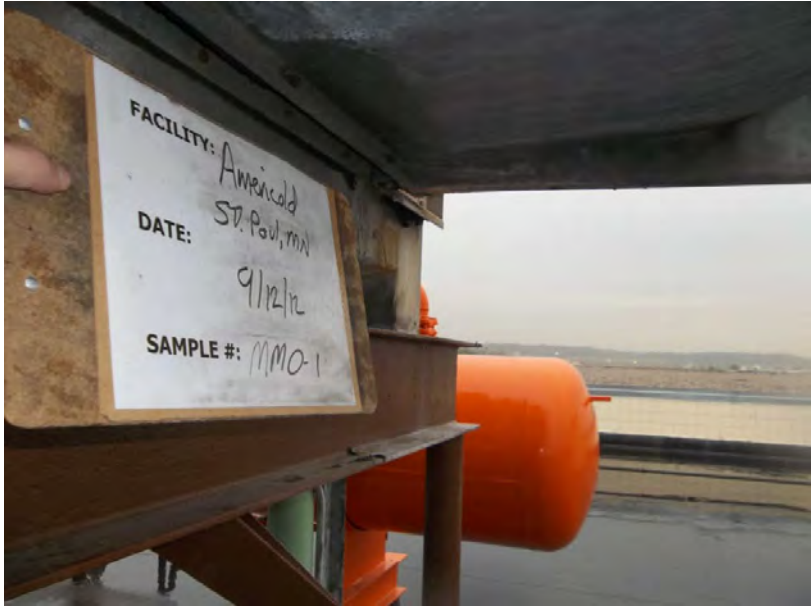
MMO-1

EXTERIOR CAULK, BLACK (ON NORTH ROOFTOP CONDENSERS)

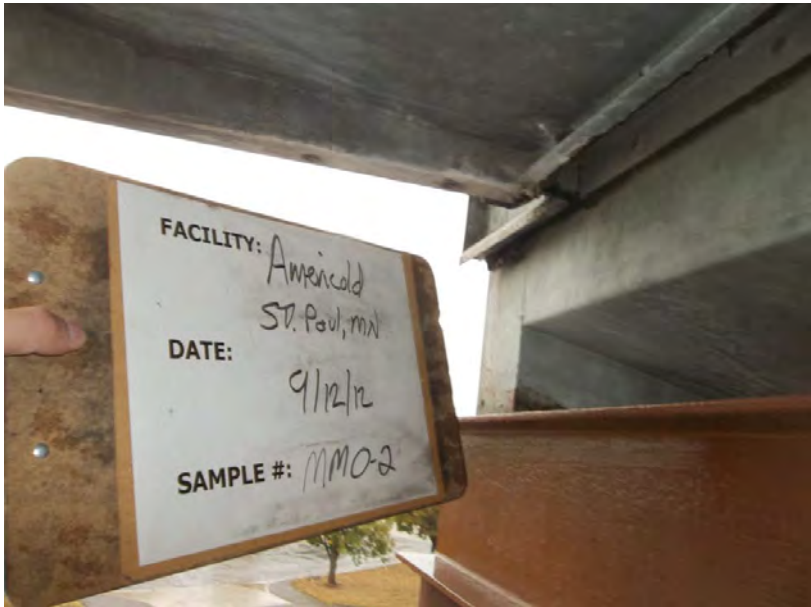
MMO-2

EXTERIOR CAULK, BLACK (ON NORTH ROOFTOP CONDENSERS)

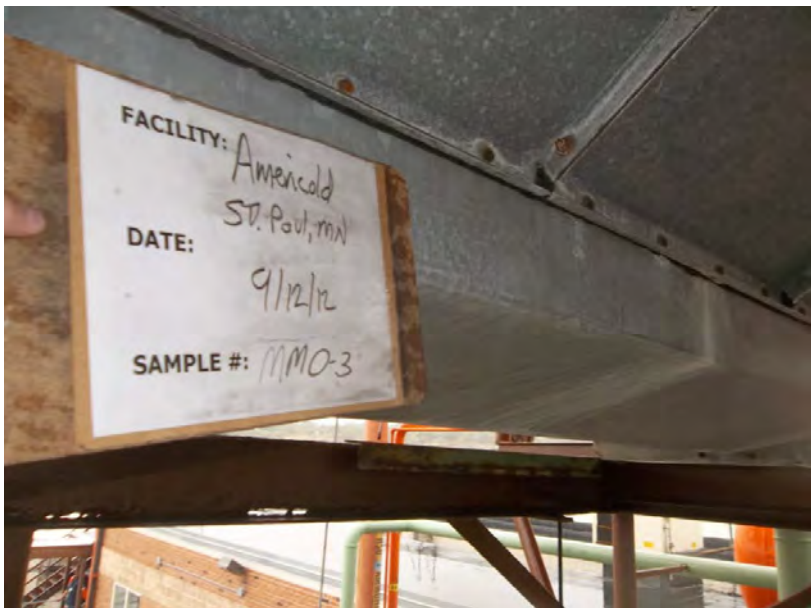
MMO-3

EXTERIOR CAULK, BLACK (ON NORTH ROOFTOP CONDENSERS)

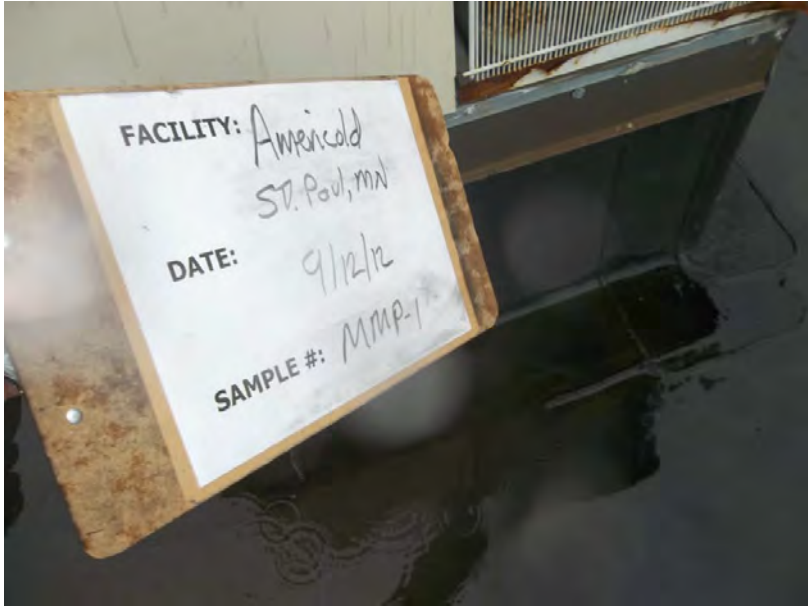
MMP-1

EXTERIOR CAULK, BLACK (ON ROOFTOP FAN UNITS)

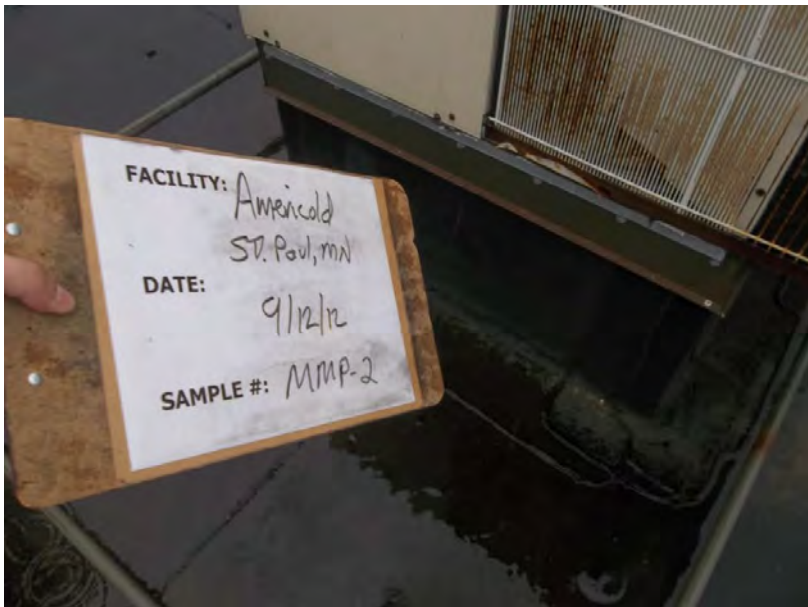
MMP-2

EXTERIOR CAULK, BLACK (ON ROOFTOP FAN UNITS)

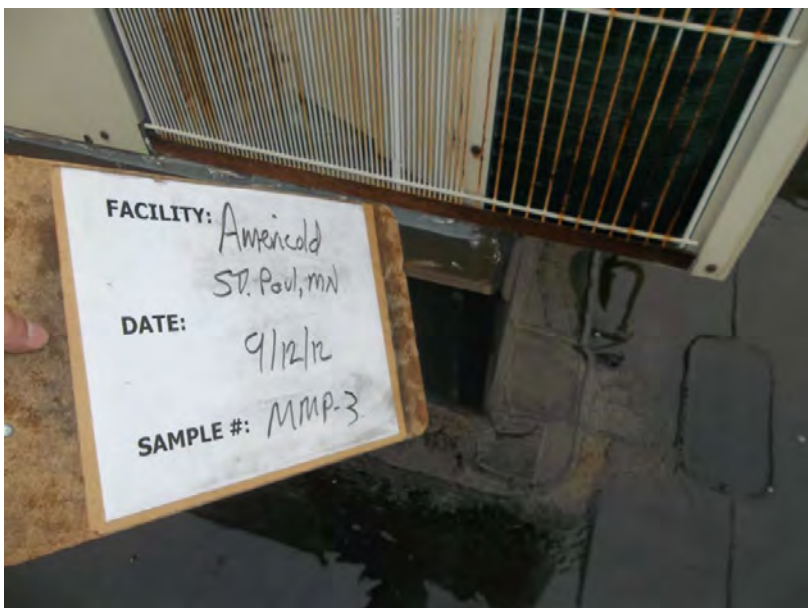
MMP-3

EXTERIOR CAULK, BLACK (ON ROOFTOP FAN UNITS)

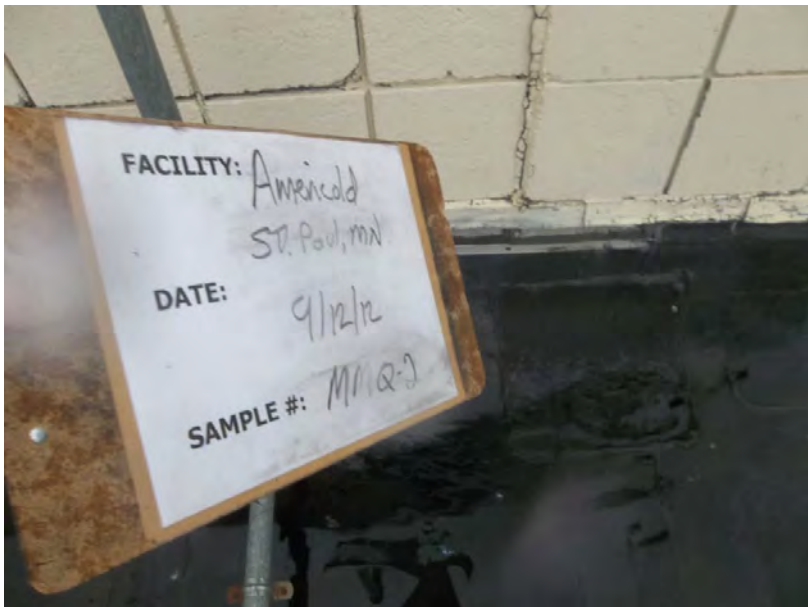
MMQ-2

EXTERIOR CAULK, WHITE (ON METAL WALLS)

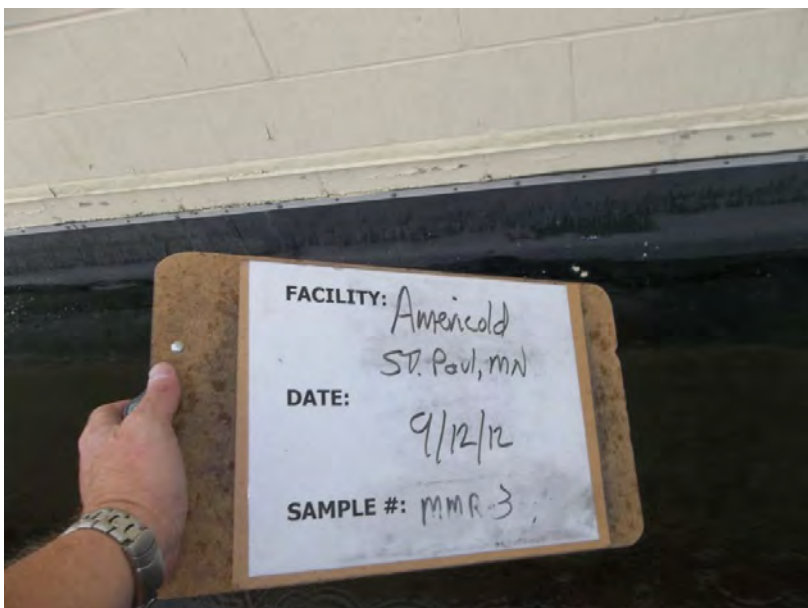
MMR-3

EXTERIOR CAULK, TAN (ON BLOCK WALLS)

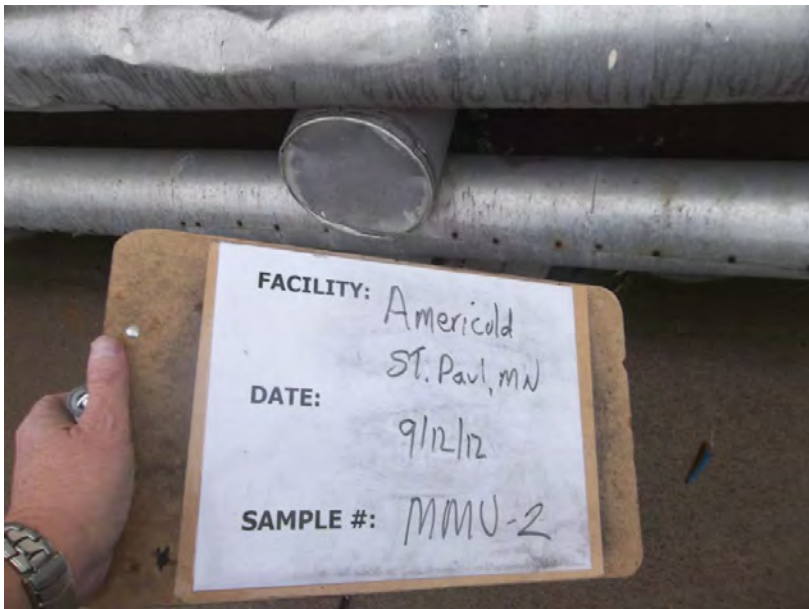
MMU-2

EXTERIOR CAULK, GRAY (ON GLYCOL LINES)

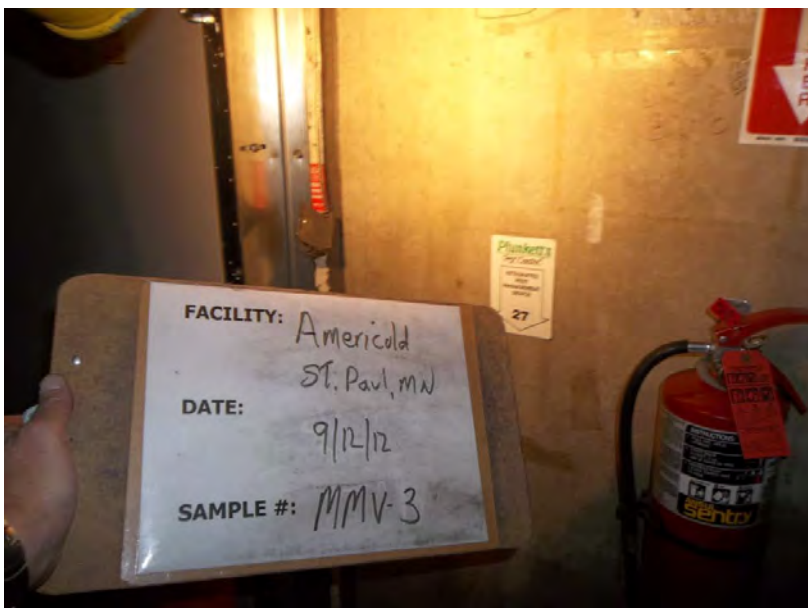
MMV-3
INTERIOR CAULK, GRAY (ON DOORS)

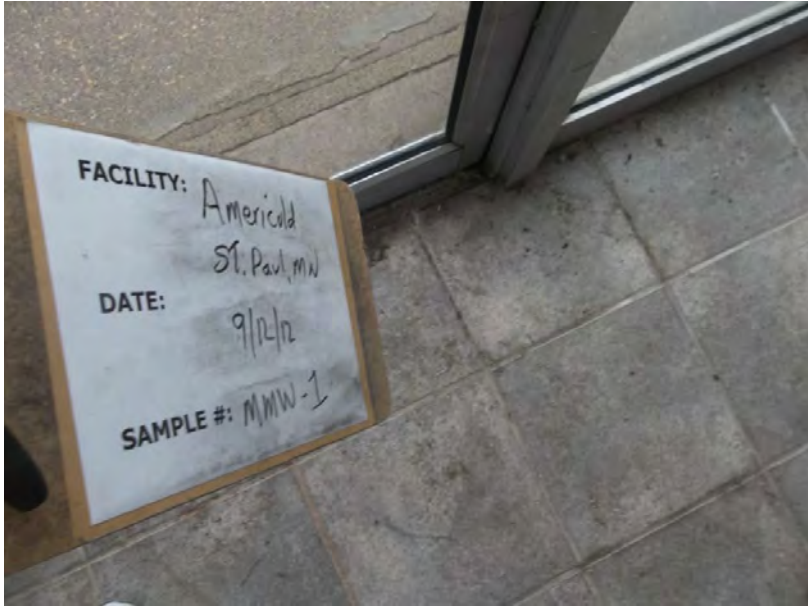
MMW-1

12" X 12" CERAMIC FLOOR TILE, GRAY
(MORTAR BED)

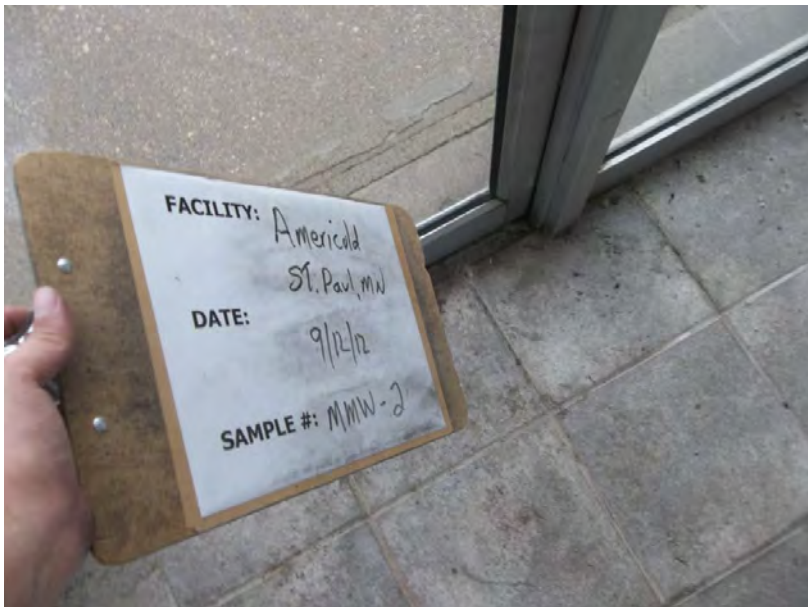
MMW-2

12" X 12" CERAMIC FLOOR TILE, GRAY
(MORTAR BED)

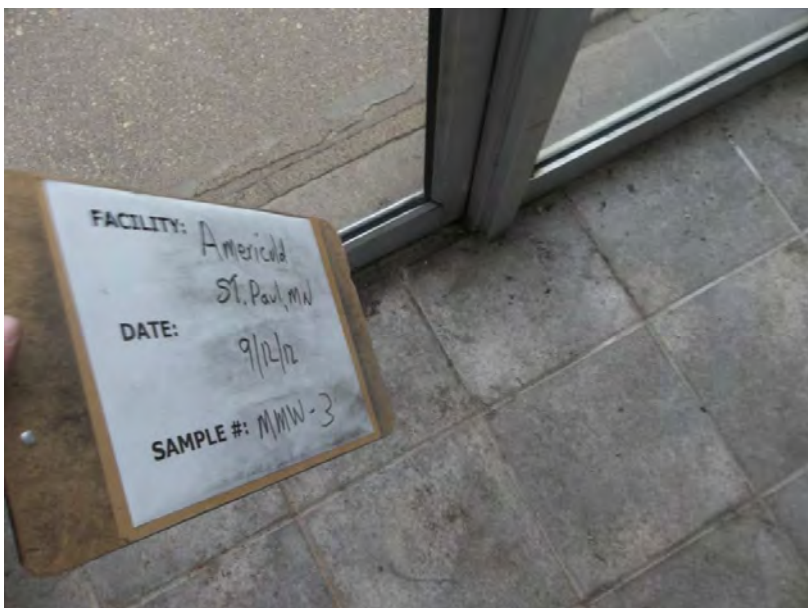
MMW-3

12" X 12" CERAMIC FLOOR TILE, GRAY
(MORTAR BED)

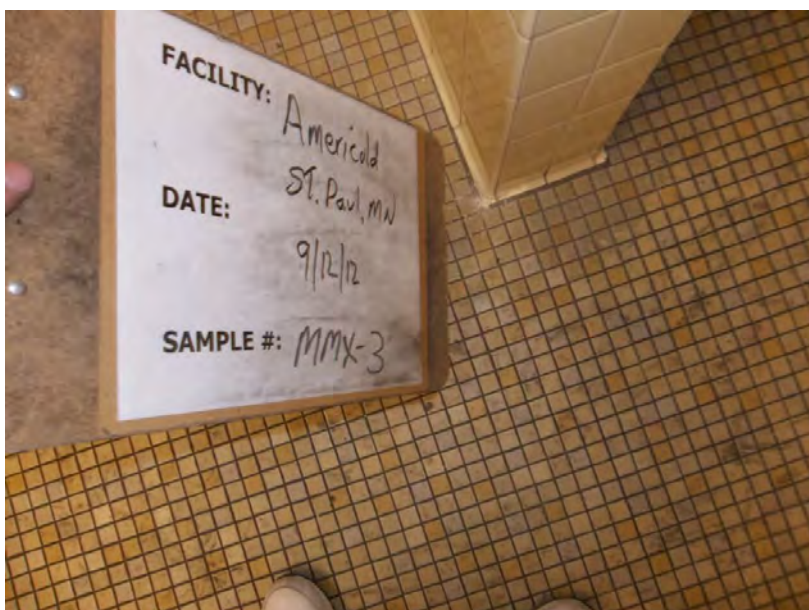
MMX-3

1" X 1" CERAMIC FLOOR TILE, YELLOW
(MORTAR BED)

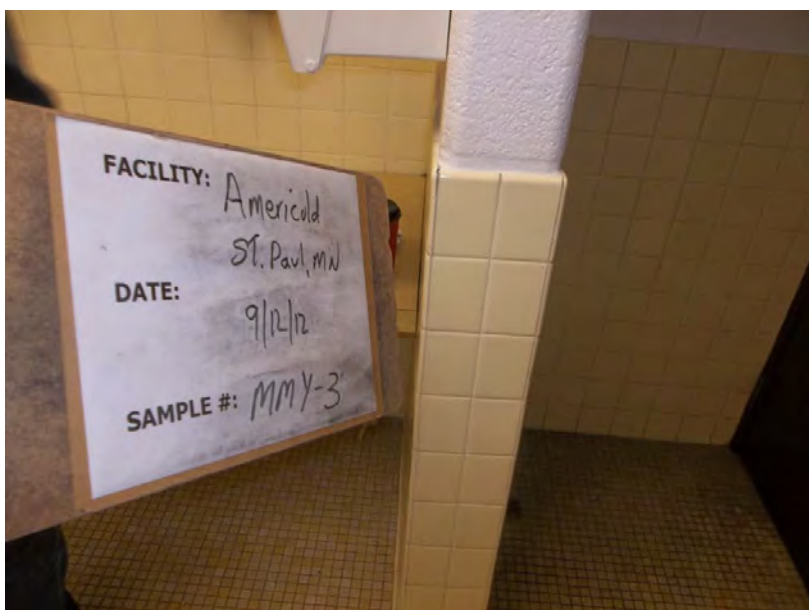
MMY-3

4" X 4" CERAMIC WALL TILE, YELLOW
(ADHESIVE)
