The Americold facility located at 240 Chester Street, St. Paul, Minnesota was inspected for asbestos containing materials. The materials found to contain asbestos are listed below:

CENTER OFFICE ABOVE DOCK
ASBESTOS INSPECTION FOR
AMERICOLD
240 CHESTER STREET
ST. PAUL, MINNESOTA 55107

RES Project #: 12237
Date: 09/11/2012
SHEET
A2
OF 2 SHEETS

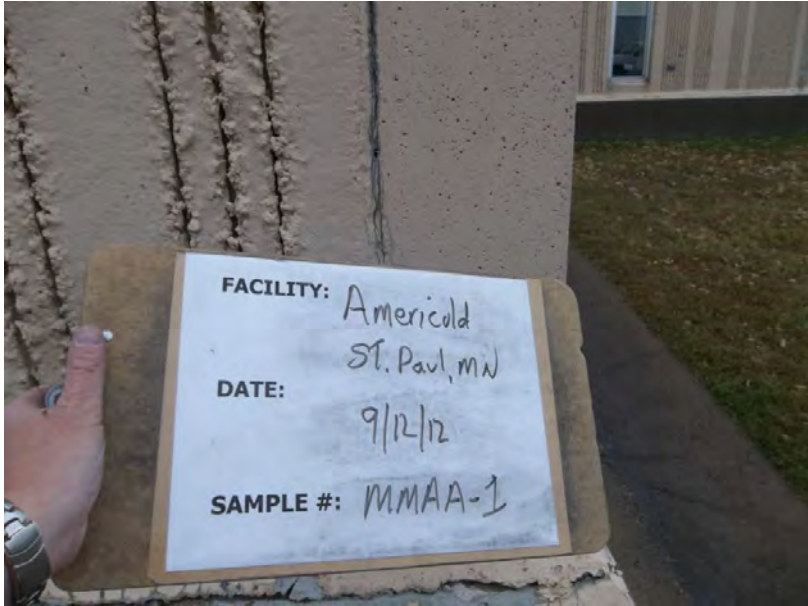
MMAA-1

EXPANSION JOINTS, GRAY (ON
CONCRETE WALL PANELS)

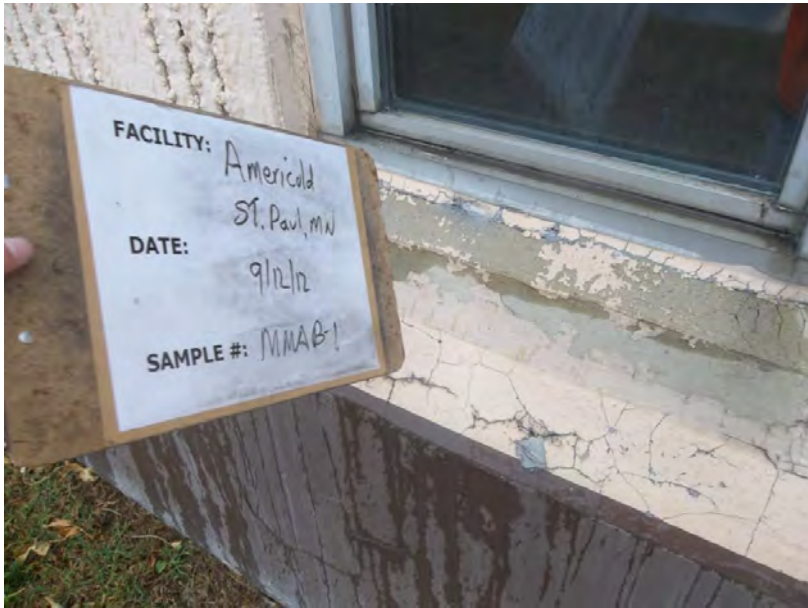
MMAB-1
EXTERIOR CAULK, TAN (ON WINDOWS)

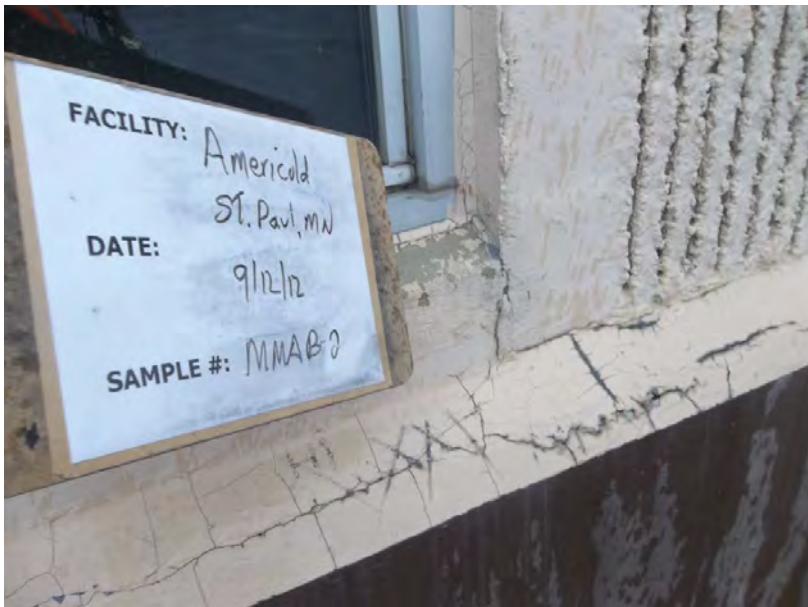
MMAB-2
EXTERIOR CAULK, TAN (ON WINDOWS)

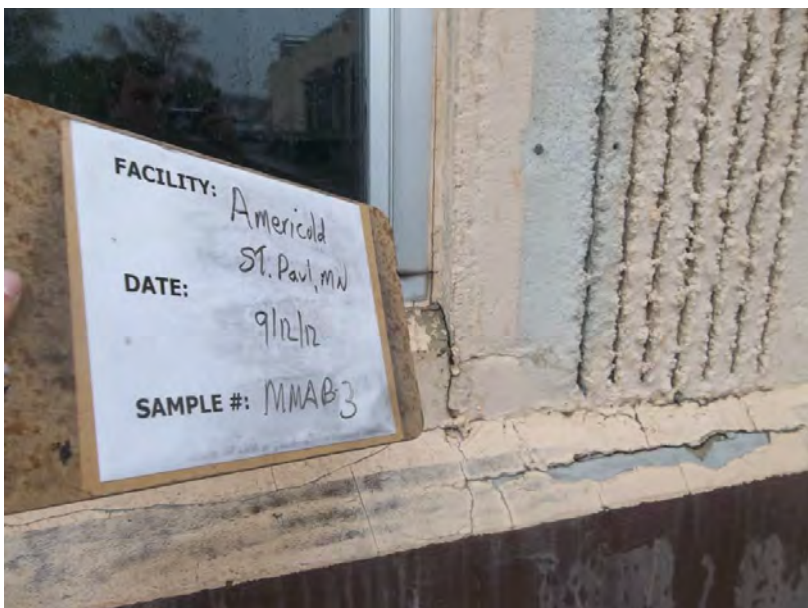
MMAB-3
EXTERIOR CAULK, TAN (ON WINDOWS)

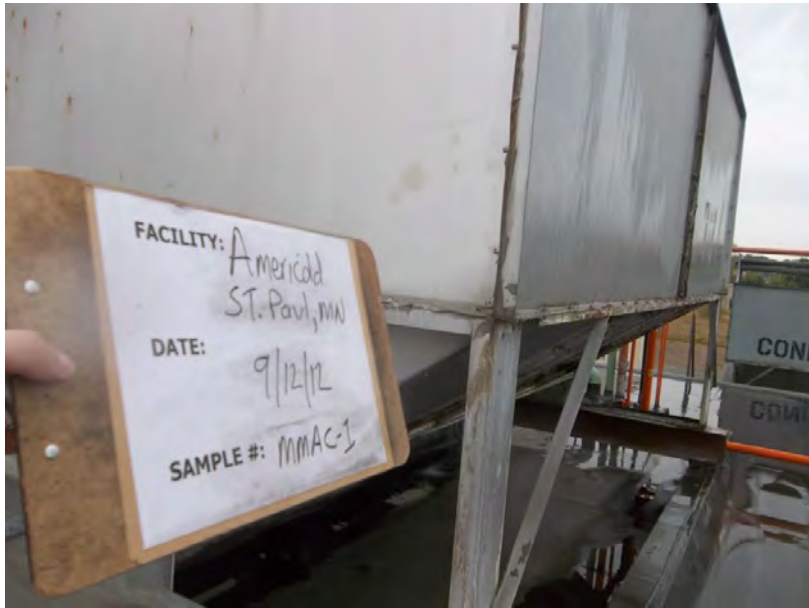
MMAC-1

EXTERIOR CAULK, WHITE (ON SOUTH ROOFTOP CONDENSERS)

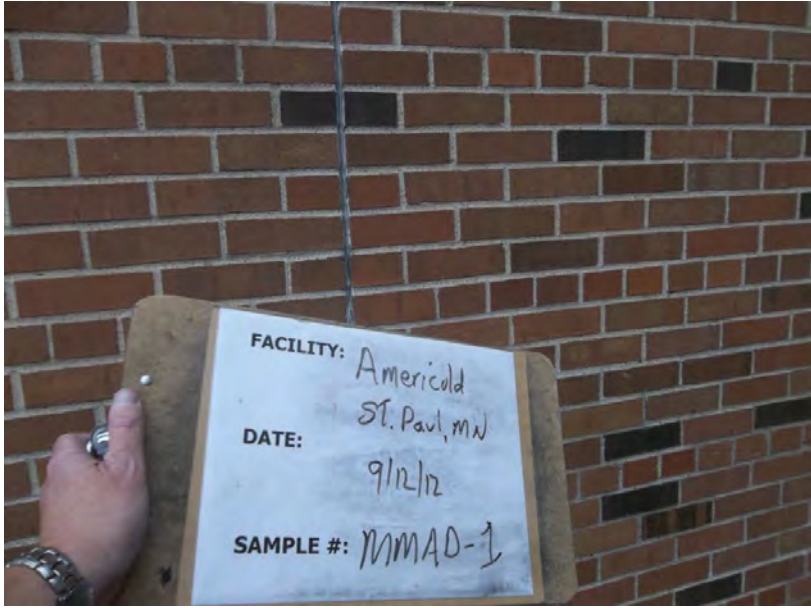
MMAD-1

EXPANSION JOINTS, WHITE (ON BRICK WALLS)

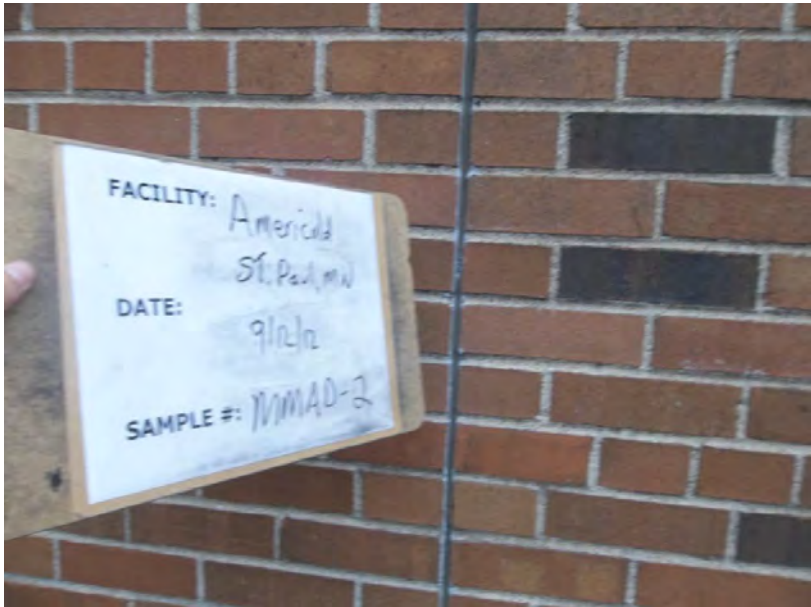
MMAD-2

EXPANSION JOINTS, WHITE (ON BRICK WALLS)

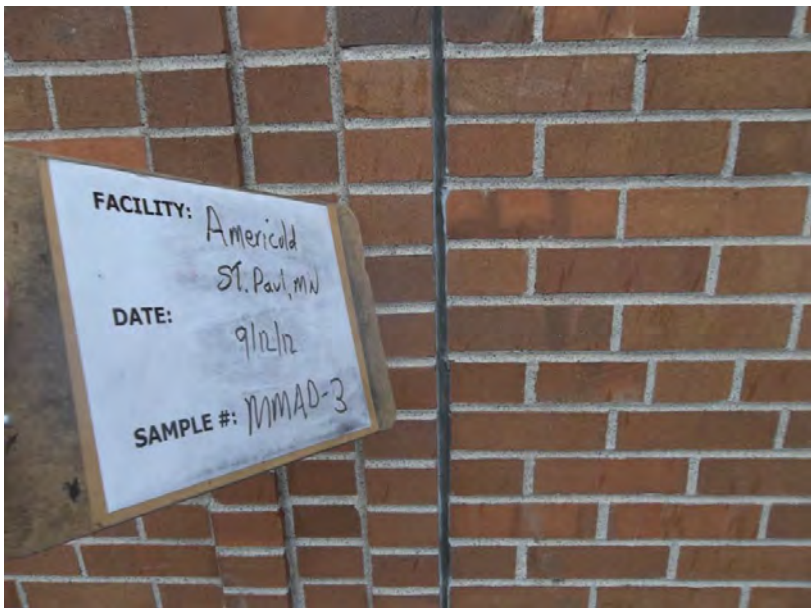
MMAD-3

EXPANSION JOINTS, WHITE (ON BRICK WALLS)

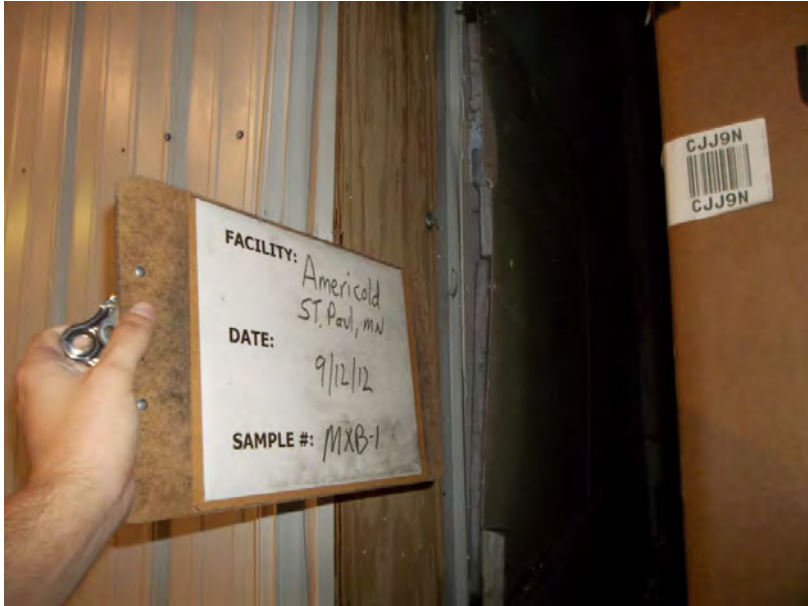
MXB-1

DRYWALL (NO COMPOUND)

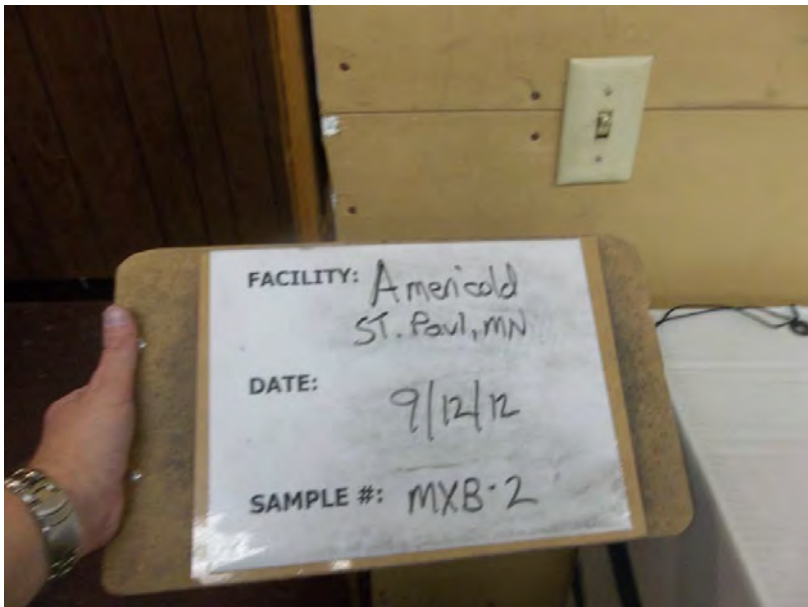
MXB-2

DRYWALL (NO COMPOUND)

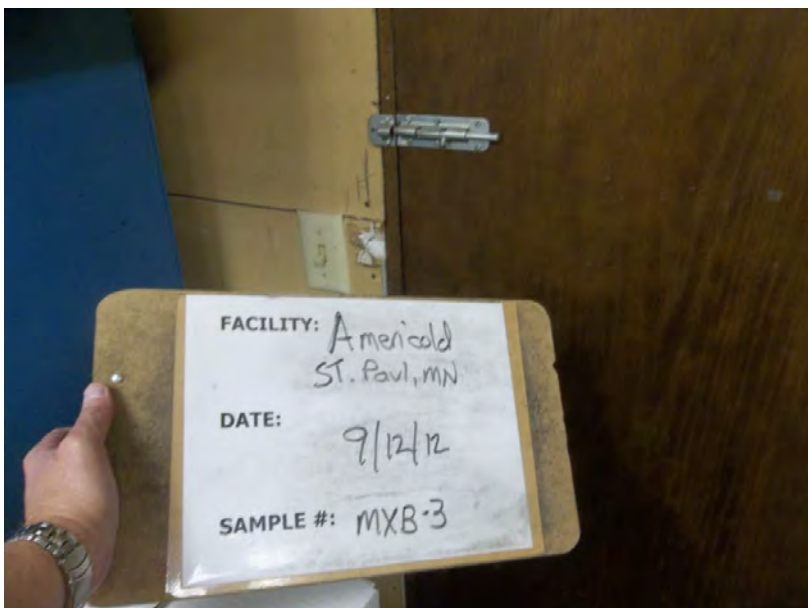
MXB-3

DRYWALL (NO COMPOUND)

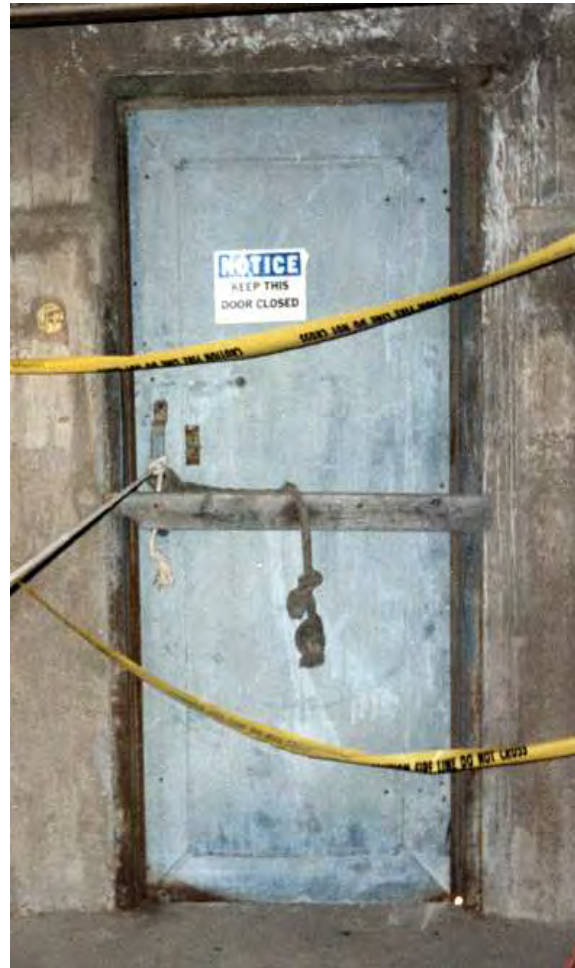
Locked and
blocked exit

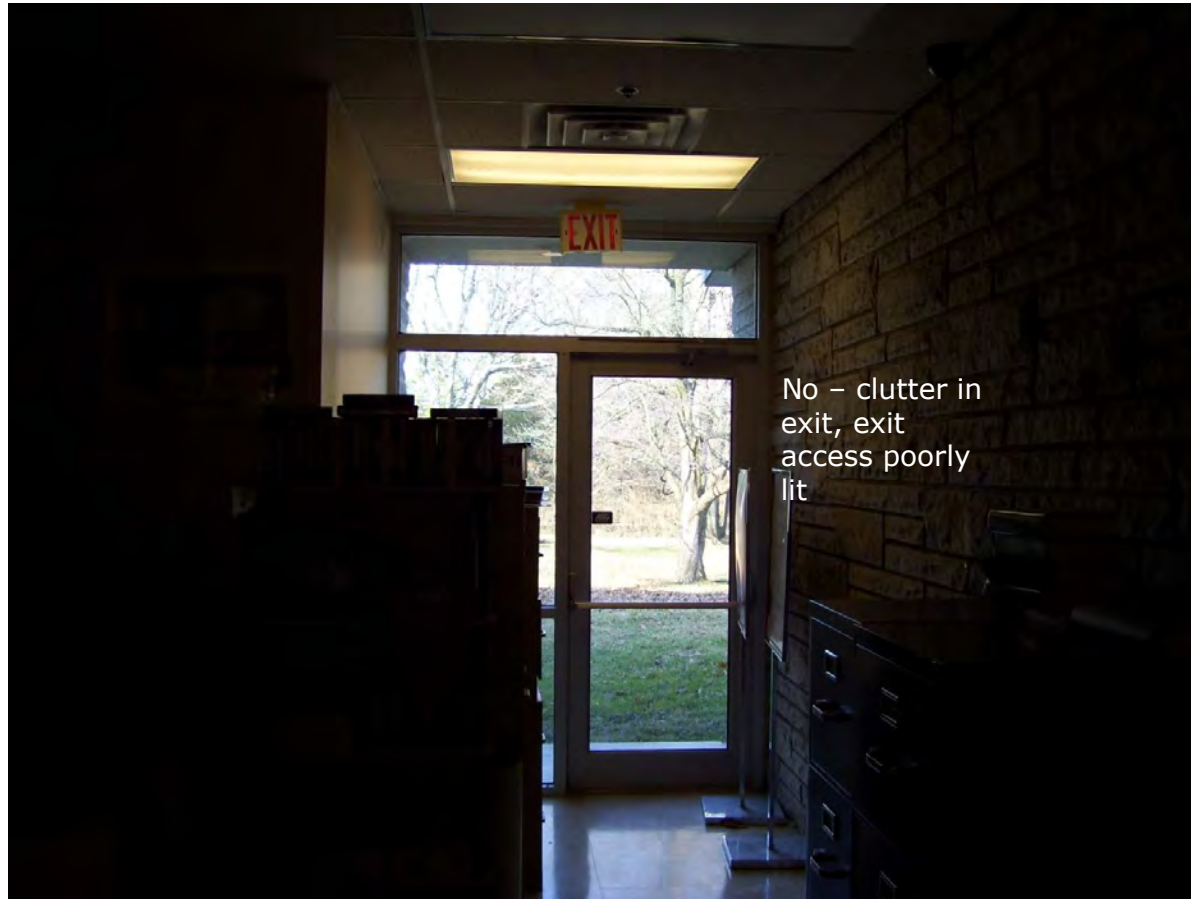
No – clutter in
exit, exit
access poorly
lit

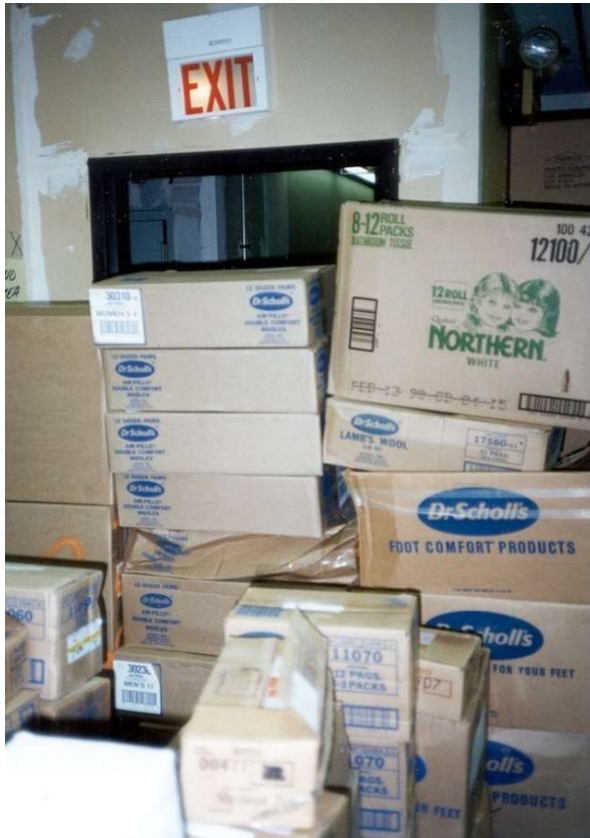
Blocked &
Obstructed exit
