Project Location:

Project Name: Protectowire System Replacement

The Americold facility located at 240 Chester Street, St. Paul, Minnesota was inspected for asbestos containing materials. The materials found to contain asbestos are listed below:

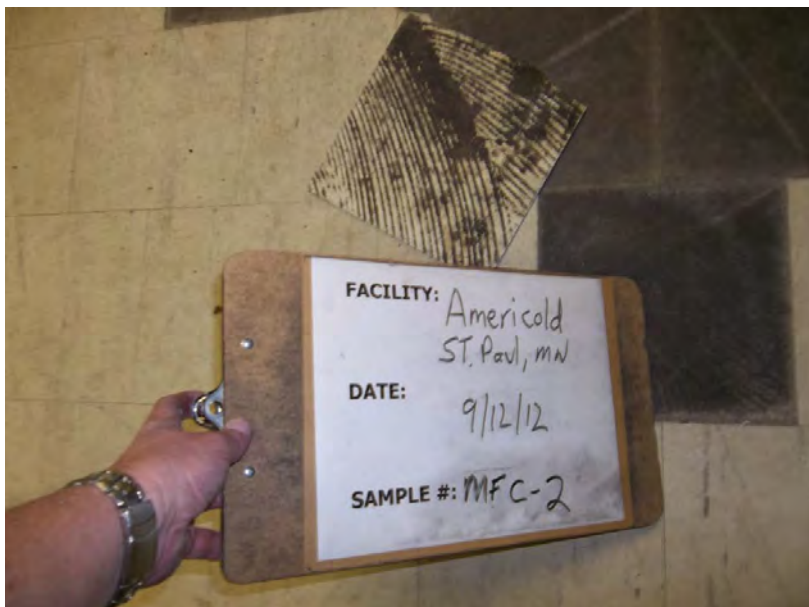
MFC-2

MFC – 9" X 9" floor tile and mastic, white with gray streaks, located in the Summit Foods/Madison Foods first floor offices contains 2-5% chrysotile asbestos as analyzed by Polarized Light Microscopy. This miscellaneous material was non-friable and in poor condition at the time of sampling. The inspector observed loose and missing tiles and areas of exposed floor tile mastic.

9" X 9" FLOOR TILE AND MASTIC, WHITE WITH GRAY STREAKS

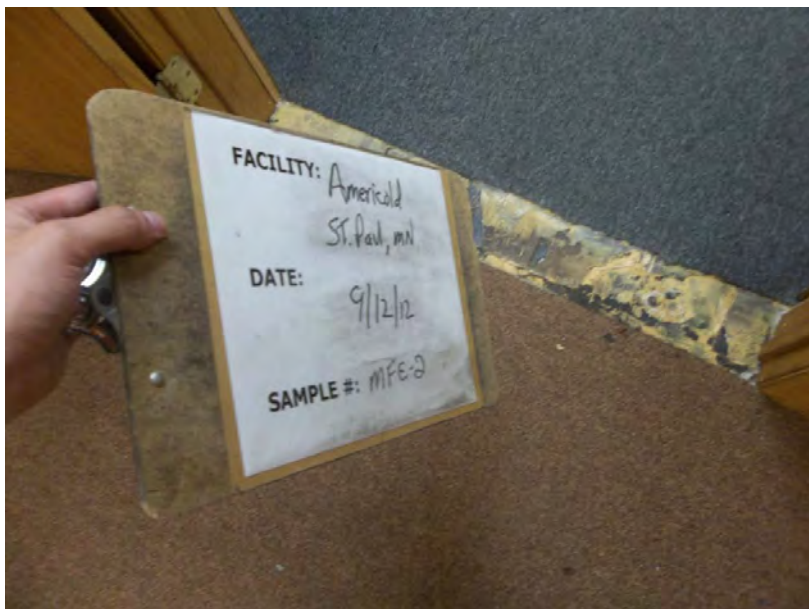
MFE-2

MFE – 9" X 9" floor tile and mastic, tan (beneath carpet), located in the second floor center offices contains 3-5% chrysotile asbestos as analyzed by Polarized Light Microscopy. This miscellaneous material was non-friable and in good condition at the time of sampling.

9" X 9" FLOOR TILE AND MASTIC, TAN
(BENEATH CARPET)

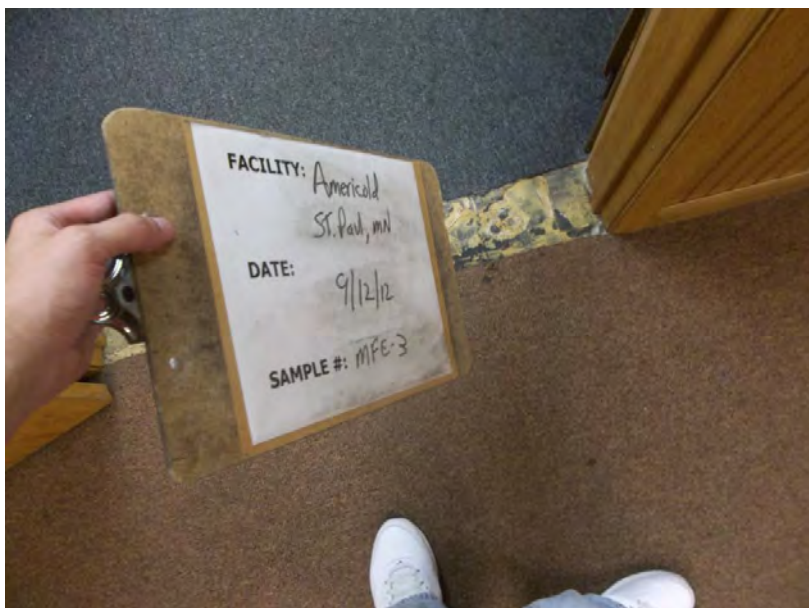
MFE-3

9" X 9" FLOOR TILE AND MASTIC, TAN
(BENEATH CARPET)

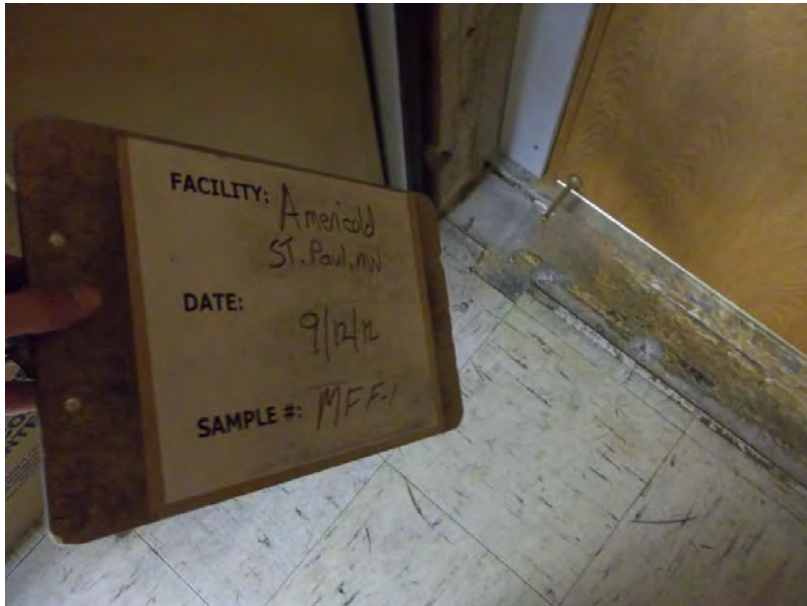
MFF-1

MFF – 12" X 12" floor tile and mastic, white with gray streaks, located in the north Schwans storeroom of the second floor center offices contains 2-3% chrysotile asbestos as analyzed by Polarized Light Microscopy. This miscellaneous material was non-friable and in good condition at the time of sampling.

12" X 12" FLOOR TILE AND MASTIC,
WHITE WITH GRAY STREAKS

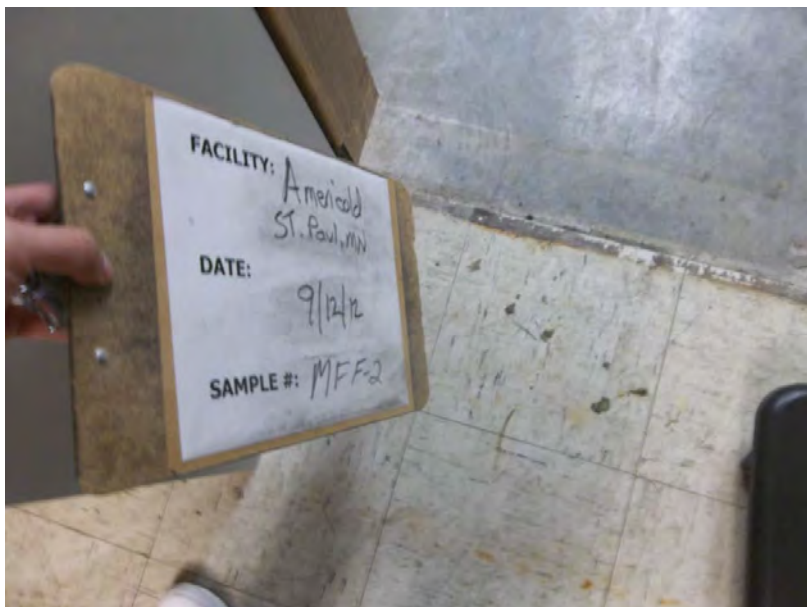
MFF-2

12" X 12" FLOOR TILE AND MASTIC,
WHITE WITH GRAY STREAKS

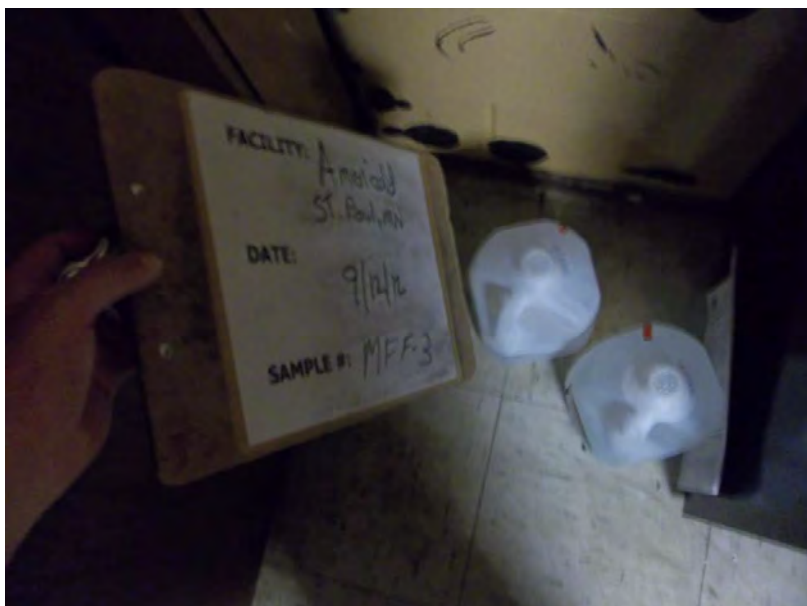
MFF-3

12" X 12" FLOOR TILE AND MASTIC,
WHITE WITH GRAY STREAKS

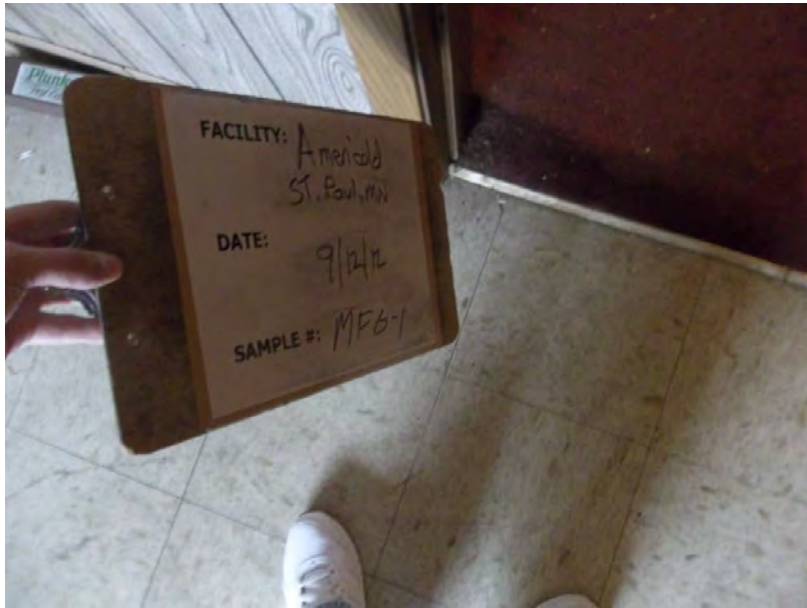
MFG-1

MFG – 12" X 12" floor tile and mastic, white with tan specks, located at the north end of the second floor center offices and in the south offices area contains 3% chrysotile asbestos as analyzed by Polarized Light Microscopy. This miscellaneous material was non-friable and in good condition at the time of sampling.

12" X 12" FLOOR TILE AND MASTIC,
WHITE WITH TAN SPECKS

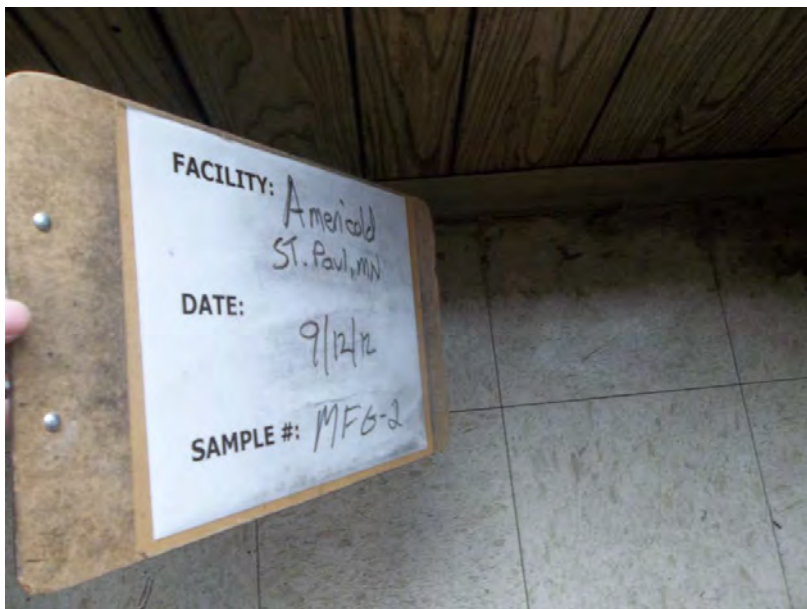
MFG-2

12" X 12" FLOOR TILE AND MASTIC,
WHITE WITH TAN SPECKS

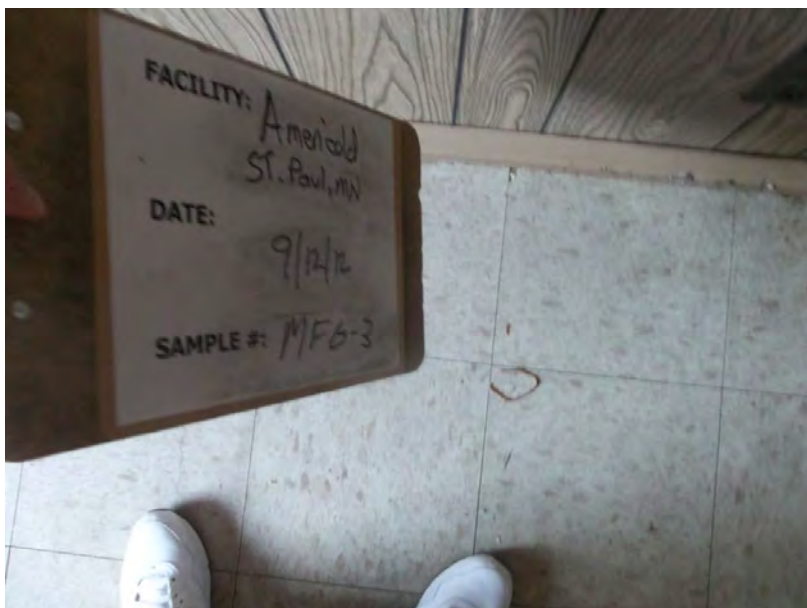
MFG-3

12" X 12" FLOOR TILE AND MASTIC,
WHITE WITH TAN SPECKS

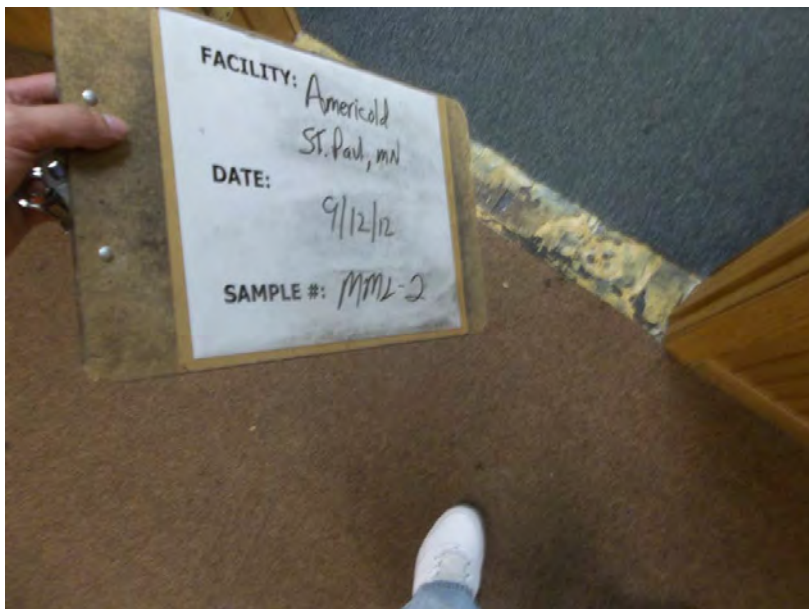
CARPET MASTIC

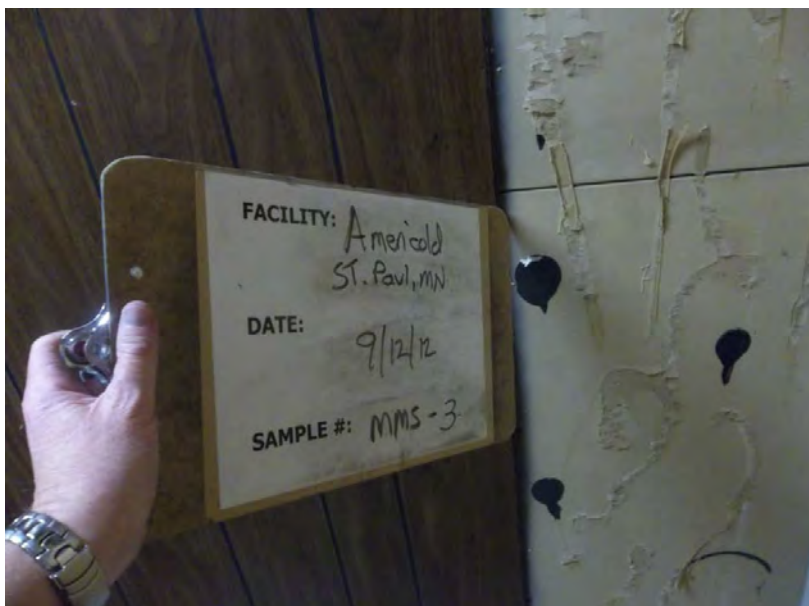
GLUE PUCKS, BLACK (ON PANELED WALLS)

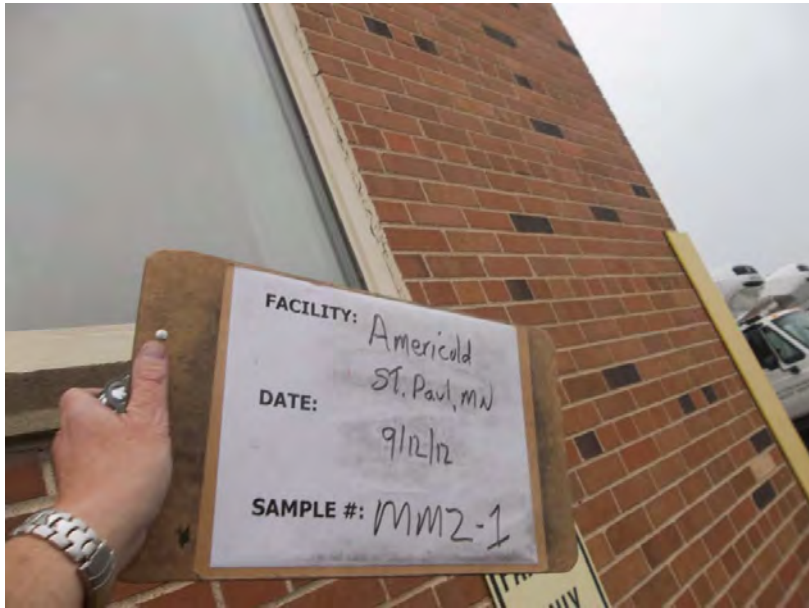
MMZ – Exterior caulk, tan, located around windows and doors of the center offices contains 3% chrysotile asbestos as analyzed by Polarized Light Microscopy. This miscellaneous material was non-friable and in good condition at the time of sampling.

EXTERIOR CAULK, TAN (ON WINDOWS)

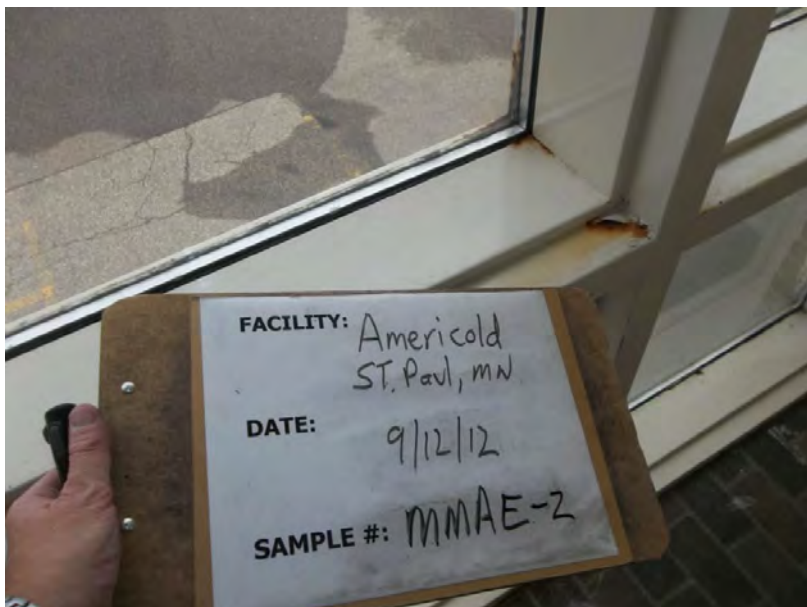
MMAE – Window glazing, black, located around windows in the second floor of the former Baldinger's Bakery offices contains 5% chrysotile asbestos as analyzed by Polarized Light Microscopy. This miscellaneous material was non-friable and in good condition at the time of sampling.

WINDOW GLAZING, BLACK

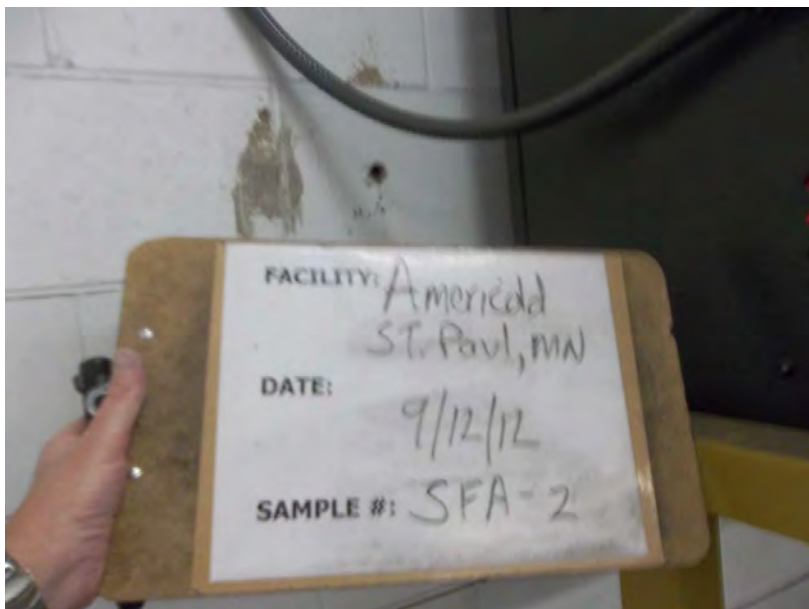
SFA – Concrete block insulation (vermiculite), located in the north dock area was sampled by RES and tested negative for asbestos content, however the Minnesota Department of Health and the Minnesota Pollution Control Agency strongly recommends assuming vermiculite insulation contains asbestos. There is no dependable way of determining the asbestos content of vermiculite. This thermal material was friable and was in poor condition at the time of sampling.

CONCRETE BLOCK INSULATION

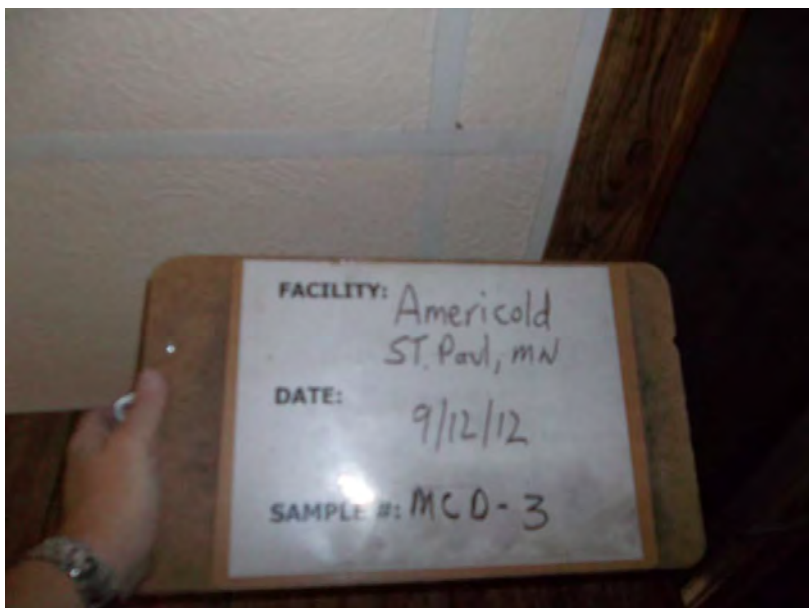
MCD-3

2' X 4' CEILING TILE, TEXTURED
PATTERN

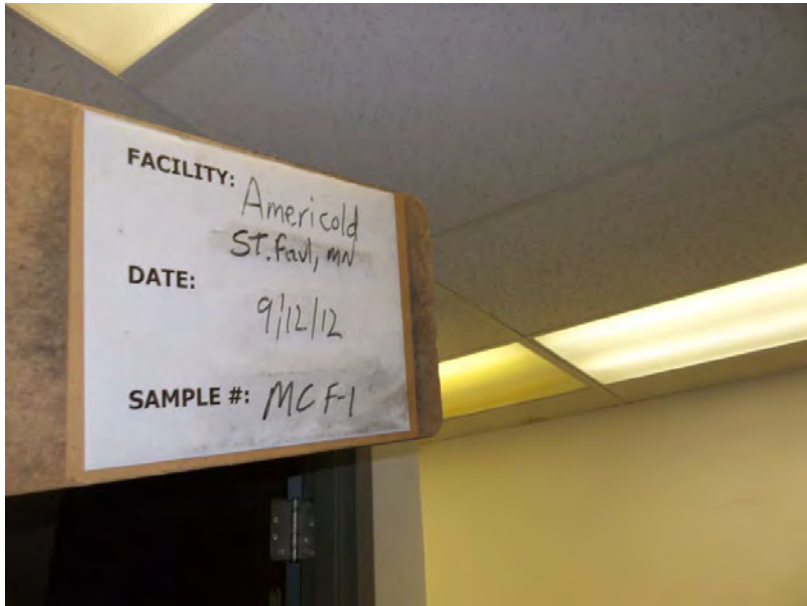
MCF-1

2' X 4' CEILING TILE, LONG FISSURES
AND PINHOLES

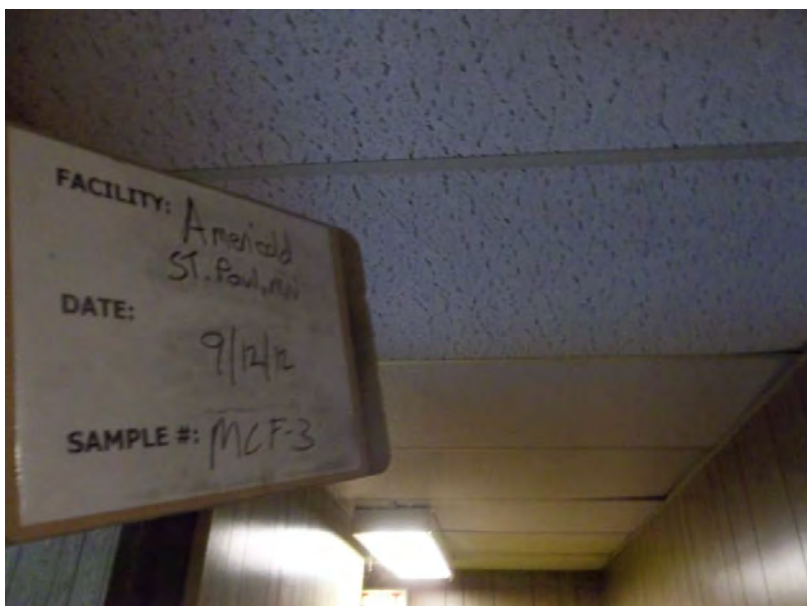
MCF-3

2' X 4' CEILING TILE, LONG FISSURES
AND PINHOLES

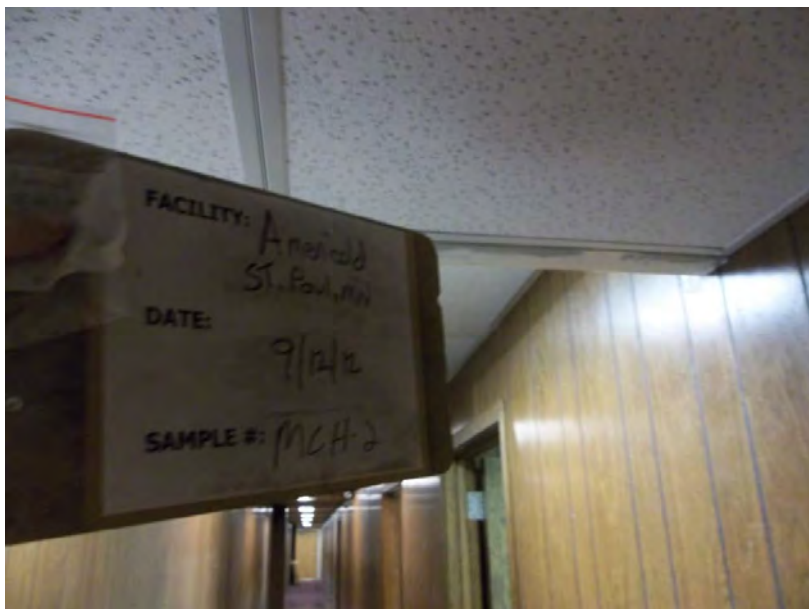
MCH-2

2' X 4' CEILING TILE, VARIOUS
PINHOLES

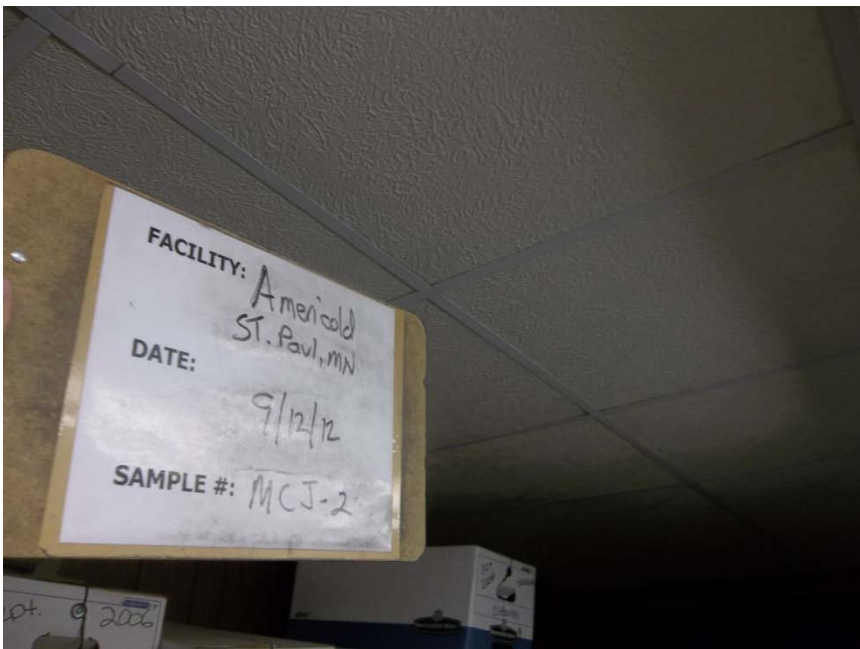
MCJ-2

2' X 4' CEILING TILE, LARGE TEXTURED
PATTERN

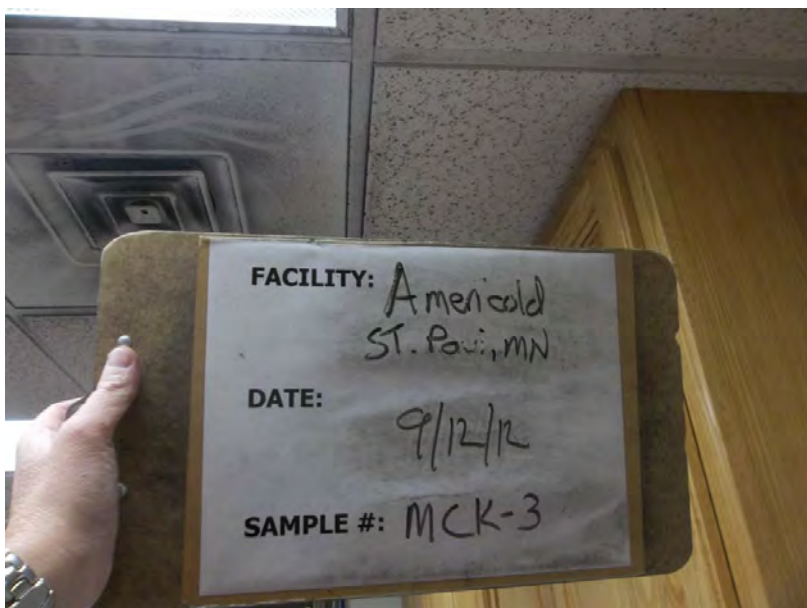
MCK-3

2' X 2' CEILING TILE, FISSURES AND
PINHOLES (RECESSED)

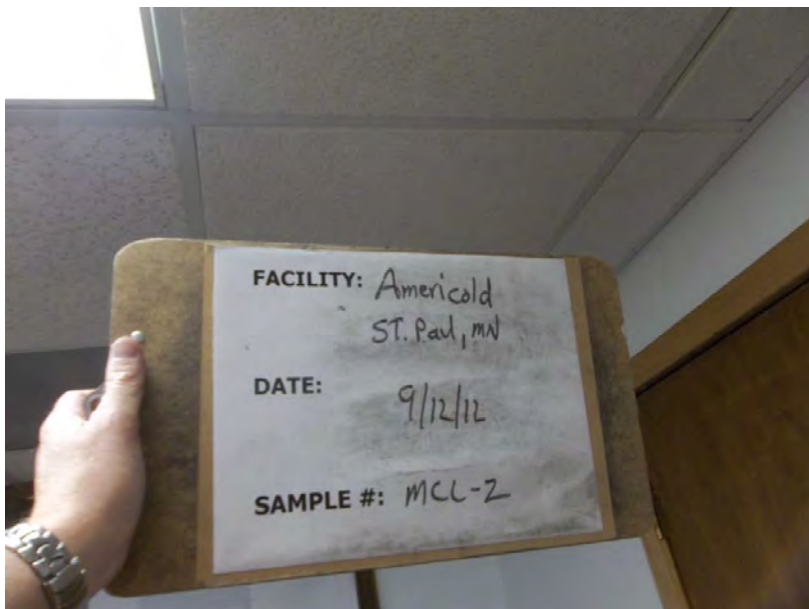
MCL-2

2' X 2' CEILING TILE, TEXTURED
(RECESSED)

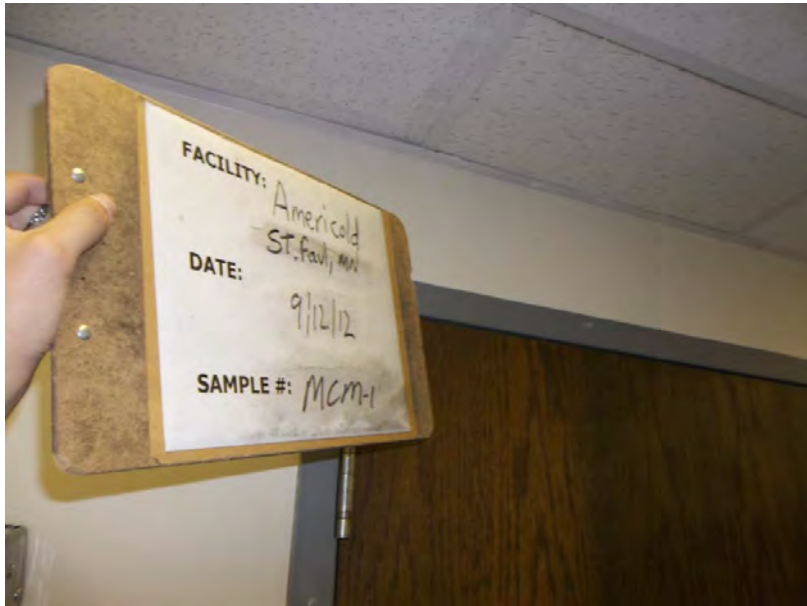
MCM-1

2' X 4' CEILING TILE, FISSURES AND
PINHOLES

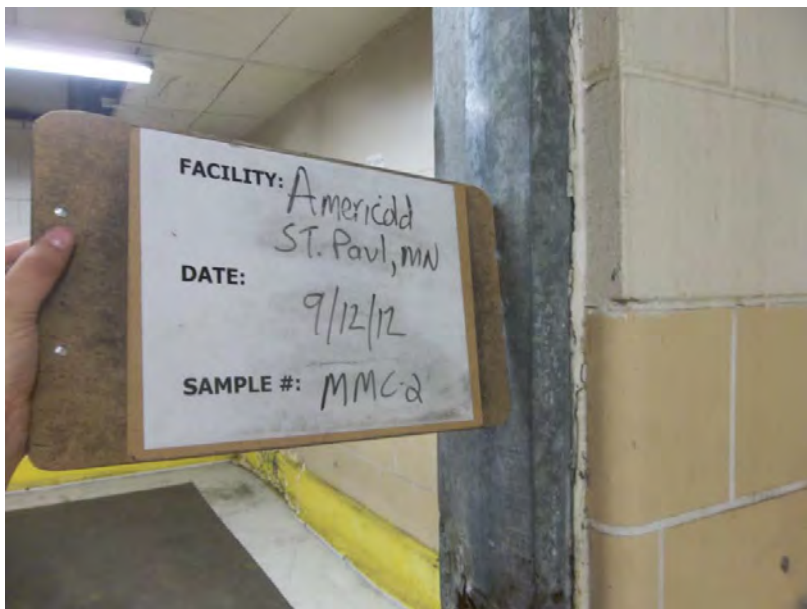
MMC-2

INTERIOR CAULK, WHITE (ON DOORS)

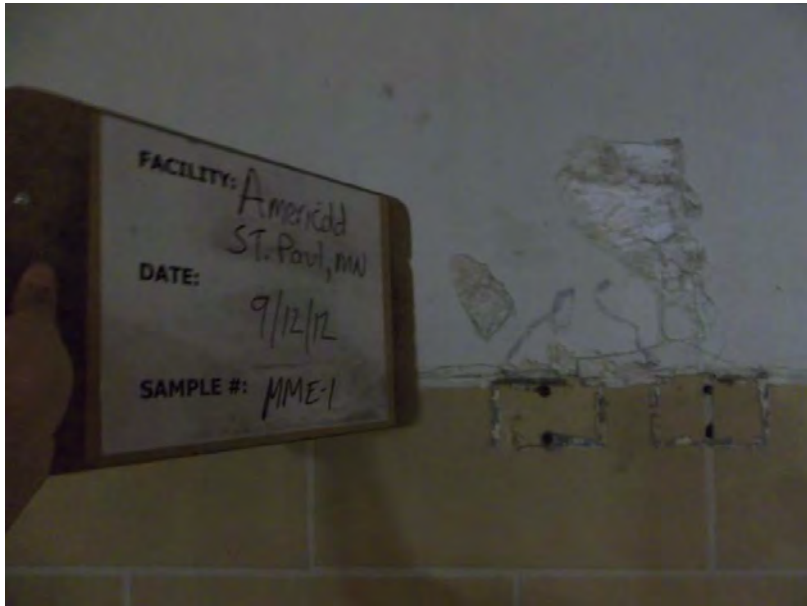
MME-1

WALLBOARD (OVER FOAM INSULATION)

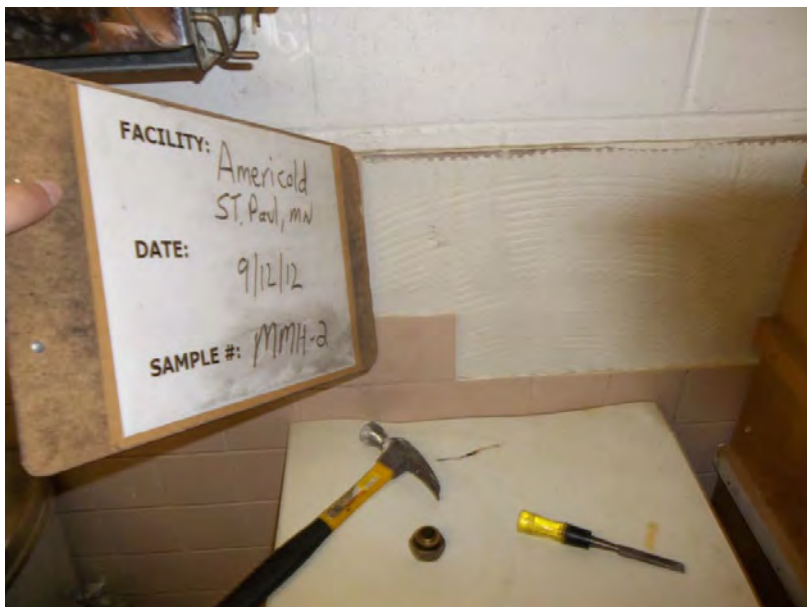
MMH-2

4" X 4" CERAMIC WALL TILE, PINK
(ADHESIVE)

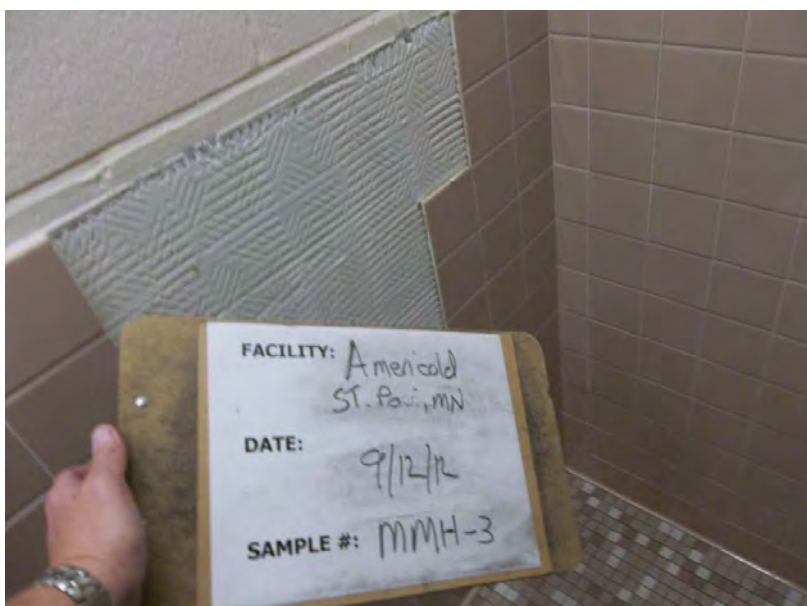
MMH-3

4" X 4" CERAMIC WALL TILE, PINK
(ADHESIVE)

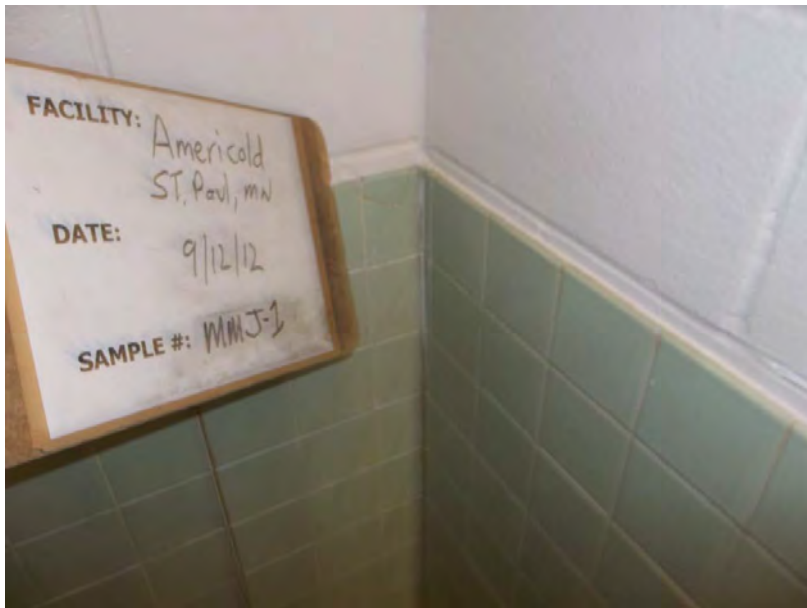
MMJ-1

4" X 4" CERAMIC WALL TILE, GREEN
(ADHESIVE)

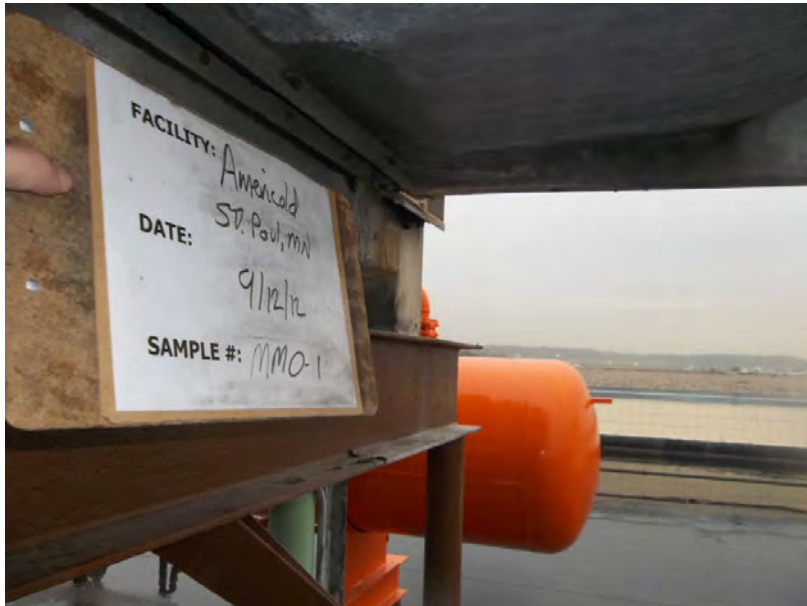
MMO-1

EXTERIOR CAULK, BLACK (ON NORTH ROOFTOP CONDENSERS)

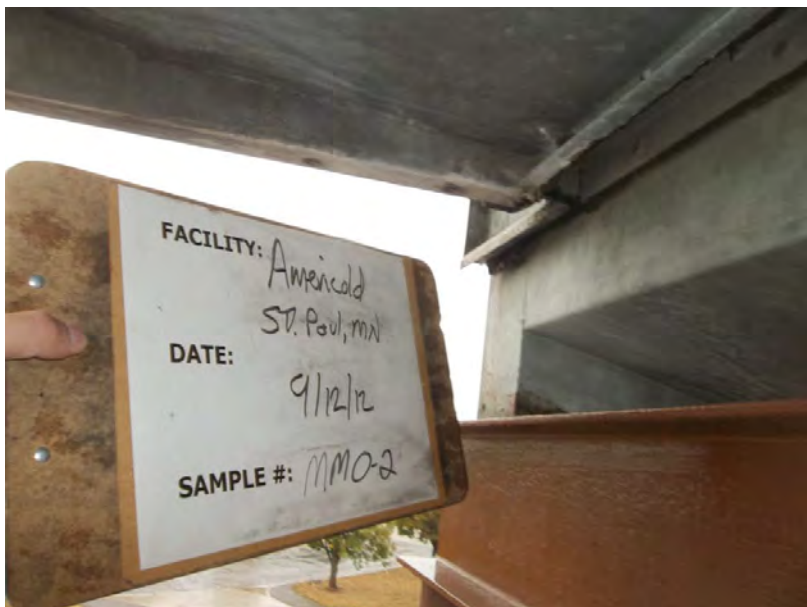
MMO-2

EXTERIOR CAULK, BLACK (ON NORTH ROOFTOP CONDENSERS)

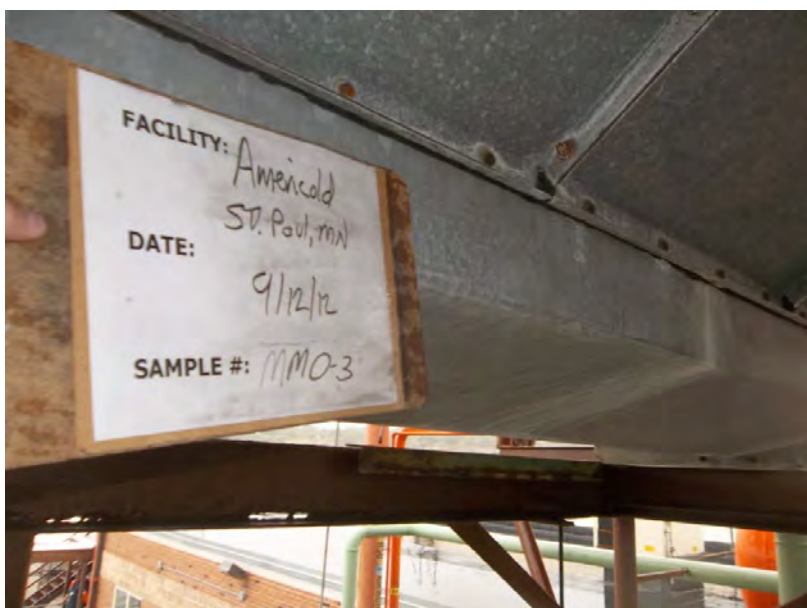
MMO-3

EXTERIOR CAULK, BLACK (ON NORTH ROOFTOP CONDENSERS)

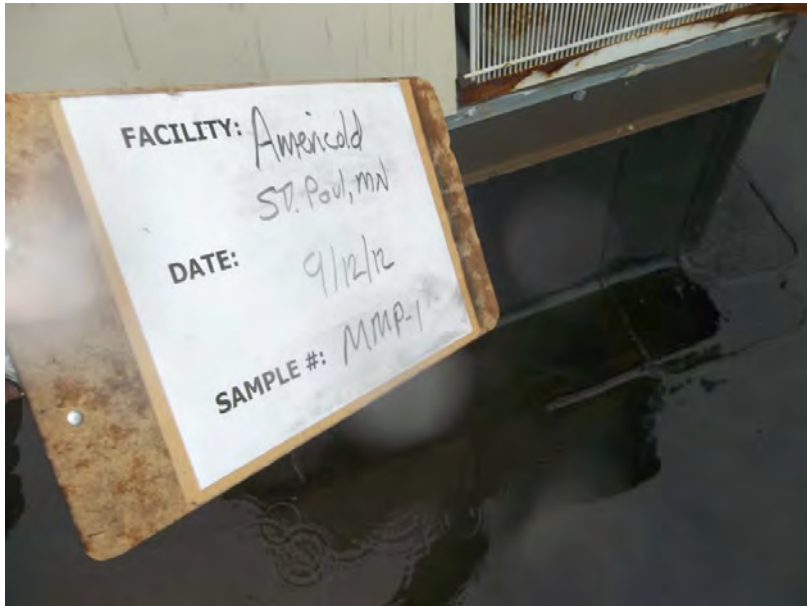
MMP-1

EXTERIOR CAULK, BLACK (ON ROOFTOP
FAN UNITS)

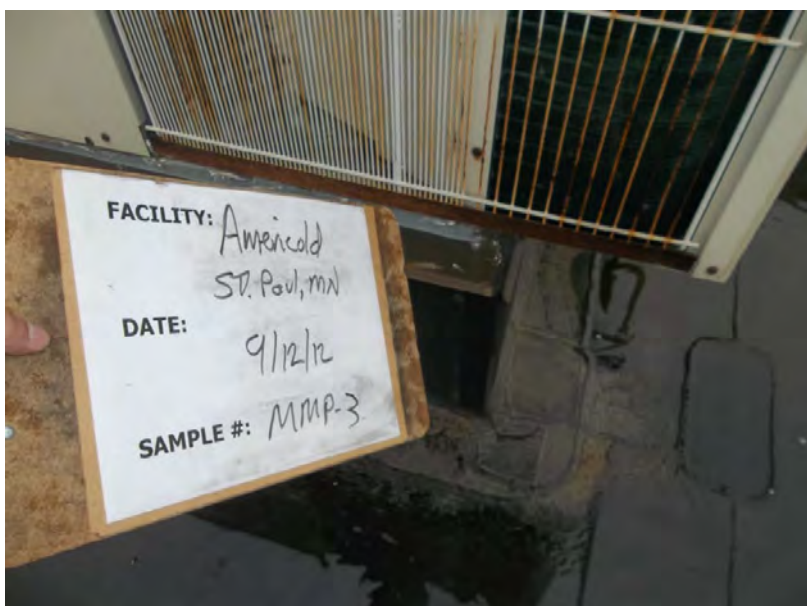
MMP-3

EXTERIOR CAULK, BLACK (ON ROOFTOP
FAN UNITS)

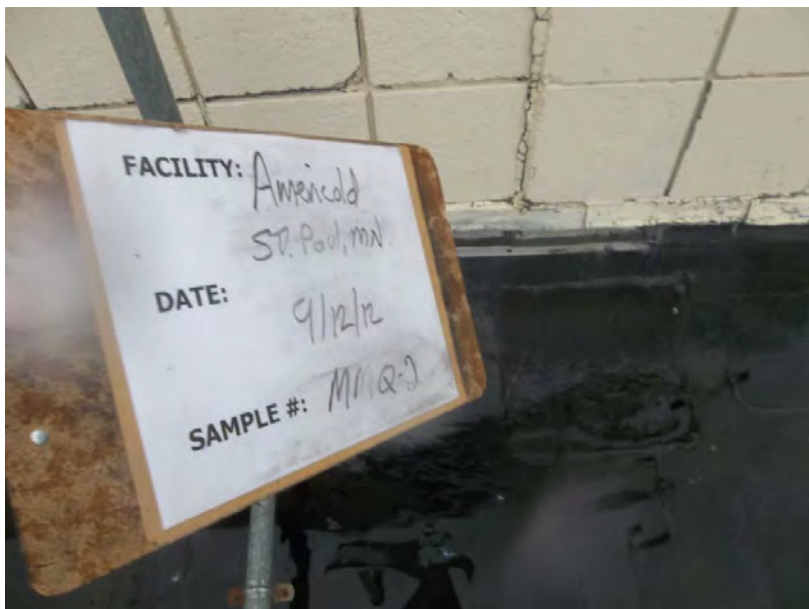
MMQ-2

EXTERIOR CAULK, WHITE (ON METAL WALLS)

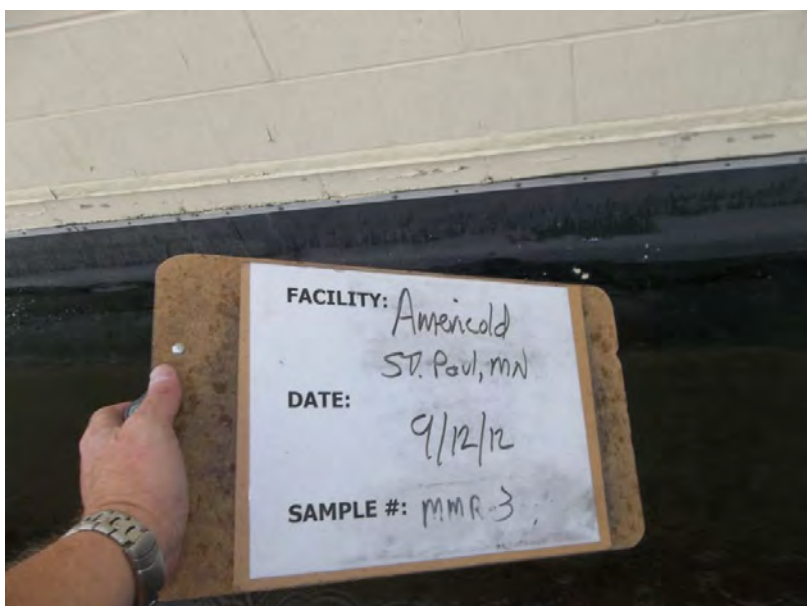
MMR-3

EXTERIOR CAULK, TAN (ON BLOCK WALLS)

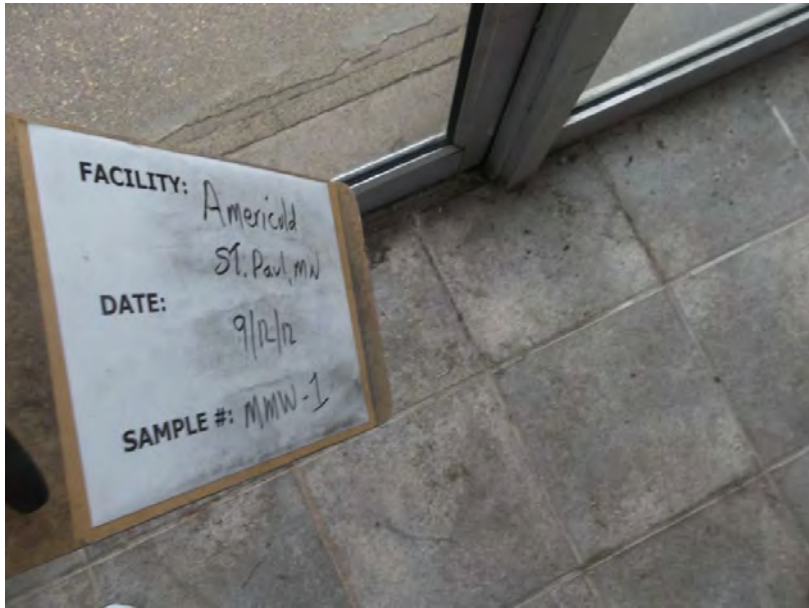
MMW-1

12" X 12" CERAMIC FLOOR TILE, GRAY
(MORTAR BED)

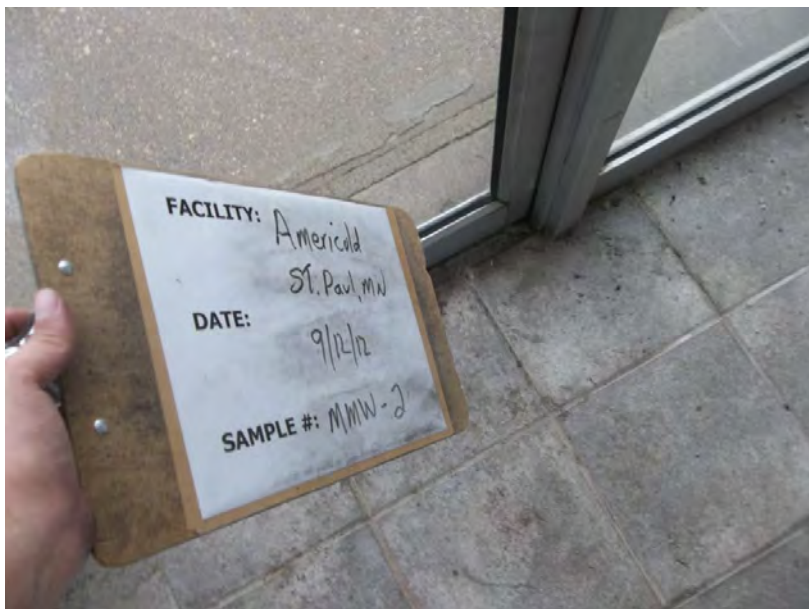
MMW-2

12" X 12" CERAMIC FLOOR TILE, GRAY
(MORTAR BED)

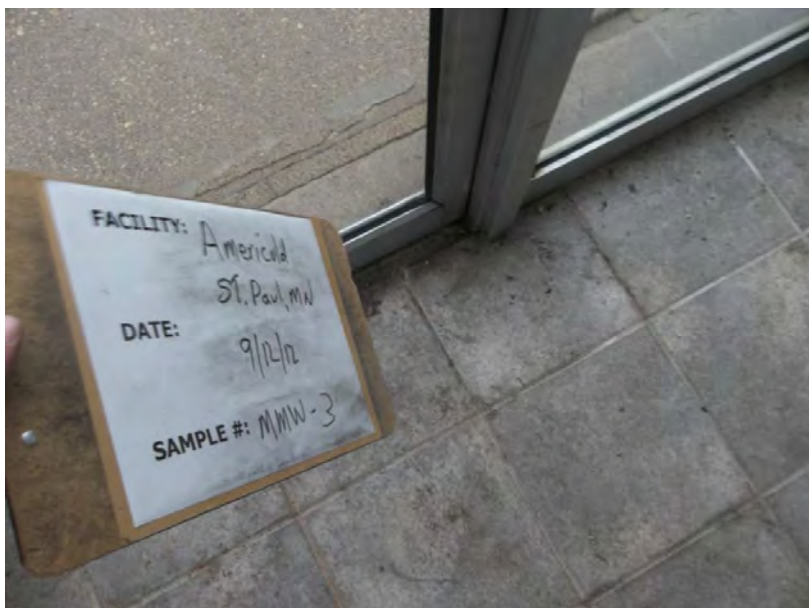
MMW-3

12" X 12" CERAMIC FLOOR TILE, GRAY
(MORTAR BED)

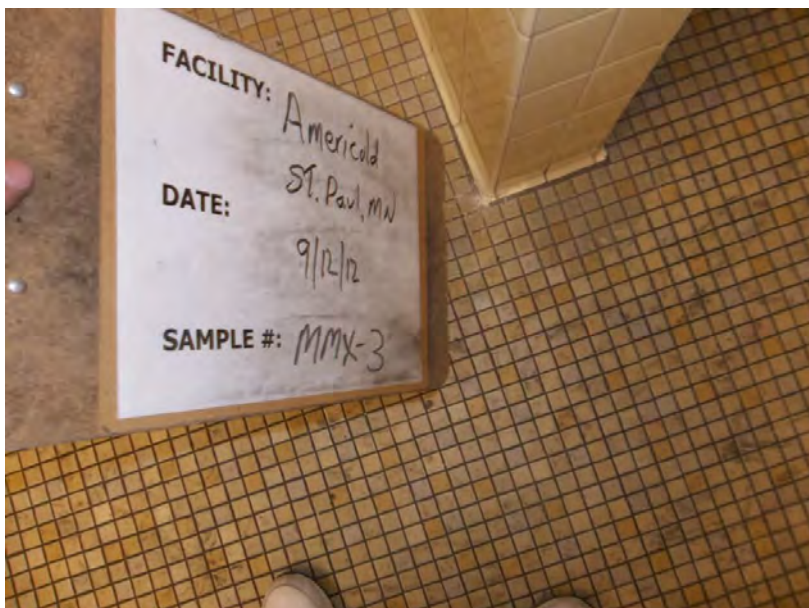
MMX-3

1" X 1" CERAMIC FLOOR TILE, YELLOW
(MORTAR BED)

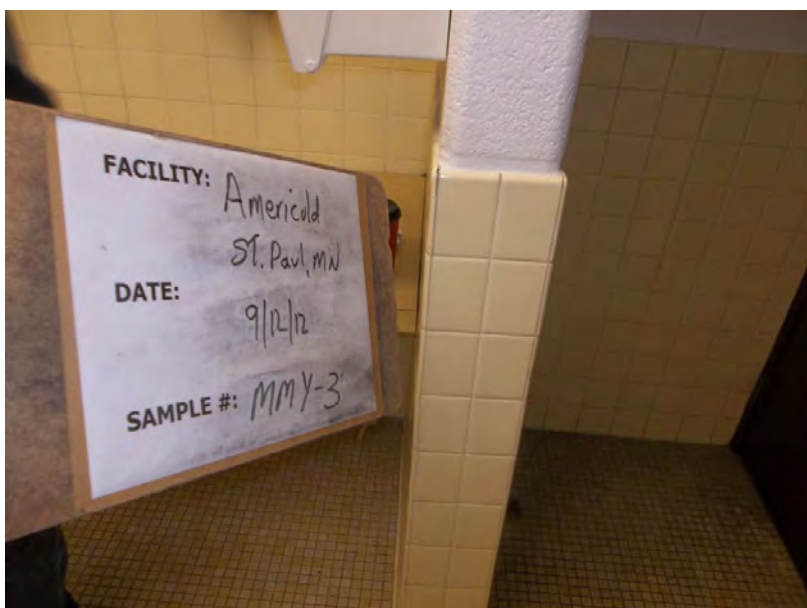
MMY-3

4" X 4" CERAMIC WALL TILE, YELLOW
(ADHESIVE)

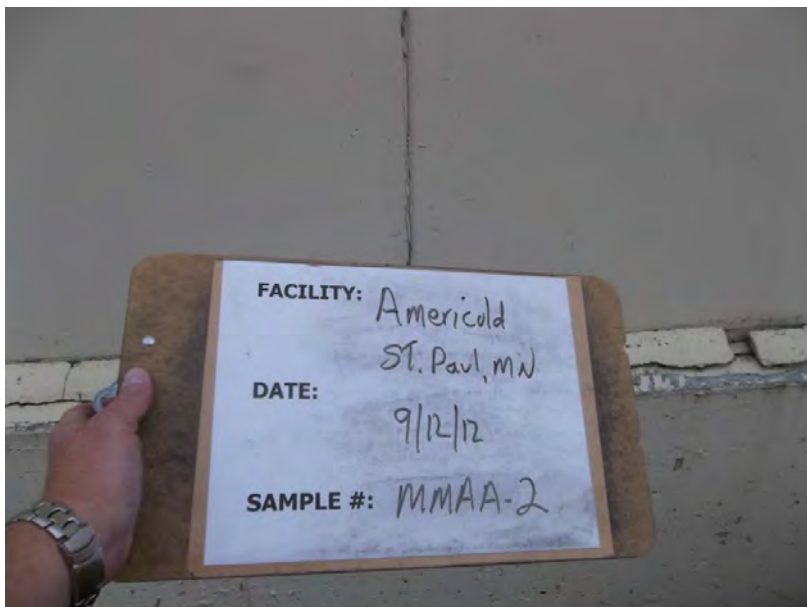
MMAA-2

EXPANSION JOINTS, GRAY (ON
CONCRETE WALL PANELS)

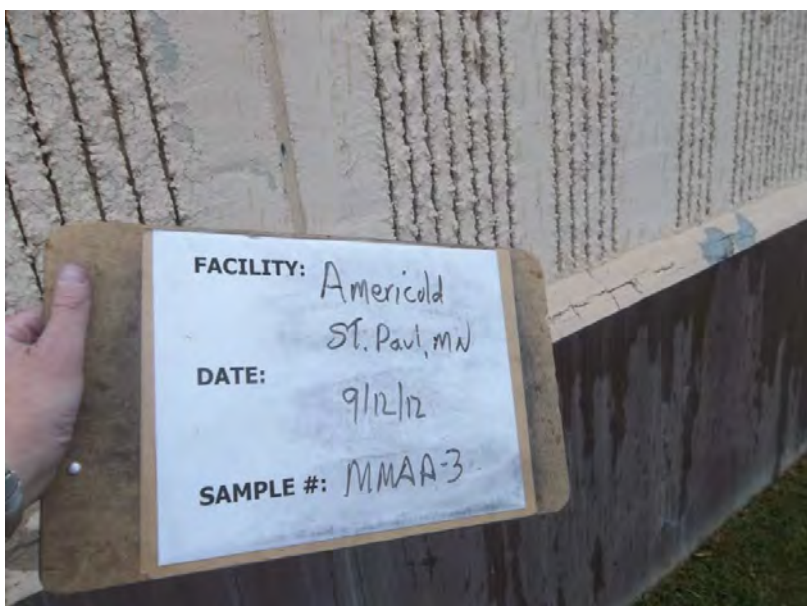
MMAA-3

EXPANSION JOINTS, GRAY (ON
CONCRETE WALL PANELS)

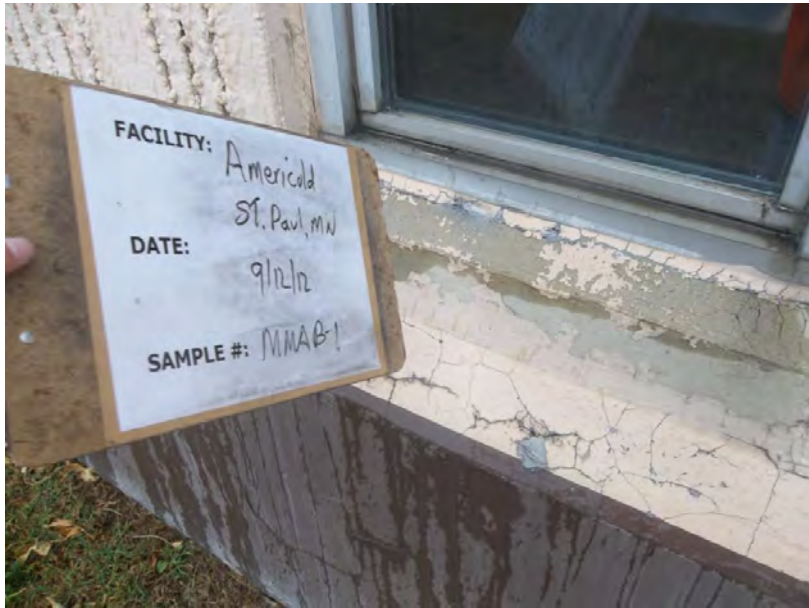
MMAB-1

EXTERIOR CAULK, TAN (ON WINDOWS)

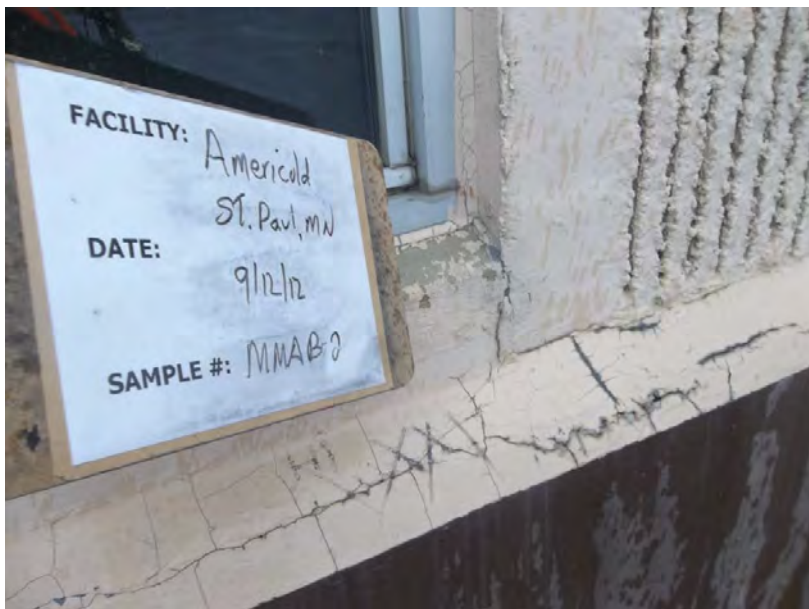
MMAB-2

EXTERIOR CAULK, TAN (ON WINDOWS)

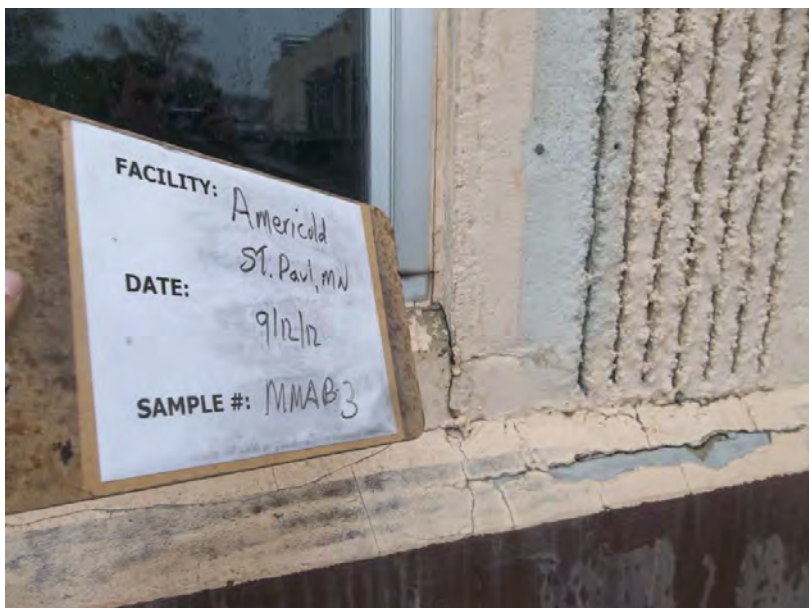
MMAB-3

EXTERIOR CAULK, TAN (ON WINDOWS)
