Project Location:

Project Name: Protectowire System Replacement

The Americold facility located at 240 Chester Street, St. Paul, Minnesota was inspected for asbestos containing materials. The materials found to contain asbestos are listed below:

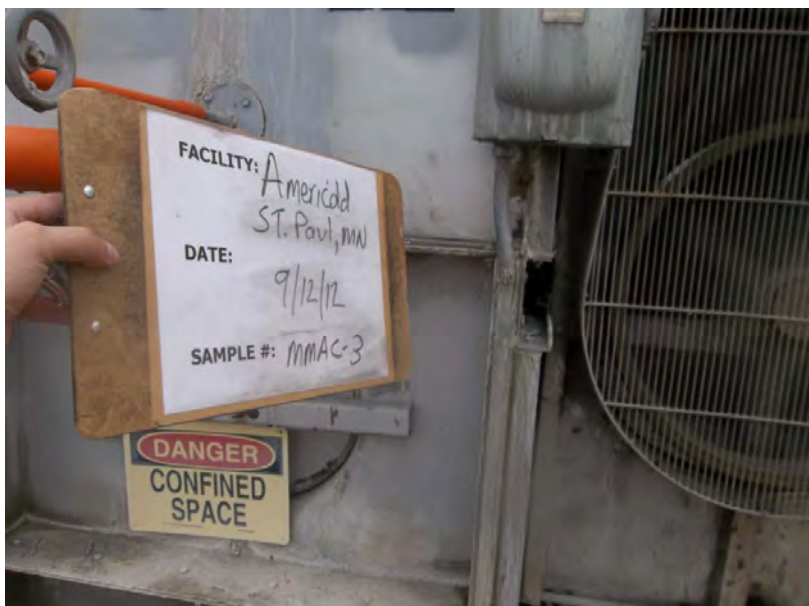
MMAC-3

EXTERIOR CAULK, WHITE (ON SOUTH
ROOFTOP CONDENSERS)

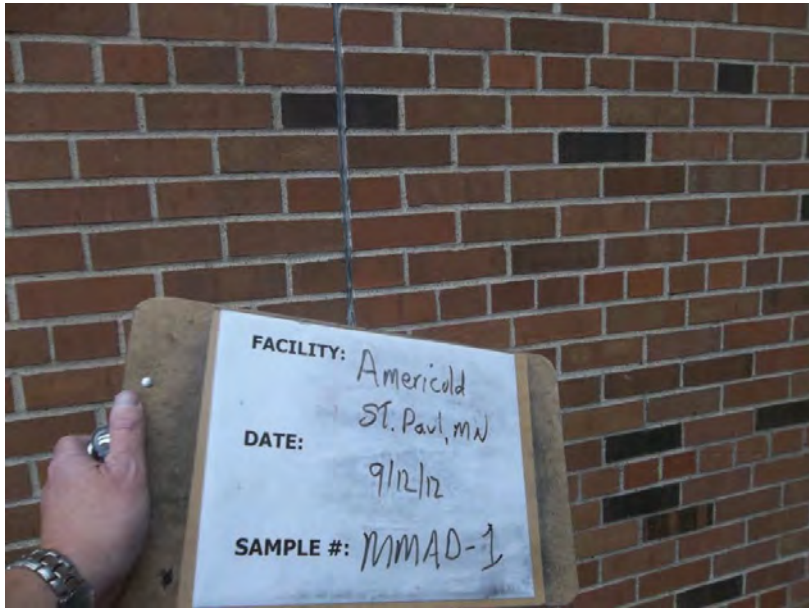
MMAD-1

EXPANSION JOINTS, WHITE (ON BRICK WALLS)

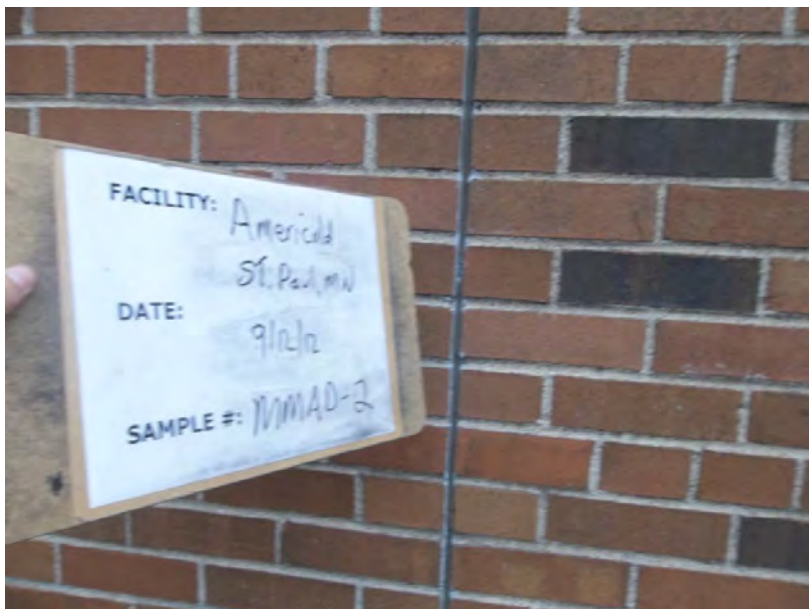
MMAD-2

EXPANSION JOINTS, WHITE (ON BRICK WALLS)

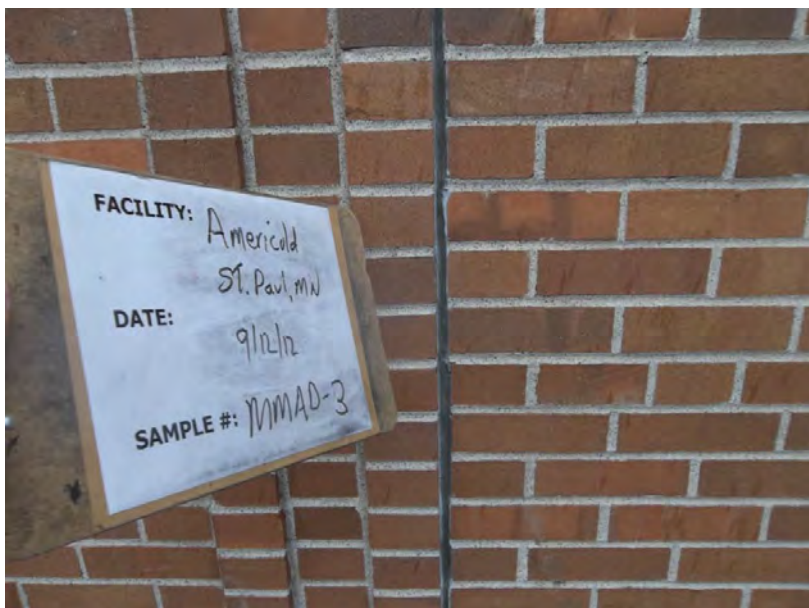
MMAD-3

EXPANSION JOINTS, WHITE (ON BRICK WALLS)

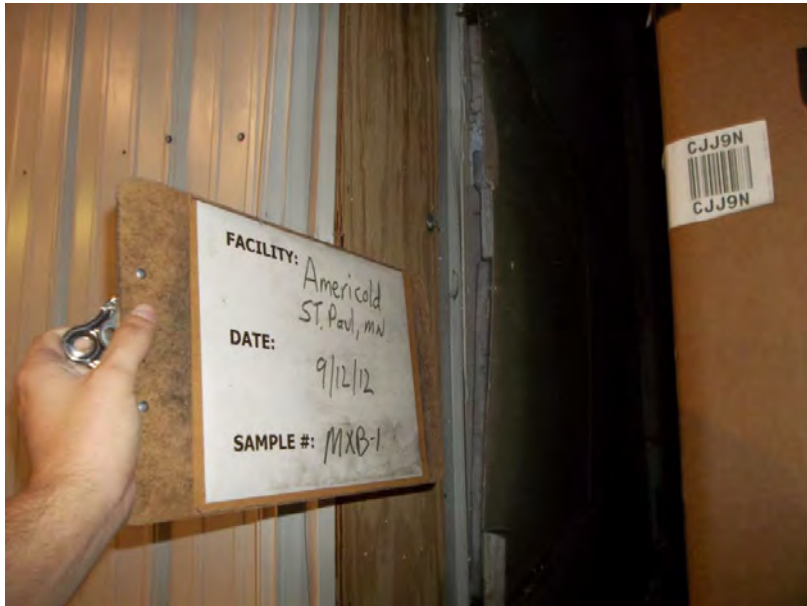
MXB-1

DRYWALL (NO COMPOUND)

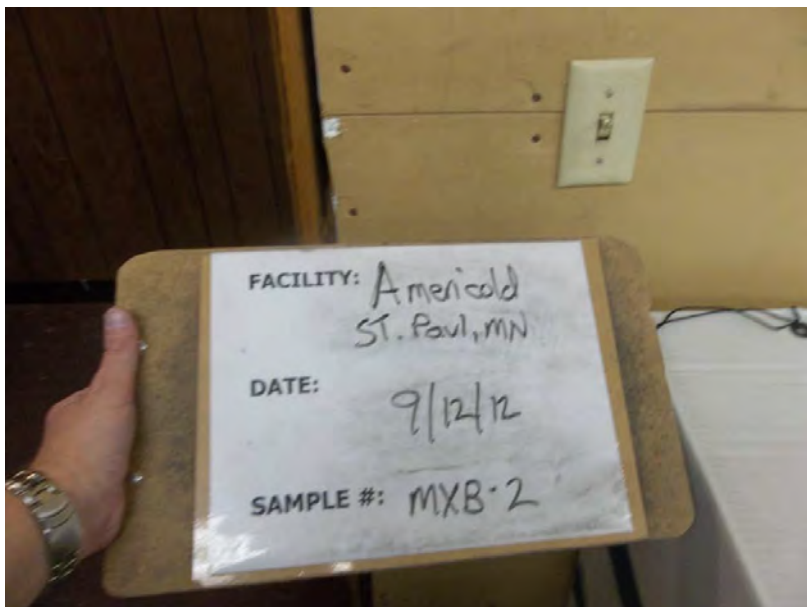
MXB-2

DRYWALL (NO COMPOUND)

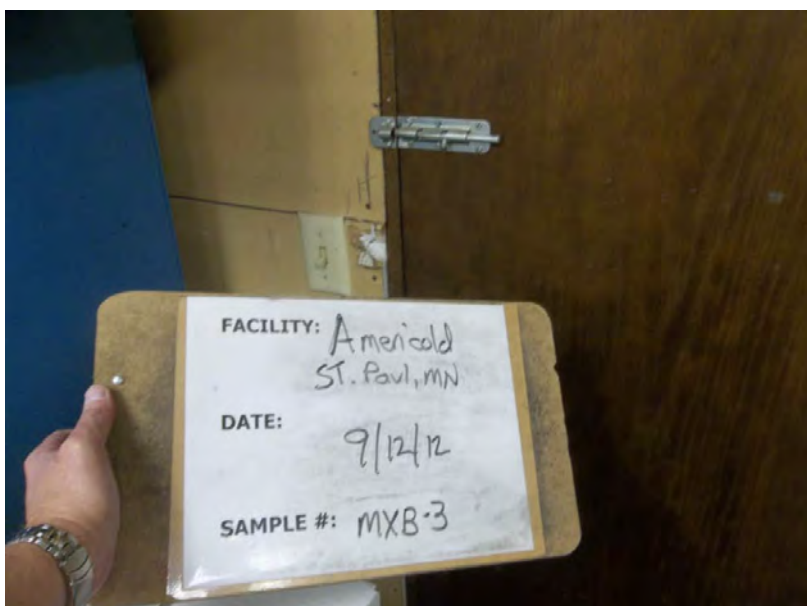
MXB-3

DRYWALL (NO COMPOUND)
