PARKING RAMP EVALUATION REPORT

Best Western Plus Como Park Hotel Parking Ramp
1015 Bandana Boulevard East
Saint Paul, Minnesota 55105

Encompass Project #: 22-8144-000

Re: Best Western - 2022 Parking Ramp Review
1015 Bandana Boulevard East
Saint Paul, Minnesota 55105

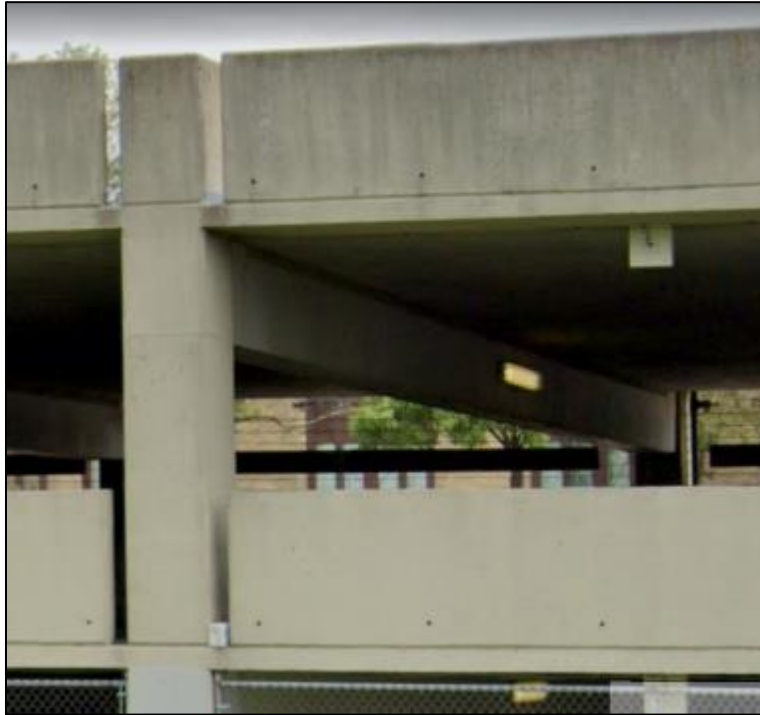
SK-2: Google Image of Level 3 ½ PT Beam

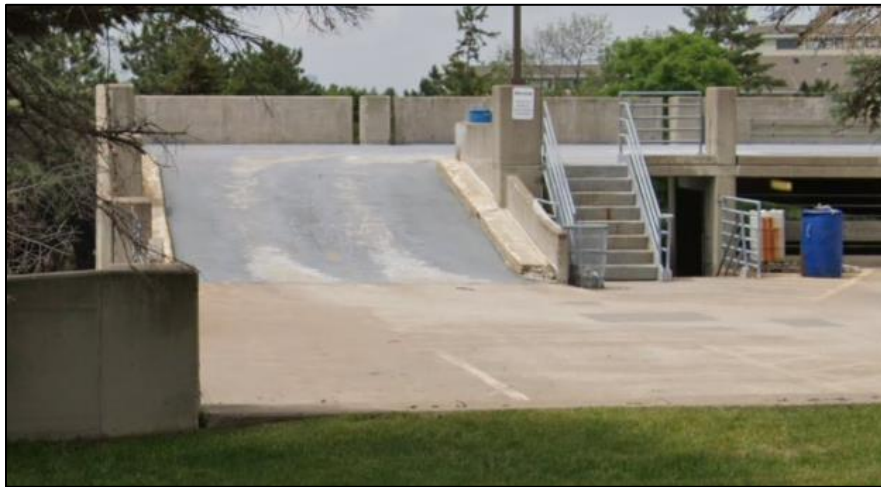
SK-3: Google Image of South Vehicle Ramp Between Levels 3 and up to 3 ½. Stair A next to ramp

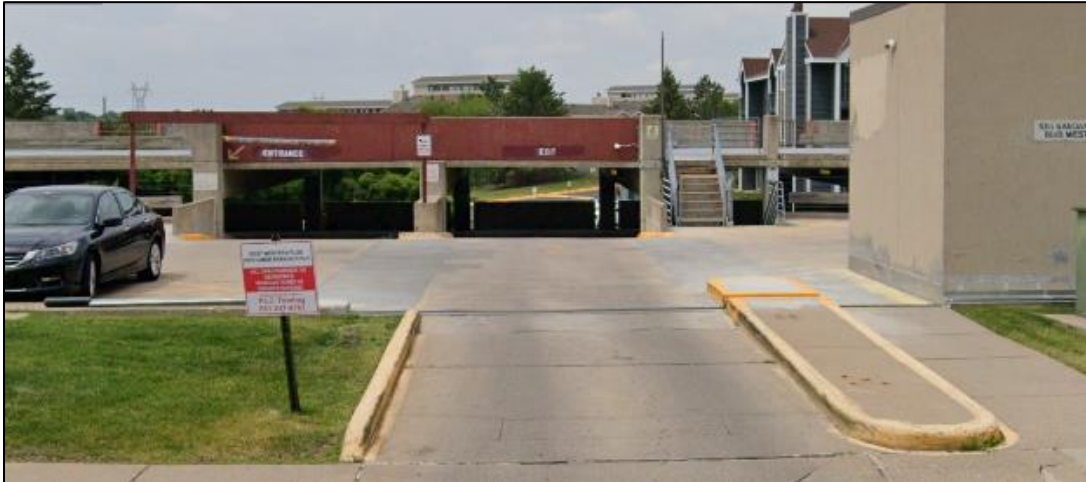
SK-4: Google Image of Center Vehicle Ramps from Level 3 going up and down to Levels 2 ½ and 3 ½. Stair B next to ramps. This is main vehicle entry from east between hotel and ramp.

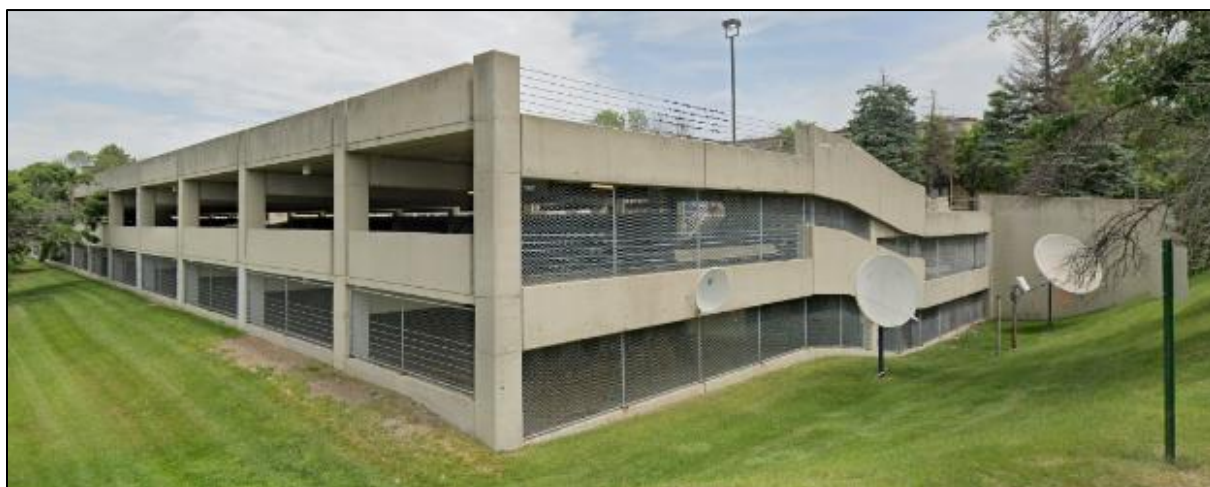
SK-6: Google Image of Southwest Corner of Levels 1 ½, 2 ½, and 3 ½ in foreground.

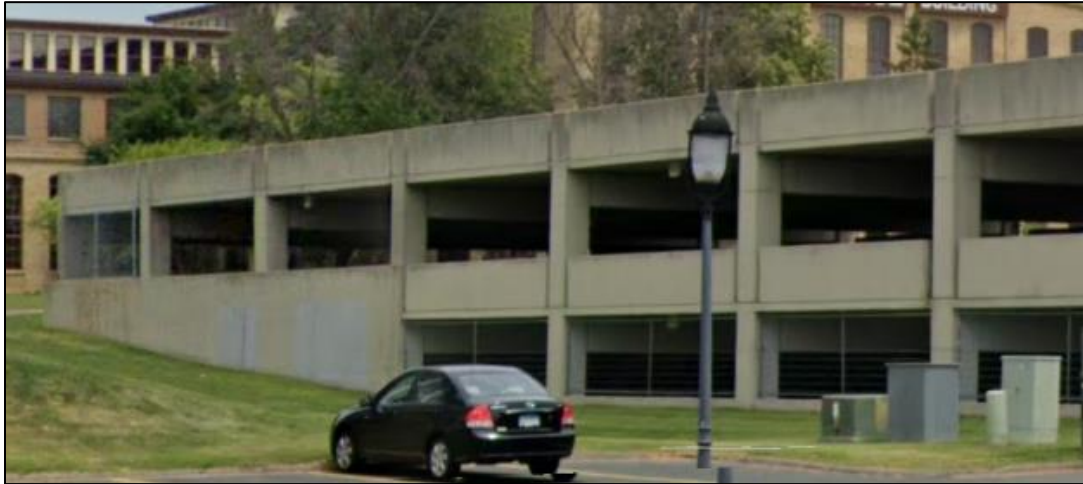
SK-7: Google Image of Northwest Corner of Levels 1 ½, 2 ½, and 3 ½. Note grade rising on north (left) end.

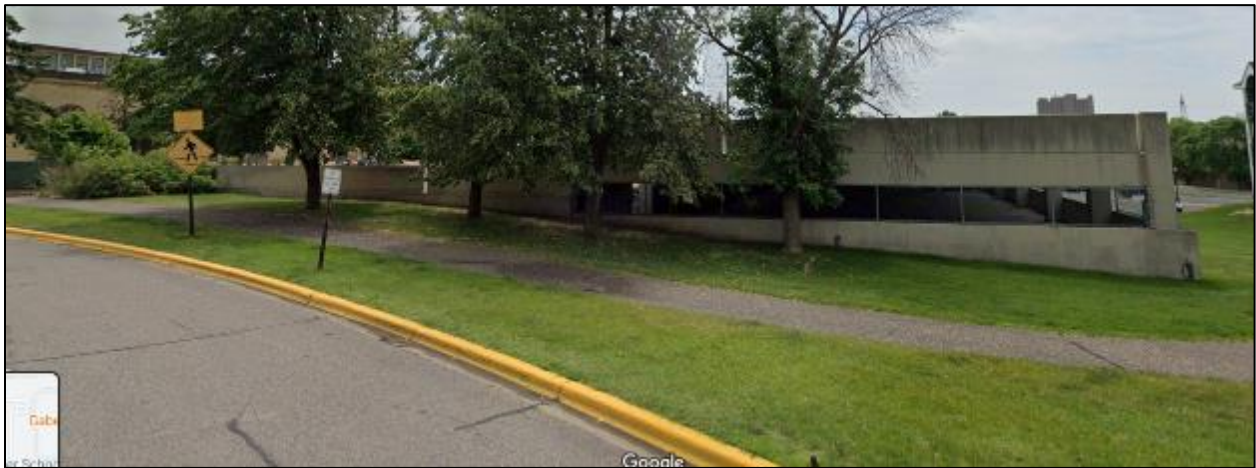
SK-8: Google Image of north end Levels 2½, and 3½. Note grade rising on east (left) end.

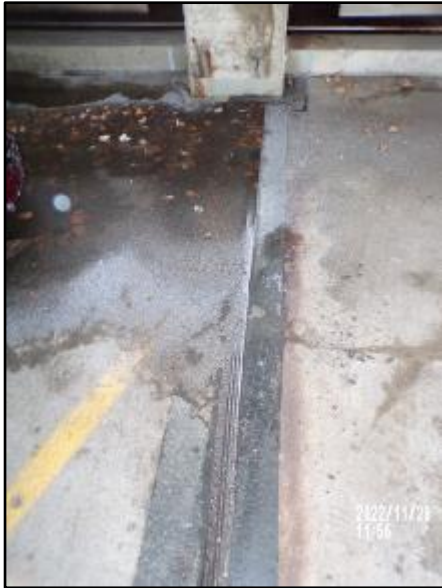
Level 2.5

2.4.1.1 The expansion joints primarily serve to divide the full structure into three separate structures, allowing each section to expand and contract due to extreme outdoor temperature variations. The condition of the expansion joints was variable ranging from good to poor condition.

2.4.1.2 The expansion joints in poor condition had visible tears and debonding of the top horizontal wings (legs) at various points along the joint.

Expansion Joint Top

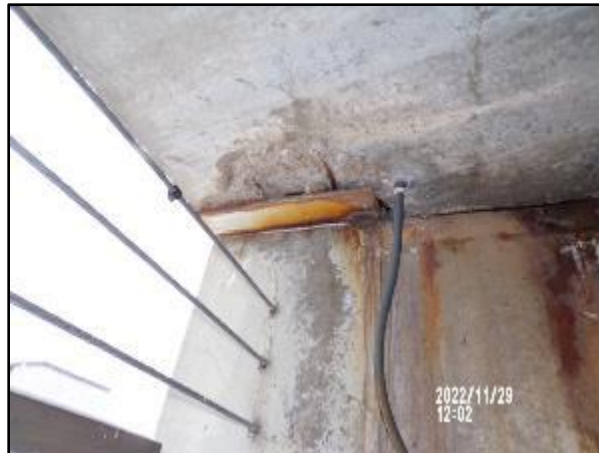
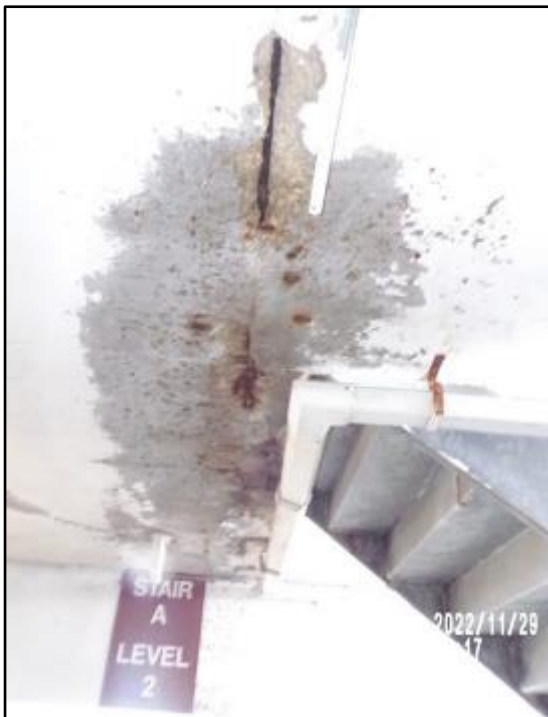
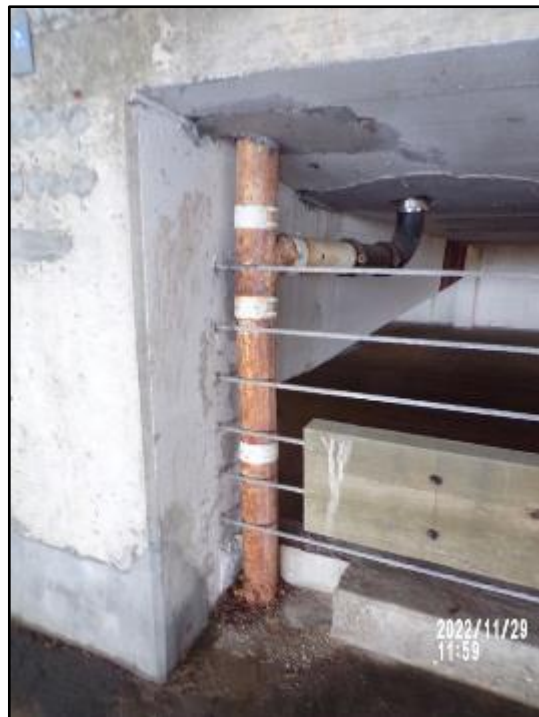
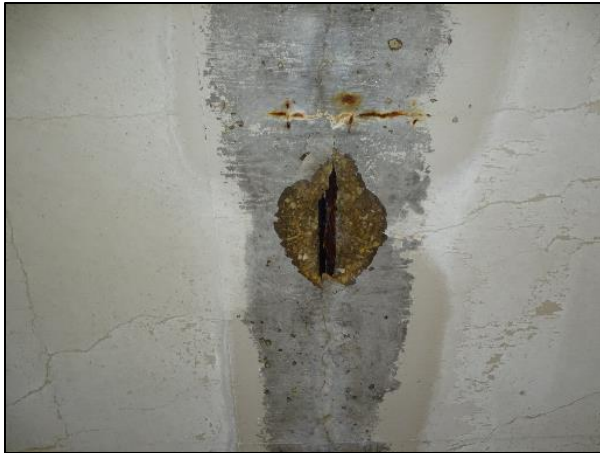
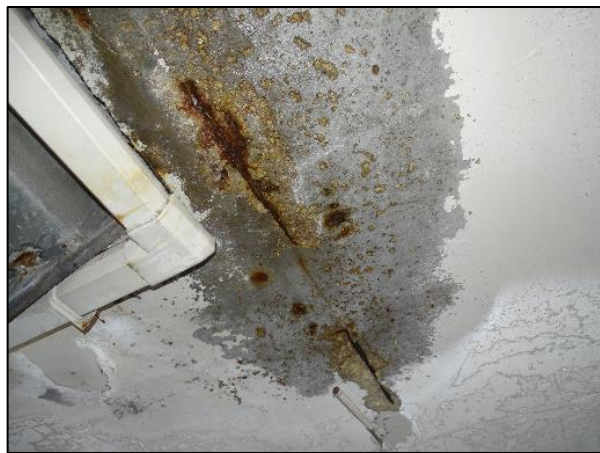
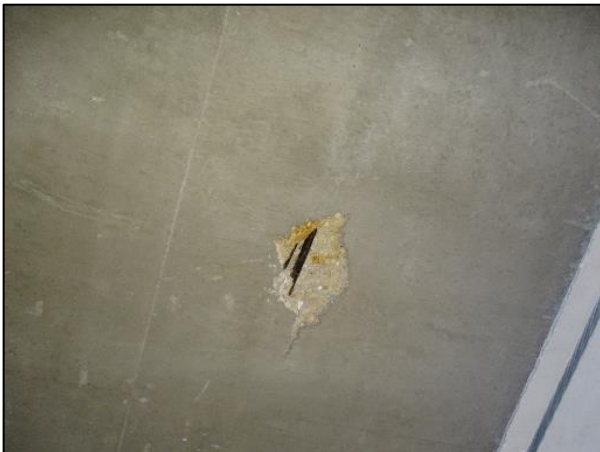
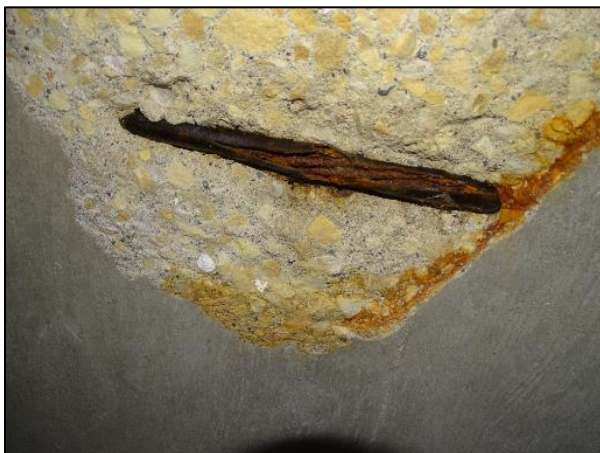
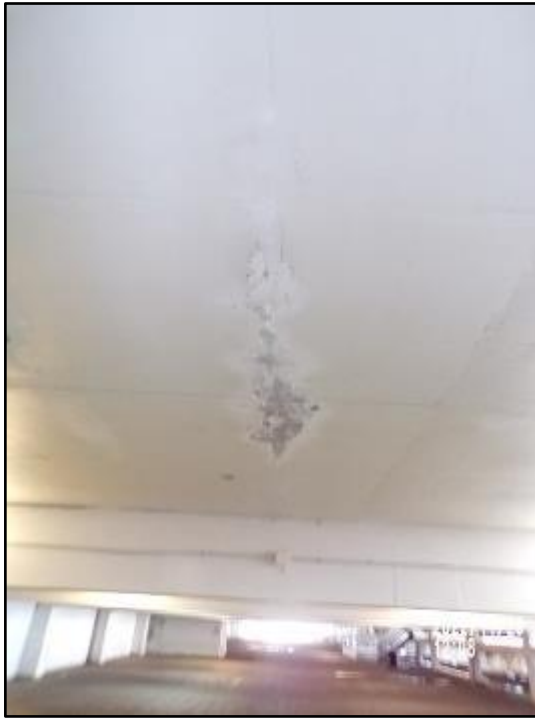
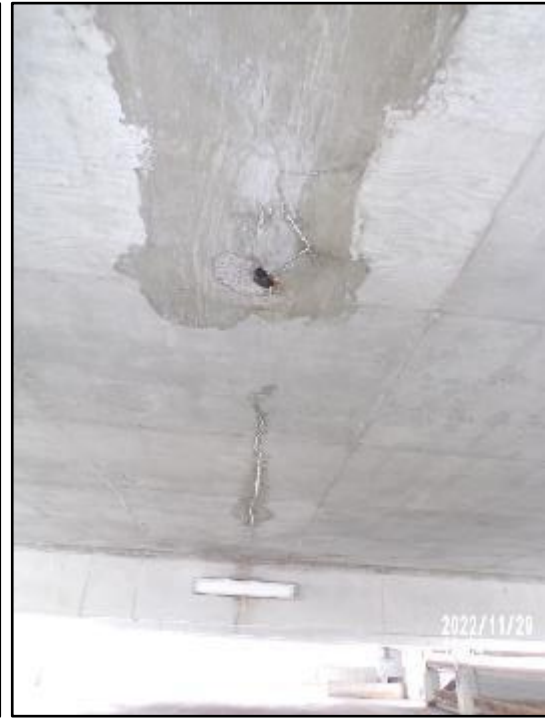
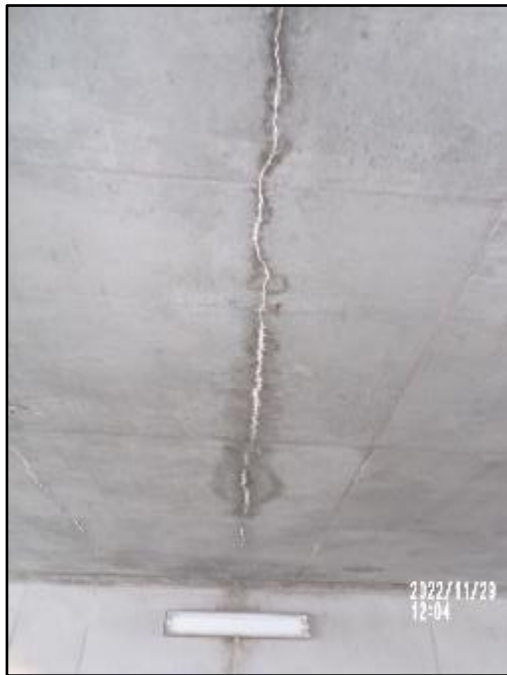
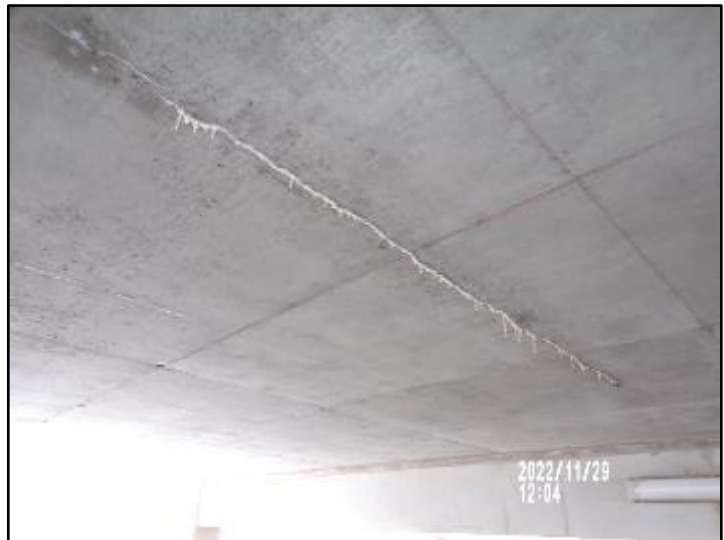
2.5.1 Bottom cracking is present on the underside of all PT slabs with varied levels of cracking.

2.5.1.2 Cracks in the underside of the slabs showed varied degrees of efflorescence present.

2.5.2 Moisture penetration and wet spots were noted on all undersides of the PT slabs but was most noticeable at beams supporting the expansion joints on grids 7 and 13.

2.5.2.1 Corrosion staining from a steel angle or plate corrosion was present at all locations with the expansion joint above it.

2.5.3 Several locations had deteriorated concrete and corroded non-epoxy coated rebar visible.

2.5.4 Several concrete spalls with exposed broken PT tendons were observed on the underside of slabs at all levels.

Bottom Surfaces of PT Slabs and Beams

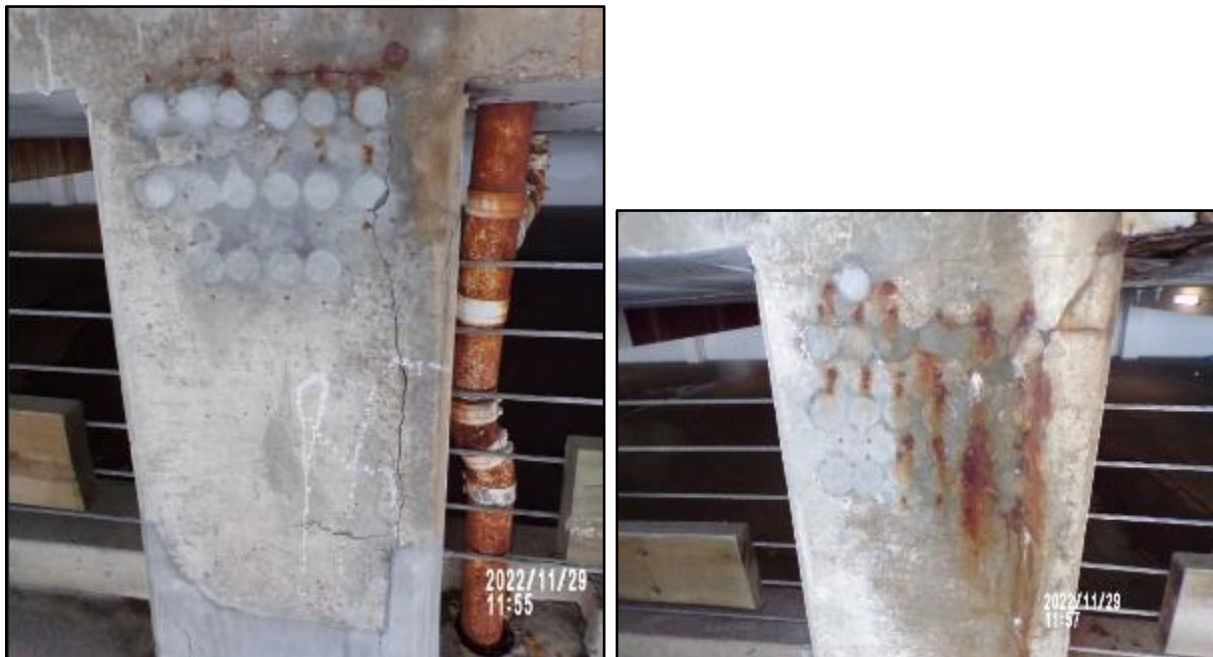
Level 2.5 previous column base patching starting to re crack

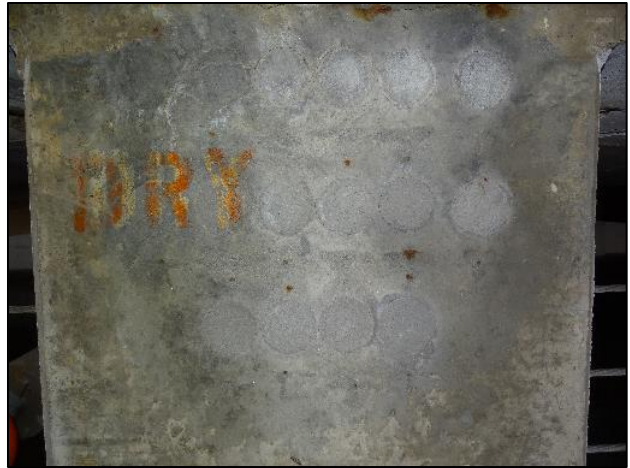
2.5.4.2 At some locations, the broken tendons have contracted after breaking.

Broken PT Cable at column
